EL03-031e

EXTERIOR LAMP FOGGING

APPLIED VEHICLES: 2001-2010 Infiniti, All Models

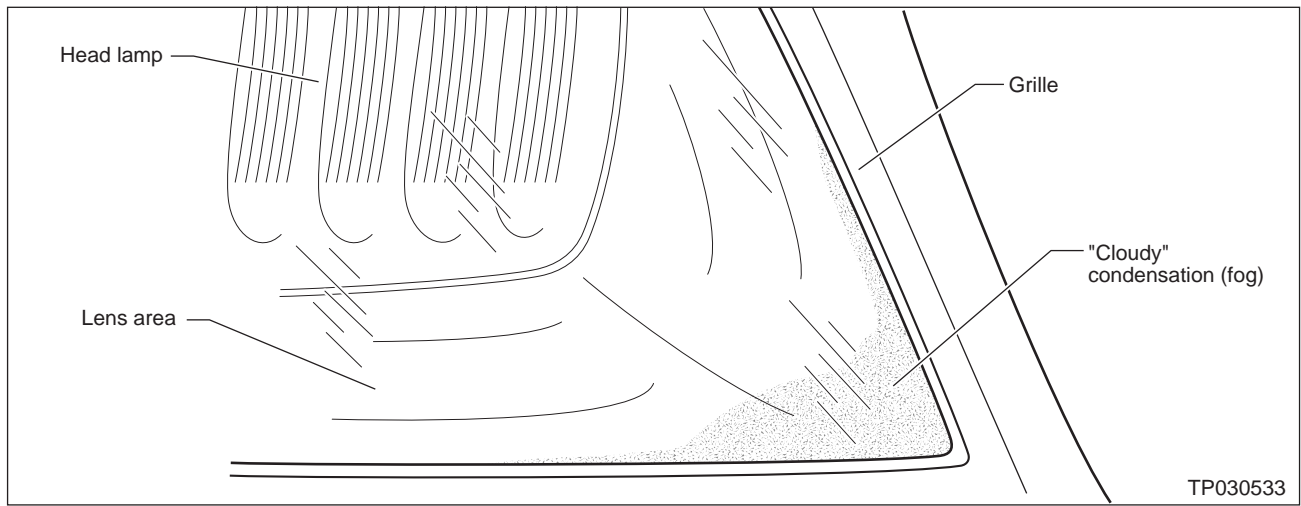
Fog may temporarily form inside the lens of the exterior lights based on environmental conditions or sudden temperature changes (such as in a car wash). This is normal. See Figure 1.

Figure 1: Example of normal condensation, ok

NOTE: This condensation can appear anywhere on the outer lens, typically at its coldest location.

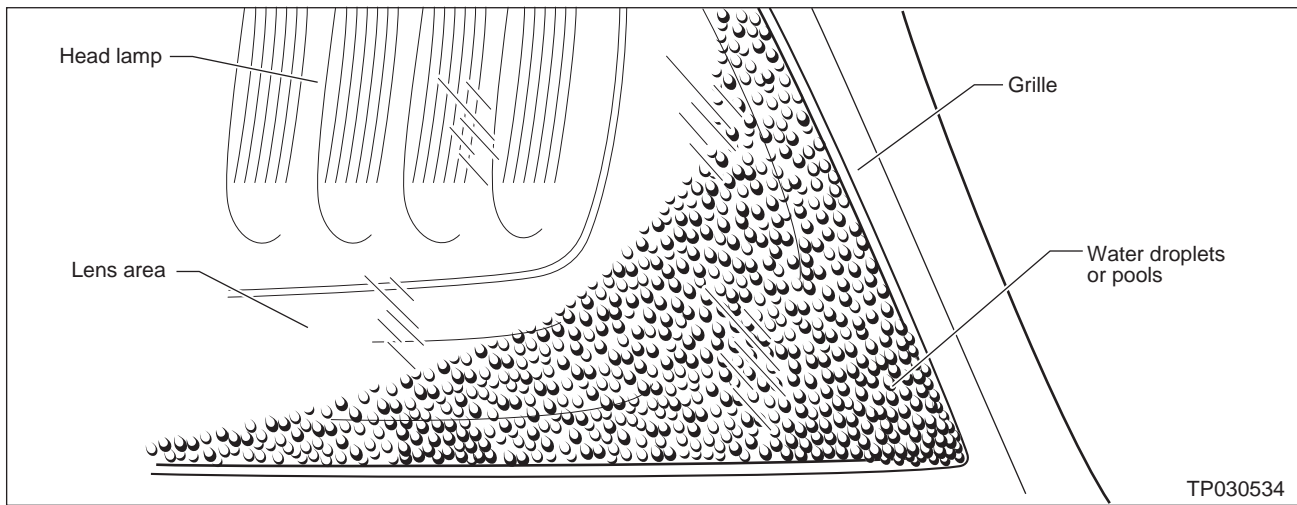
Figure 2: Condition may not be normal

If the moisture trickles, drips, or pools, it may not be considered normal and the headlamp assembly may have a water leak path. See Figure 2 for an example.

If large drops of water collect inside the lens, refer to the flow chart on page 3 to find the next step to take.
