**Classification:**  
 EC08-010b

**Reference:**  
 ITB08-028b

## 2008 G37 COUPE; NOISE FROM BANK 2 VVEL ACTUATOR

**APPLIED VEHICLE:** 2008 G37 Coupe (CV36)

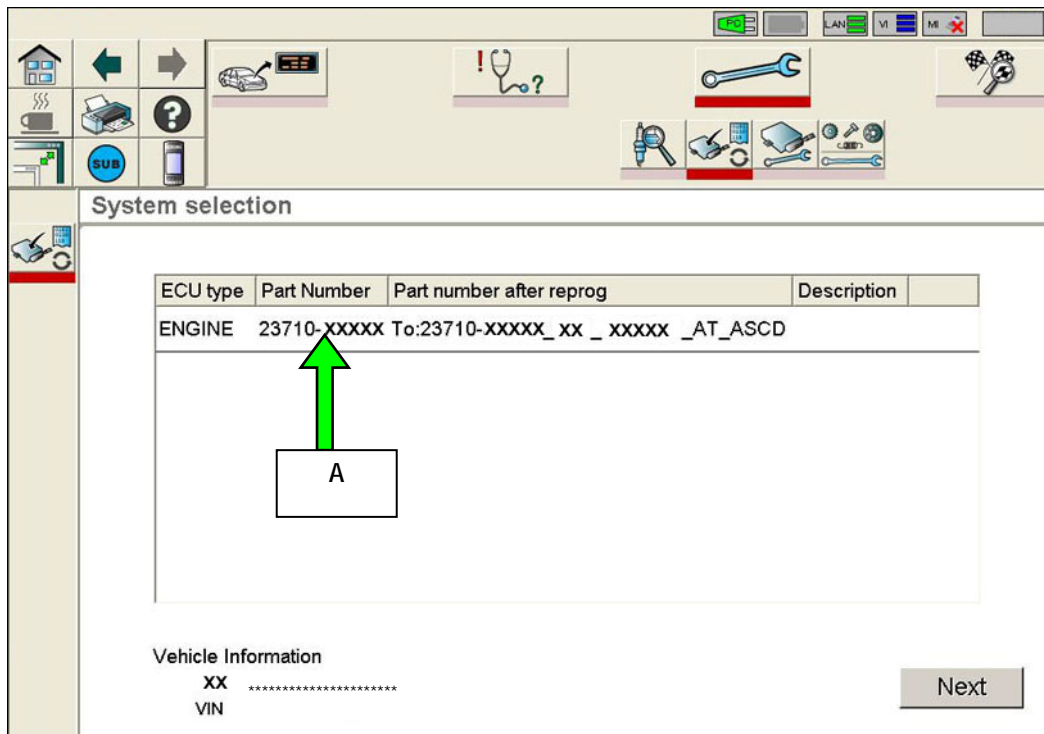
Figure 1

2. When you get to the ECM Reprogramming screen shown in Figure 1, confirm this bulletin applies as follows:

A. On your C-III screen, look at the **Part Number** column (see Figure 1):

- If this column is **blank** (no part number listed), this **bulletin does not apply**. Close C-III and refer to ASIST for further diagnostic information.
- If a Part Number is listed, write it on the Repair Order.

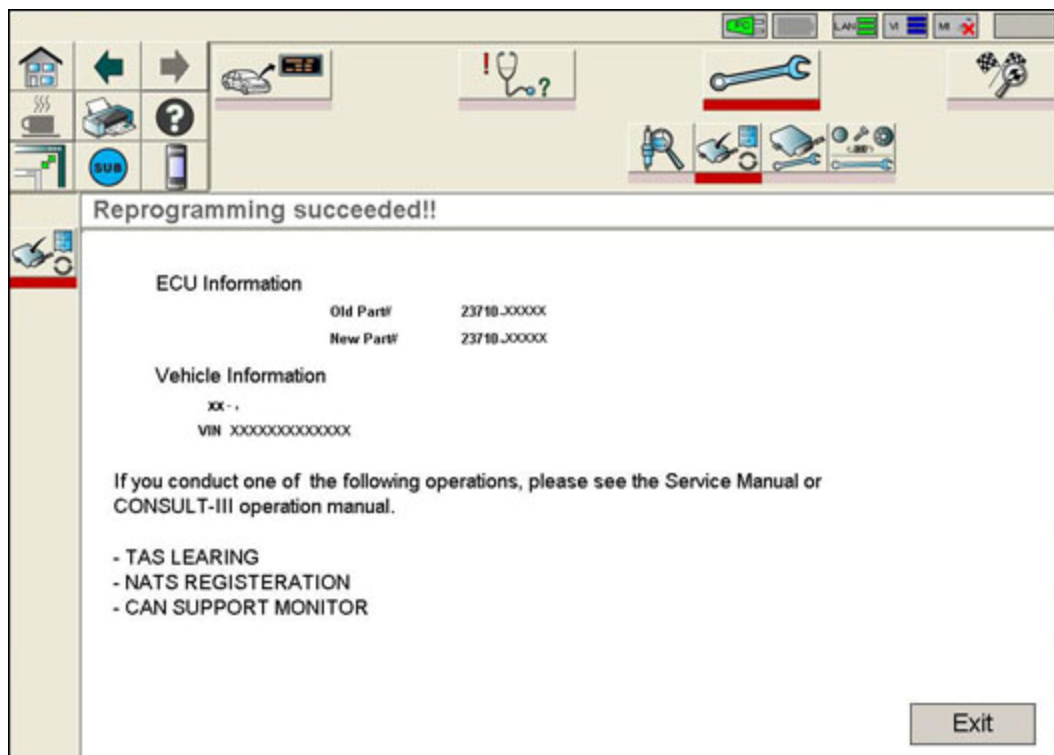
**Figure 2**

3. If this bulletin applies and you have performed ECM reprogramming, the screen in Figure 2 displays when the reprogramming is completed.

Print this screen and attach it to the Repair Order for Warranty documentation.
