EL09-003

ITB09-025

## 2008 – 2009 G37 COUPE; WINDOWS MOVE DOWN / UP WHEN GLOVE BOX IS CLOSED

**APPLIED VEHICLE:** 2008 – 2009 G37 Coupe (CV36) with Vehicle Security System (VSS) accessory impact sensor installed.

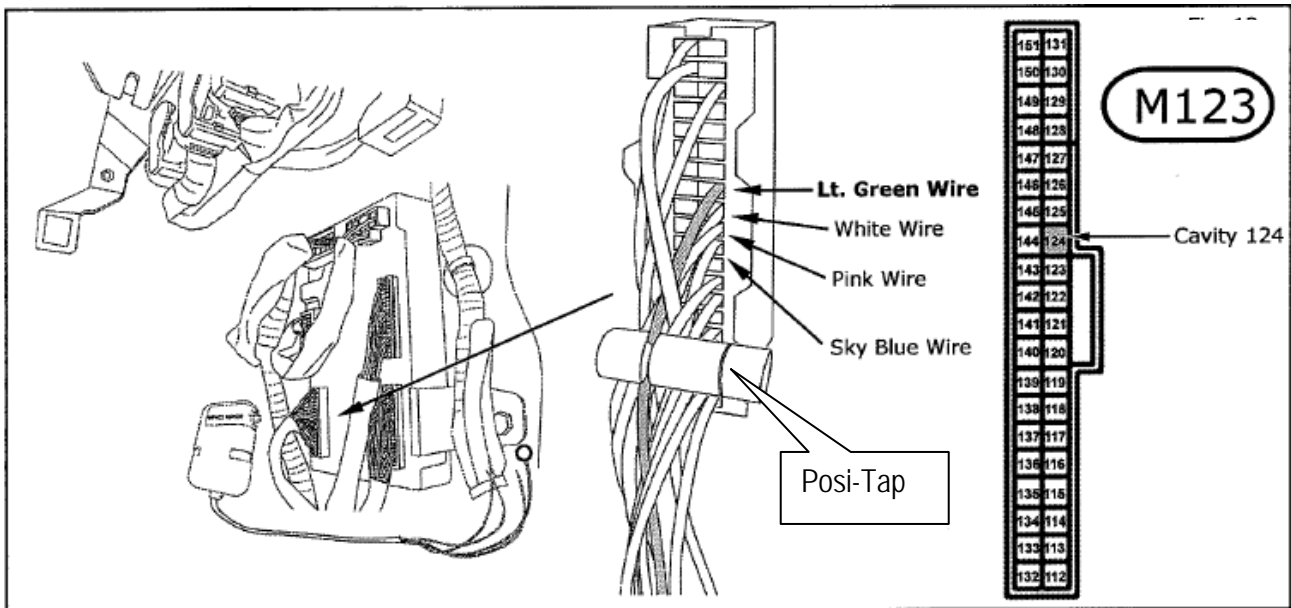
Figure 1

When the glove box is pushed from open to close the side windows move down about an inch and then back up.

5. Remove / disconnect the impact sensor Brown wire from the Light Green wire in BCM connector 123, cavity 124 (see Figure 1).

- To access the BCM, refer to the Service Manual.
- Do not damage the Posi-Tap® - it will be reused to reattach the brown wire.
- If needed, refer to [Posi-Tap® Use](#) on page 5.
