BT09-019

SUNROOF WIND NOISE

APPLIED VEHICLES: M35 / 45 (Y50)
 G35 / 37 Sedan (V36)
 G37 Coupe (CV36)
 FX35 / 50 (S51)
 EX35 (J50)

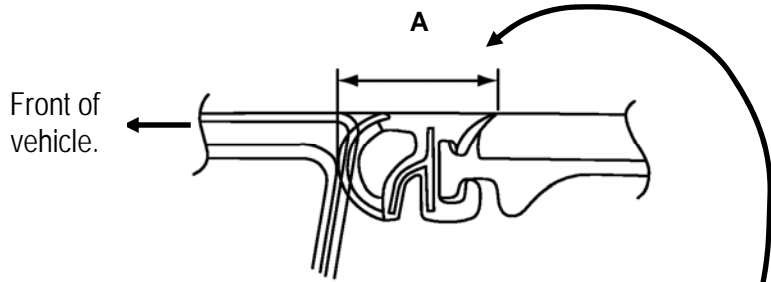
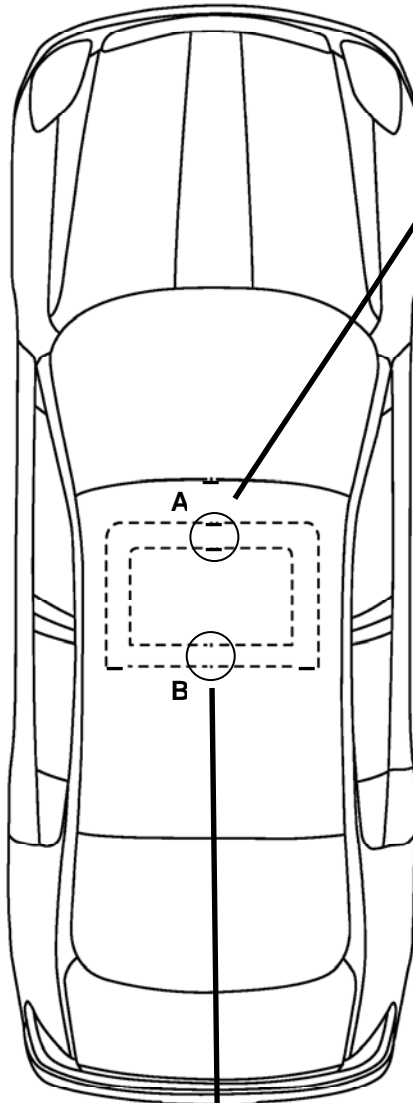
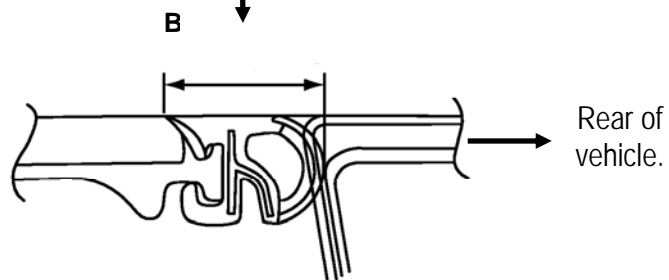
Measure gaps at A and B.

TARGET: Difference no greater than 1 mm.

1. Clean the Sunroof Glass Lid Assembly (glass lid) seal and sunroof opening edge.
 - Use isopropyl alcohol or suitable cleaner.
2. Inspect the fit of the glass lid. Adjust as needed (refer to Figure 1 on page 3, and Figure 2 on page 4).
 - Use the appropriate ESM as needed.
 - The front of the glass lid should be flush but no more than 0.5 mm below the roof surface.
 - The rear of the glass lid should be flush but no more than 0.5 mm above the roof surface.
 - The difference in the glass lid's front-to-rear gaps should be no greater than 1 mm.
