EC09-003a

June 5, 2009

## 2008 G35 AND 2009 G37; MIL 'ON' WITH DTC P0116 (ENGINE COOLANT TEMP SENSOR)

**APPLIED VEHICLE:**    2008 G35 Sedan (V36)  
                                  2009 G37 Sedan and Coupe (V36 and CV36)

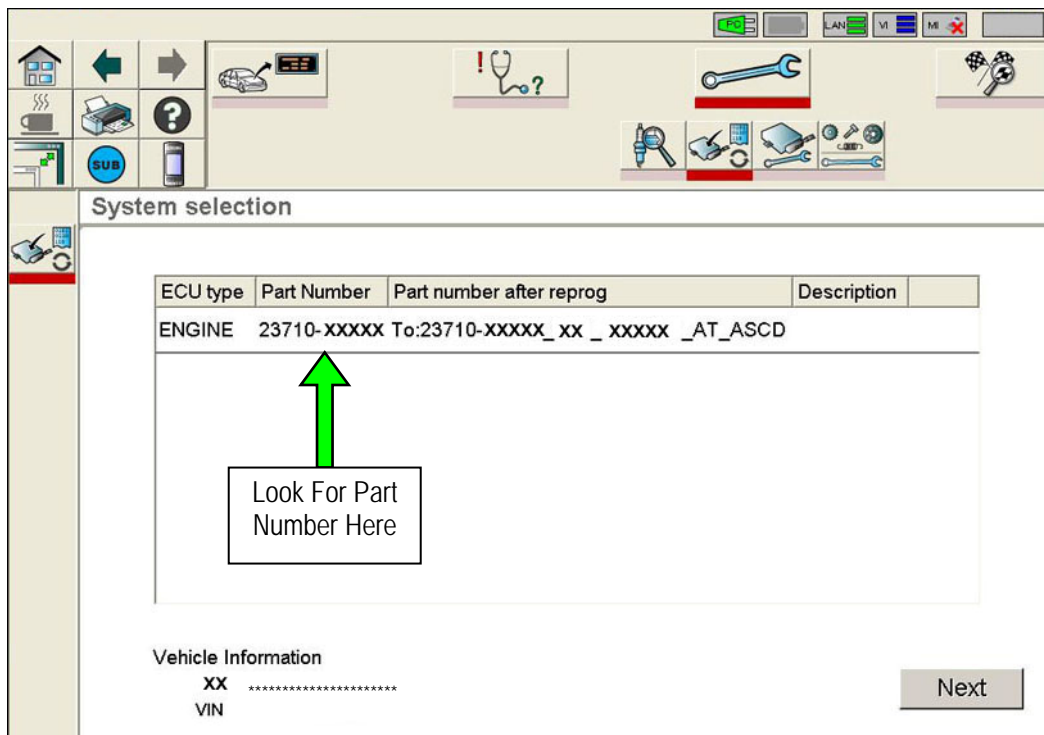
2. When you get to the ECM Reprogramming screen shown in Figure 1, confirm this bulletin applies as follows:

- A. On your C-III screen, look at the **Part Number** column (see Figure 1 example).

- If this column is **blank** (no part number listed), this **bulletin does not apply.**
- If a Part Number is listed, write it on the Repair Order and then go to Step B.

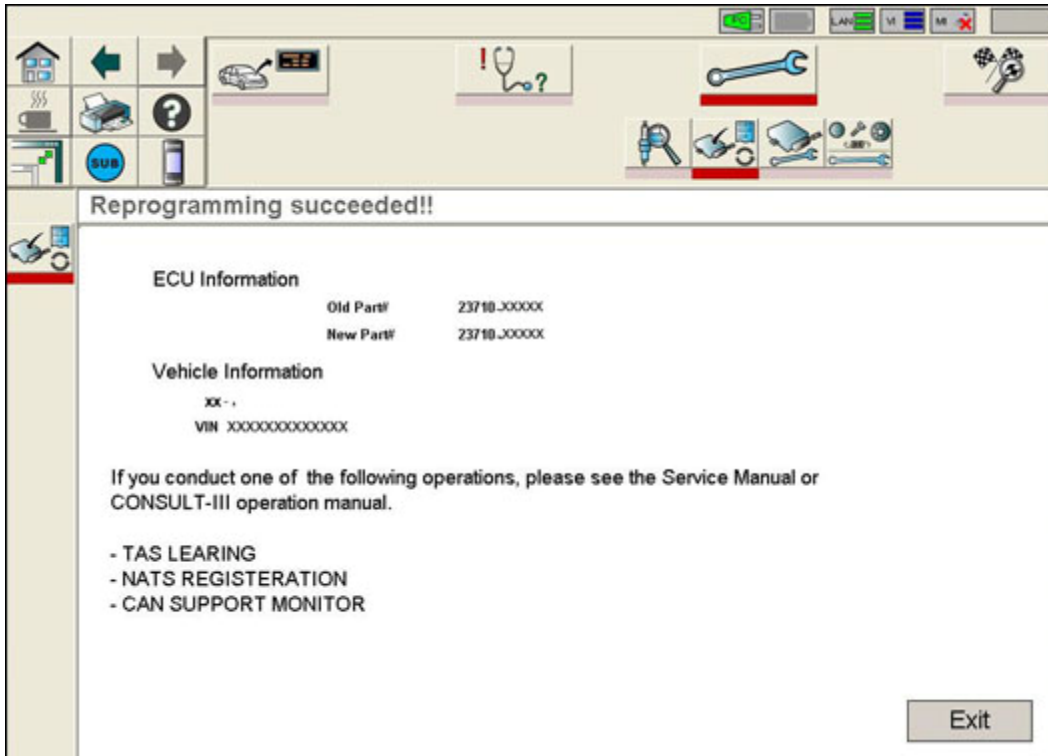
3. If this bulletin applies and you have performed ECM reprogramming; when reprogramming is complete, the screen in Figure 2 appears.

Print the page from C-III (C-III page example below) and attach it to the Repair Order for Warranty documentation.
