Classification:
 AT09-009b

Reference:
 ITB09-032b

7 SPEED A/T HARSH 4>3 DOWNSHIFT ON DECELERATION

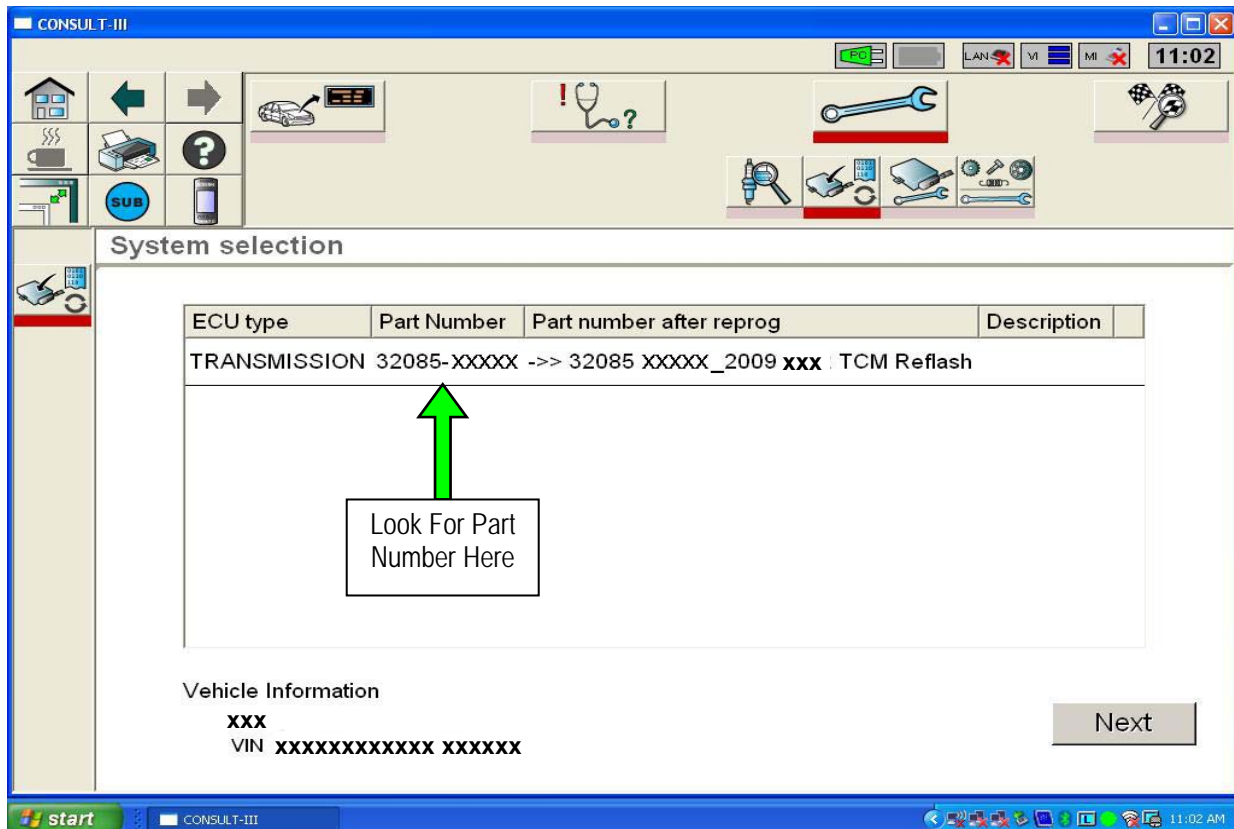
2. When you get to the TCM Reprogramming screen shown in Figure 1, confirm this bulletin applies as follows:
 - A. On your C-III screen, look at the **Part Number** column (see Figure 1 example).
 - If this column is **blank** (no part number listed), this **bulletin does not apply.**
 - If a Part Number (P/N) is listed, write it on the Repair Order and then go to Step B.

B. Compare the P/N you wrote down to the numbers in the **Current TCM P/N** column in **Table A** below.

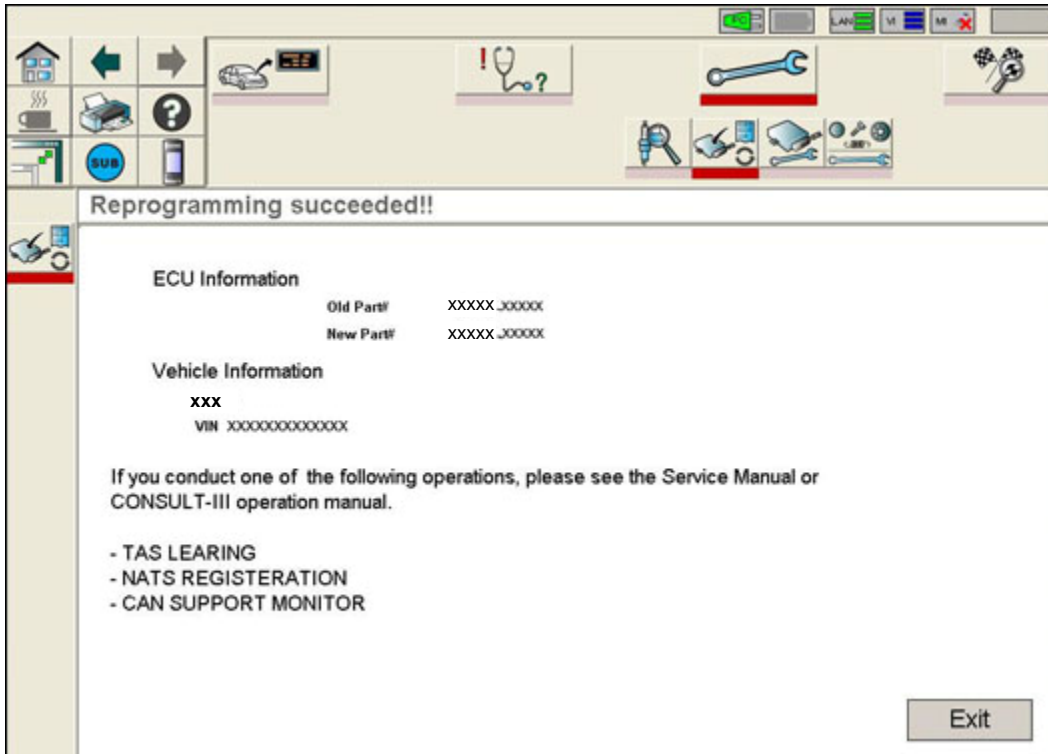
3. If this bulletin applies and you have performed TCM reprogramming; when reprogramming is complete, the screen in Figure 2 appears.

Print the page from C-III (C-III page example below) and attach it to the Repair Order for Warranty documentation.
