EL10-042

ITB10-066

NAVIGATION / BLUETOOTH / VOICE RECOGNITION FUNCTION ISSUES

APPLIED VEHICLES: 2010-2011 EX35 (J50)
2010-2011 FX35/FX50 (S51)
2010-2011 G37 Coupe, Convertible, Sedan (C/H/V36)
2011 M37/M56 (Y51)
2011 QX56 (Z62)

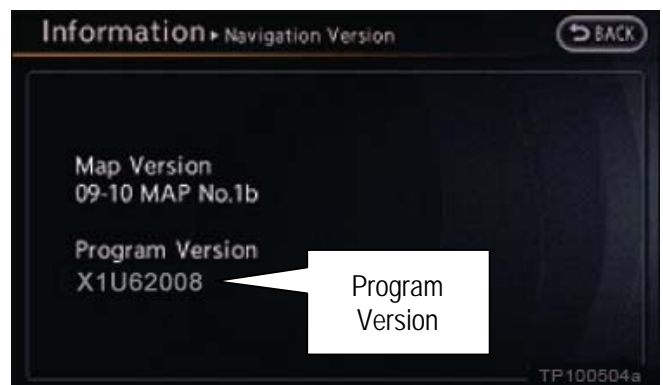
Figure 3

6. Check the **Program Version**.
 - If the Program Version is not **X1U72001** or **X2U32001**, continue with Step 7 on the next page.
 - If the Program Version is **X1U72001** or **X2U32001**, this bulletin does not apply. Refer to ASIST for further diagnostic information.

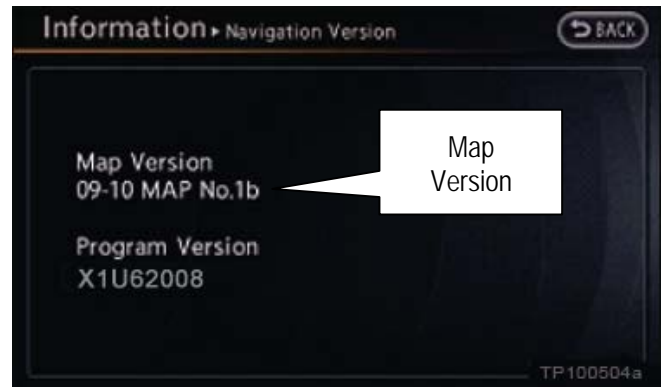
Figure 4

7. Check the **Map Version**.

- If the Map Version is not **09-10 MAP No. 1a**, continue with section B of this bulletin (Disable Bluetooth® Function).
- If the Map Version is **09-10 MAP No. 1a**, first perform the procedure in ITB10-031. Once complete, continue with section B of this bulletin (Disable Bluetooth® Function).

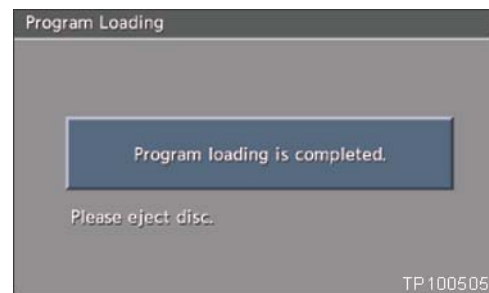
Figure 8

- The Reprogramming Software DVD will automatically eject.
- "Program loading is completed" will display.

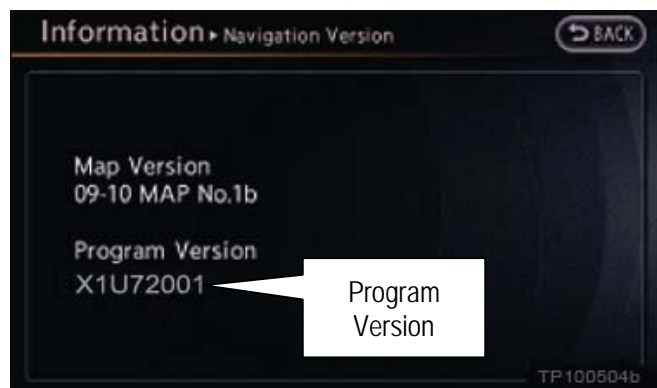
Figure 10

- c. The Program Version should be **X1U72001** or **X2U32001**.
 - If the Program Version is not **X1U72001** or **X2U32001**, perform the Load Reprogramming Software DVD procedure again.
