EL10-042d

November 3, 2011

## NAVIGATION SOFTWARE UPDATE

**VEHICLES:** 2011 EX35 (J50) built **after** September 6, 2010  
2011 FX35/FX50 (S51) built **between** August 20, 2010 and August 1, 2011  
2011 G37 Sedan (V36) built **after** August 17, 2010  
2011 G37 Coupe & Convertible (C/HV36) built **after** Sept. 20, 2010  
2011 QX56 (Z62) built **after** September 8, 2010  
2012 QX56 (Z62) built **before** August 1, 2011  
2012 M37/M56 (Y51) built **between** February 9, 2011 and August 1, 2011  
2012 M35h Hybrid (Y51HV) / built **between** February 8, 2011 and August 1, 2011

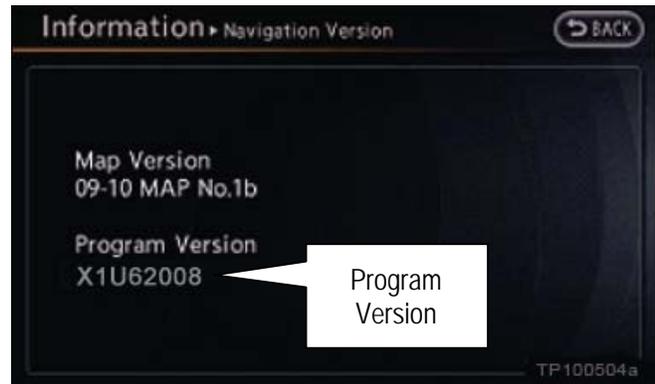
Figure 3

6. Check the **Program Version**.

7. Refer to the Flow Chart below.

1. Perform steps 1-7 of **Check Navigation Program Version** in the Service Procedure to verify whether or not this bulletin applies.
2. If this bulletin applies, Follow the Service Procedure to load the Reprogramming Software DVD referenced in the Parts Information section.

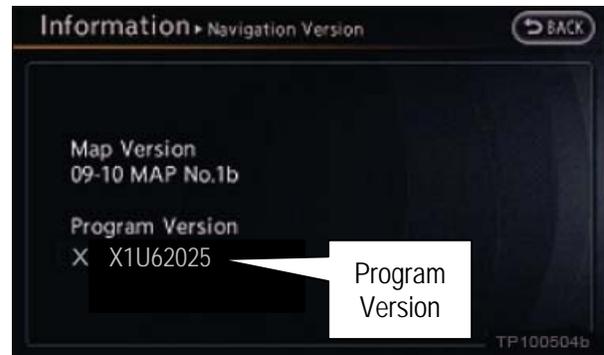
Figure 7

- c. The Program Version should be **X1U62025**.
- If the Program Version is not X1U62025, perform the Load Reprogramming Software DVD procedure again.
