Classification:
BT10-037

Reference:
ITB10-069

G37 CONVERTIBLE; HEADLINING SERVICE INFORMATION

APPLIED VEHICLE: 2009 – 2011 G37 Convertible (HV36)

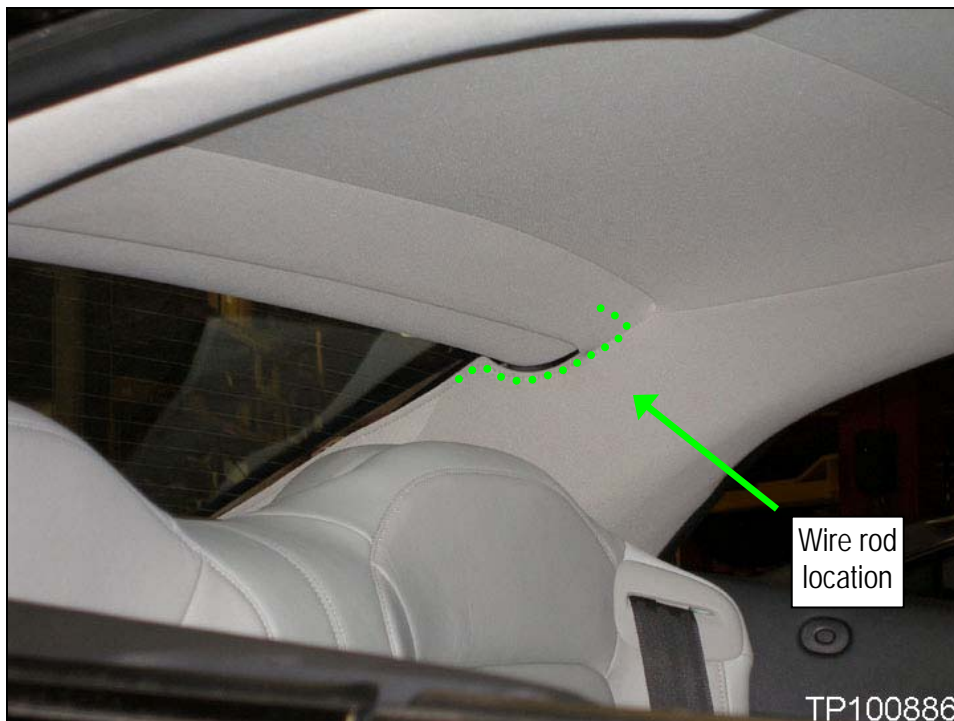
NOTE: There are two (2) wire rods, one at each end of the rear rib. The photo below shows its location on the left side.

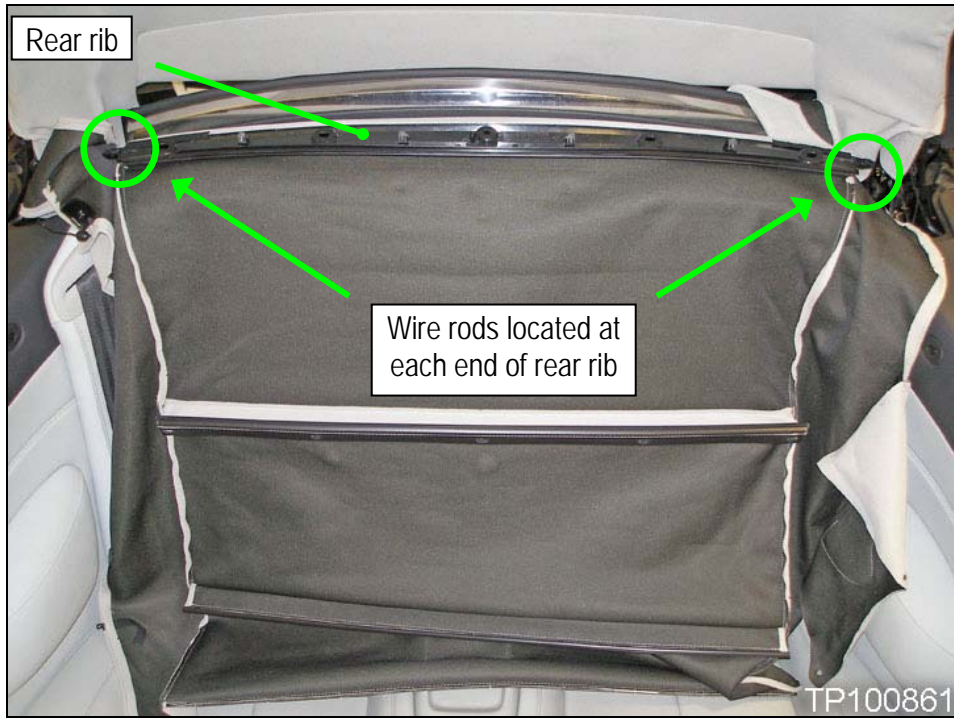
Headlining, removed

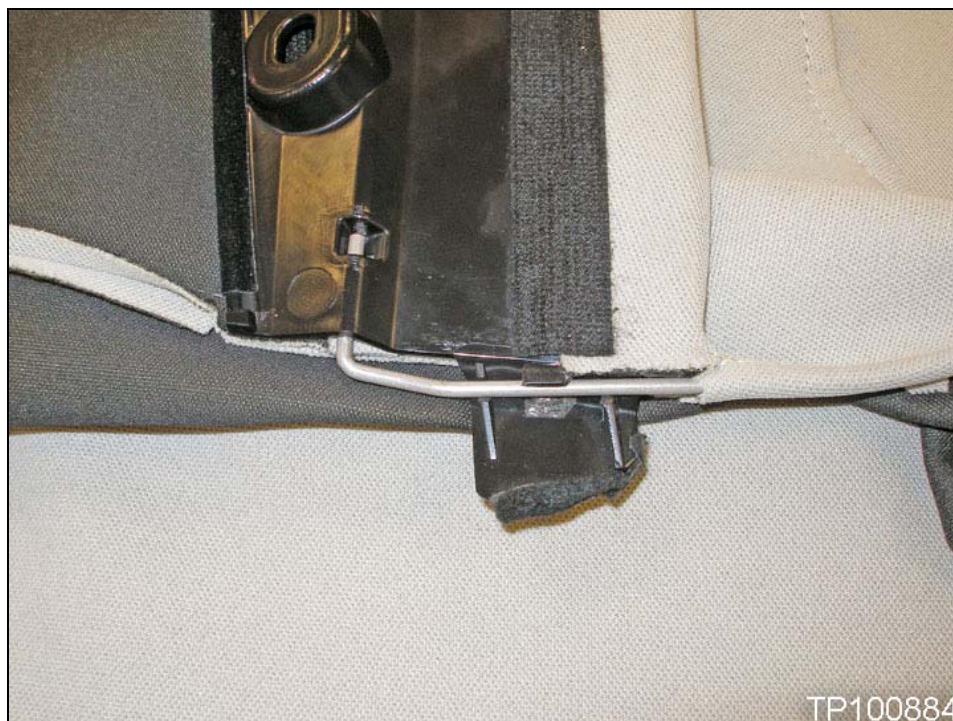
Wire rod properly installed

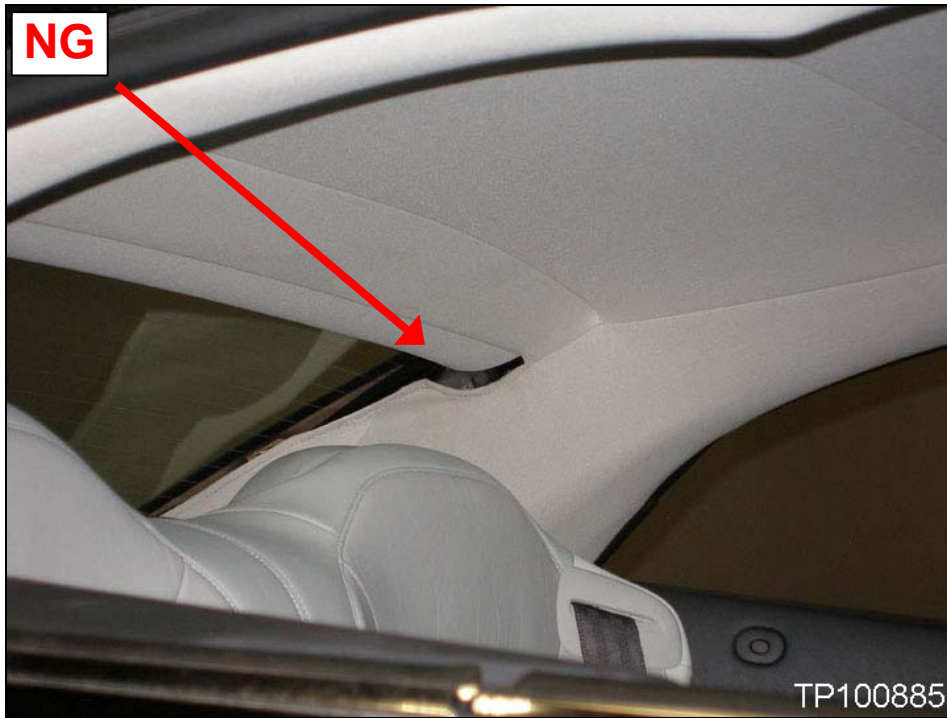
When installing the wire rods, make sure they are properly secured to the rear rib. Improper installation may cause the headlining to sag at the "C" pillar, and / or cause damage to the headlining during convertible roof operation.

Wire rod improperly installed; headlining sags

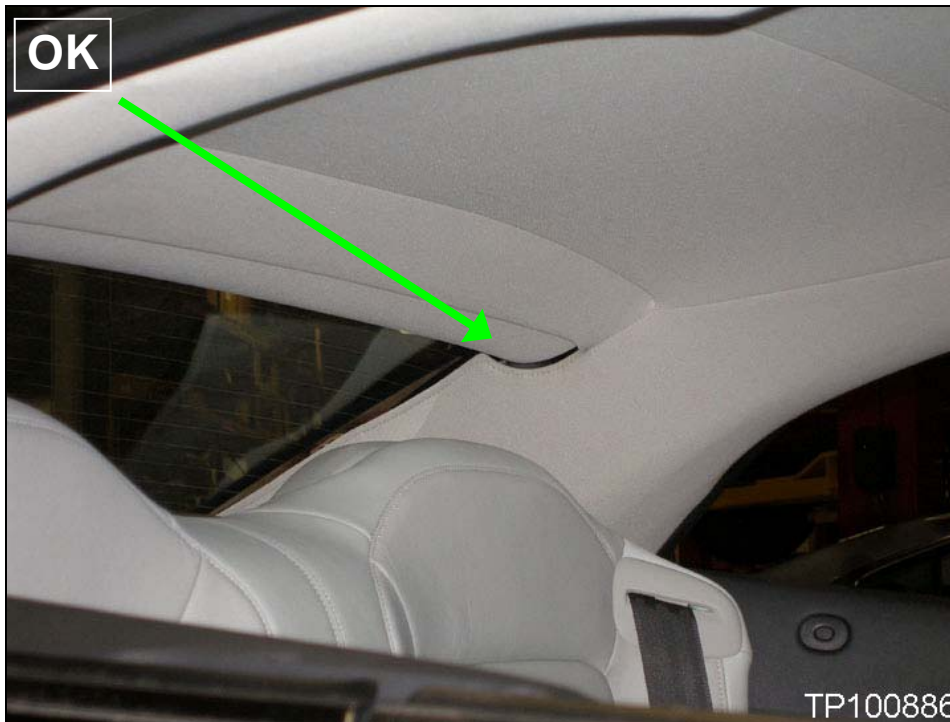
Wire rod properly installed
