PD11-001

## G37 AWD; VIBRATION AND / OR BOOMING NOISE AT HIGHWAY SPEED

**APPLIED VEHICLES:** 2009 – 2011 G37 Sedan and Coupe (V36); **AWD only****APPLIED VINs and****DATES:**

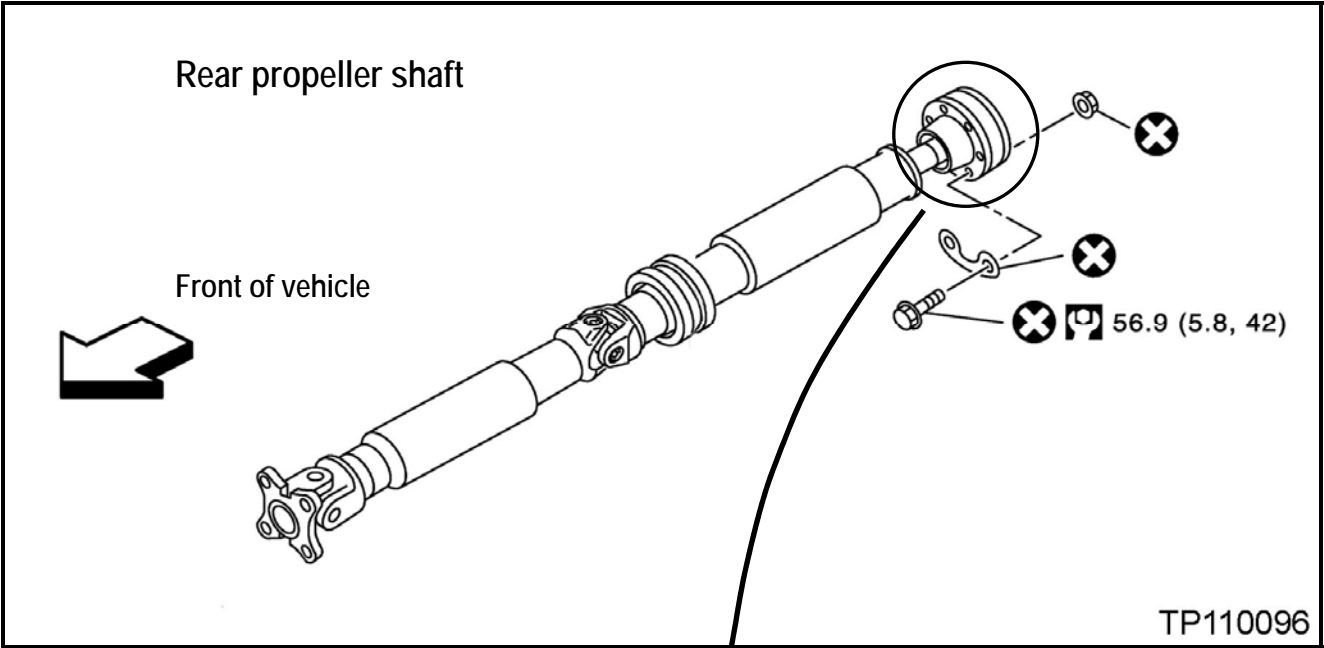
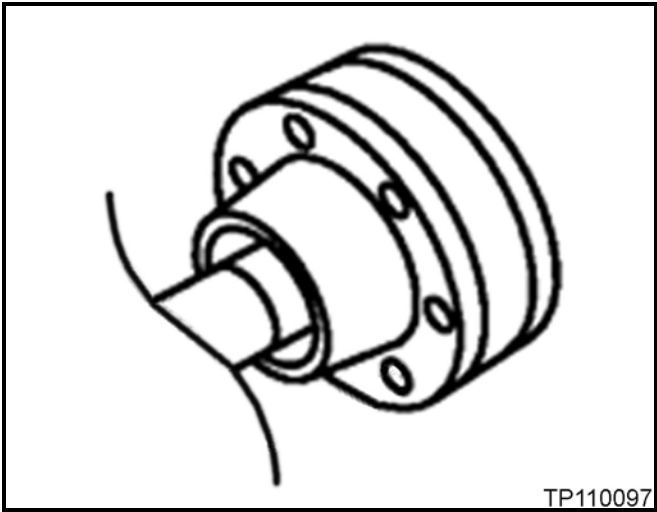
Rebro joint

- Vibration felt in the seat and / or floor
- Inside rear view mirror vibrates, causing blurred reflection
- Vibration heard from the rear parcel shelf
- Booming noise heard

"Free up" the rebro joint in the rear propeller shaft.
