BT11-022

June 13, 2011

G37 CONVERTIBLE; RATTLE OR RUBBING NOISE FROM ROOF AREA

APPLIED VEHICLE: 2009 - 2011 G37 Convertible (HV36)

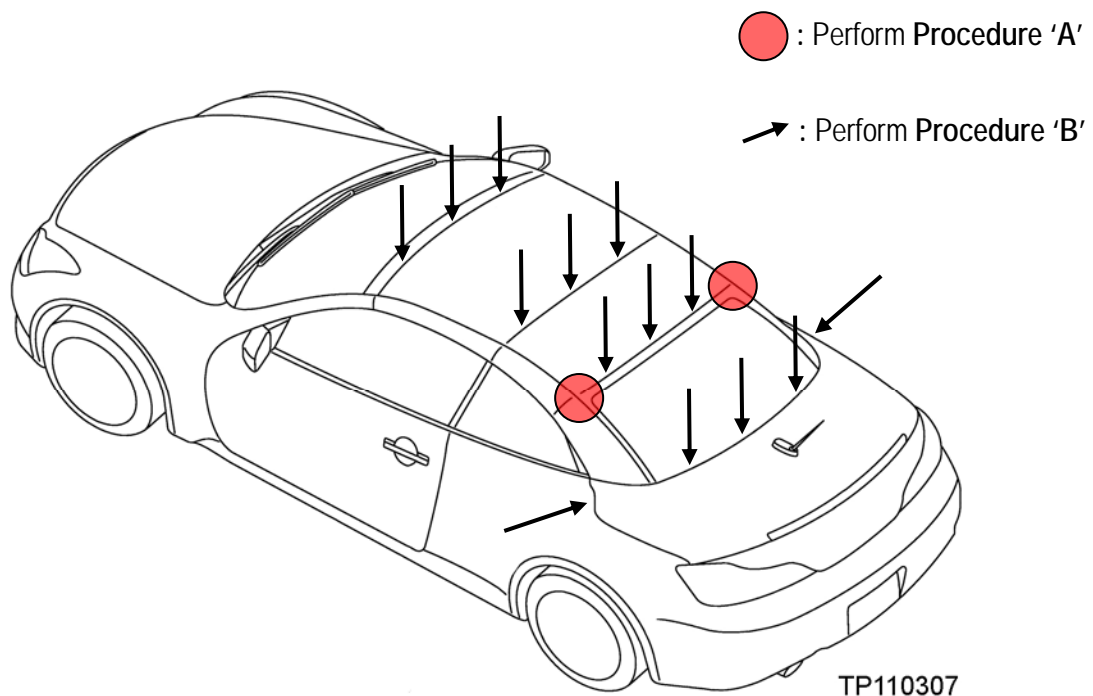
There is a rattle or rubbing / creaking noise coming from the roof area (where shown in Figure 1) while driving.

If a rattling noise is coming from the area(s) shown in Figure 1 (●), perform **Procedure 'A'** starting on Page 3: Replace both center roof panel pin O-rings, and then realign both center panel retainers.

If a rubbing / creaking noise is coming from the area(s) shown in Figure 1 (↗), perform **Procedure 'B'** starting on Page 5: Clean and condition all roof seal contact surfaces.
