EL11-039

October 19, 2011

iPOD® / iPHONE® ISSUES USING VEHICLE USB INTERFACE

APPLIED VEHICLES: All Infiniti vehicles equipped with a USB Interface

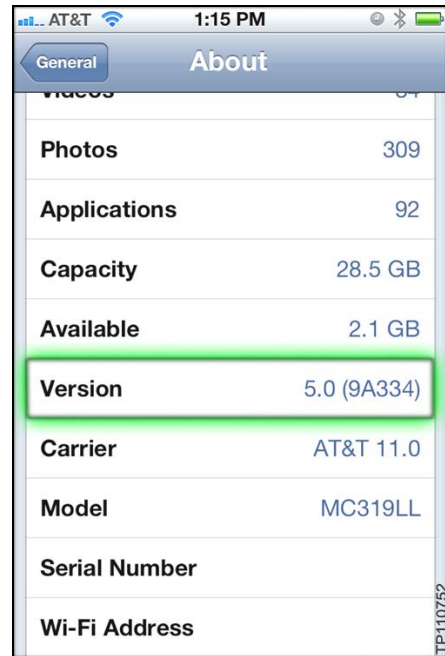
3. Confirm the latest software is installed on the iPod® / iPhone®

- Many concerns are addressed by installing the latest iPod® / iPhone® software update from Apple Inc.
- View the software version of the iPod® / iPhone® by navigating to the **Settings** area of the device, then selecting **General** > **About** or **Settings**.
- Visit <http://support.apple.com/downloads> and select the applicable device to view the latest software update offered by Apple Inc.
