EC11-030

ITB11-065

## 2011 G25; MIL IS ON WITH P050E, COLD START CONTROL

**APPLIED VEHICLES:**                    2011 G25 (V36) 2WD  
                                                  2011 G25 (V36) AWD  
**APPLIED ENGINE:**                    VQ25HR

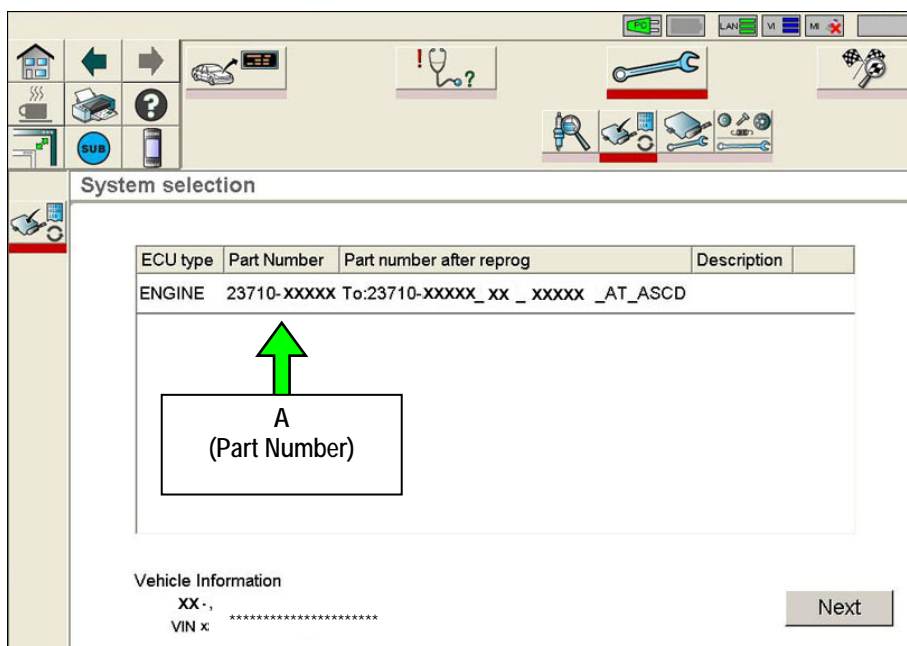
Figure 1

A. On your C-III screen, look at the **Part Number** column (see Figure 1):

- If this column is **blank** (no part number listed), this **bulletin does not apply**. Close C-III and refer to ASIST for further diagnostic information.
- If a Part Number is listed, write it on the Repair Order.

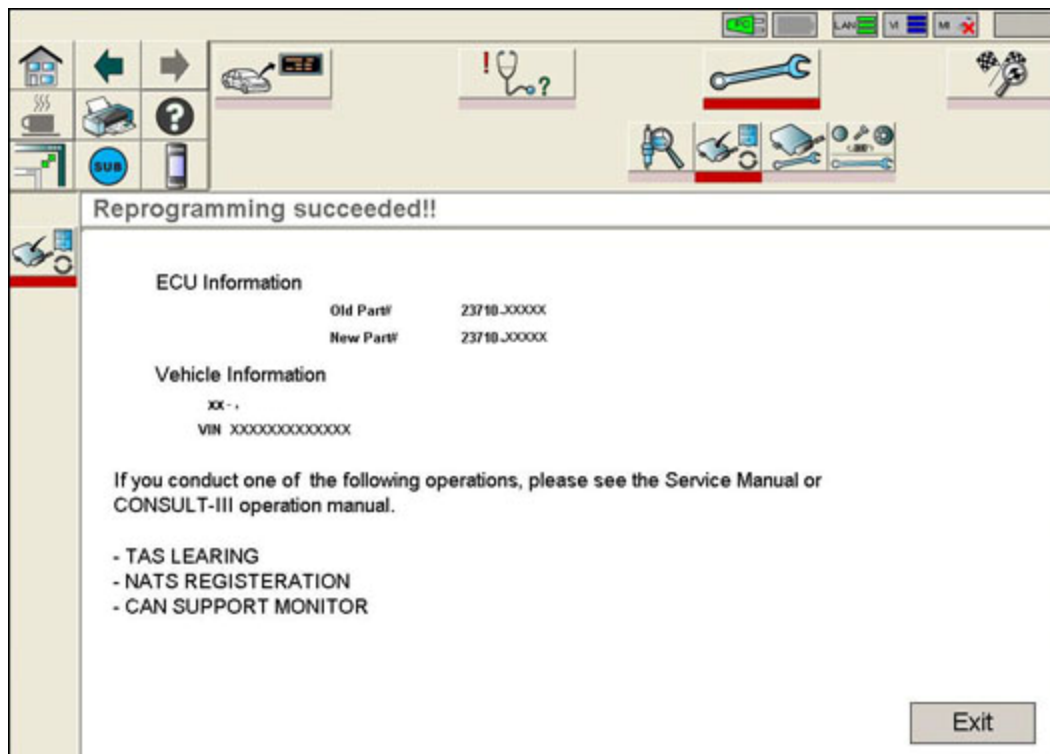
3. If this bulletin applies and you have performed ECM reprogramming, the screen in Figure 2 appears when reprogramming is complete.

- Print this screen and attach it to the Repair Order for Warranty documentation.
