BT11-031a

ITB12-003a

2009-2011 G37 CONVERTIBLE; SQUEAK / RATTLE / BUZZ NOISE FROM ROOF AREA

APPLIED VEHICLE: 2009 - 2011 G37 Convertible (HV36)

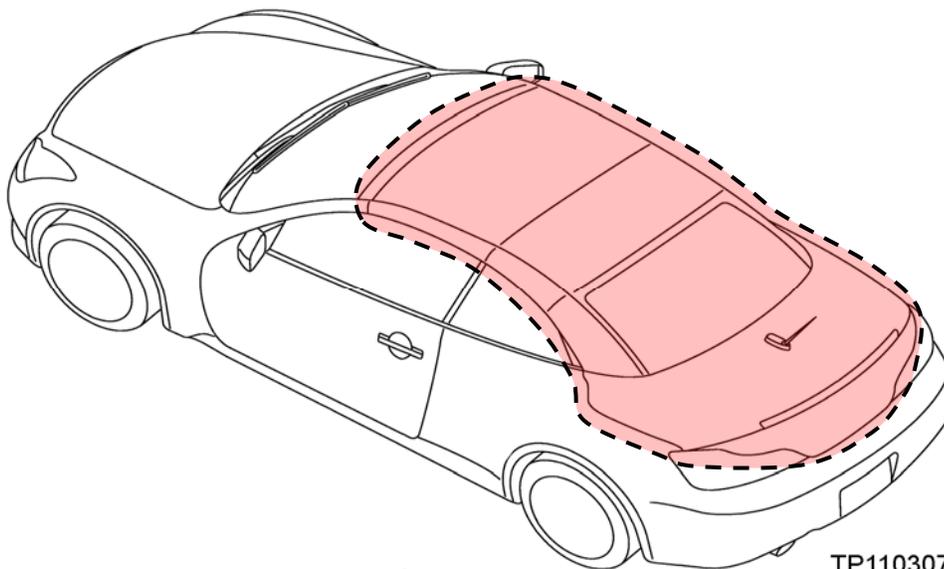
There is a squeak, rattle, or "buzz" type noise coming anywhere from the retractable hard top or trunk area while driving.

Perform all repairs as outlined in **SERVICE PROCEDURE**.

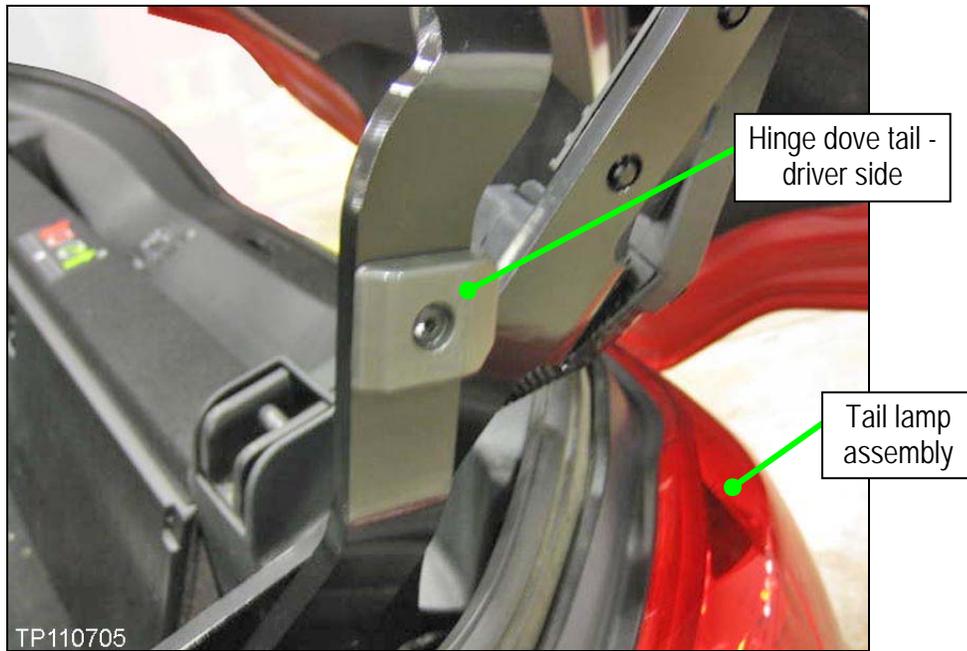
Figure 46

46. Inspect both driver and passenger side hinge dove tails (see Figure 46).

- If either one is found worn, replace both.

➤ T20 Torx bolt torque: 3.5 - 4.5 N•m (0.36 - 0.46 kg-m, 31.0 - 39.8 in lbs)
