BT12-002

ITB12-019

April 17, 2012

## G SEDAN; PAINT CHIPPING OFF EDGE OF TRUNK LID

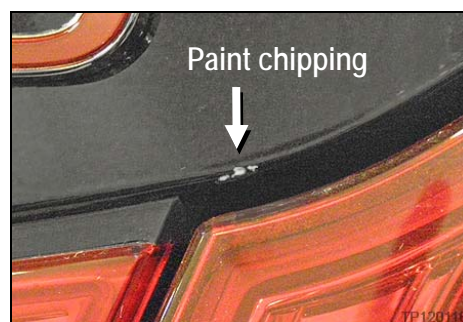
Figure 1

Paint is chipping off the edge of the trunk lid in the locations shown in Figure 2. Surface corrosion in this area may also be visible.

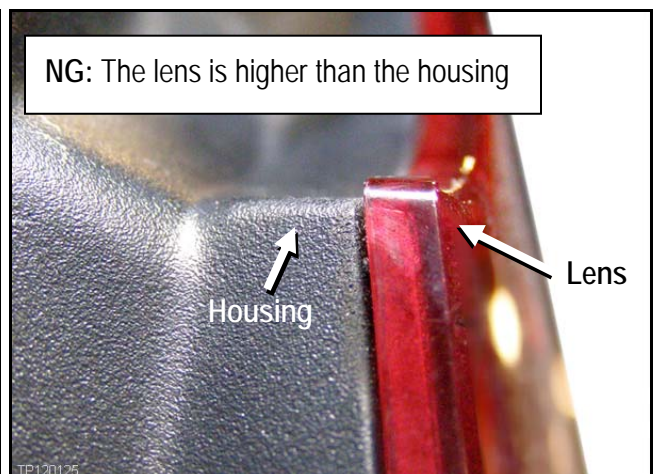
Figure 10

- 4. Confirm the position of the rear combination lamp located below the chipped paint.
  - a. Visually inspect and run your finger along the top of the rear combination lamp lens in the area shown in Figure 9.
  - b. If the lens is positioned **above** the rear combination lamp housing (see Figure 10) within the area shown in Figure 9, replace the affected rear combination lamp assembly.
  - c. If the lens is flush/even with the housing, proceed to step 5.
