EC12-010a

ITB12-026a

May 23, 2012

2010 - 2012 G37 AND M37; MIL ON WITH DTC P0106 STORED

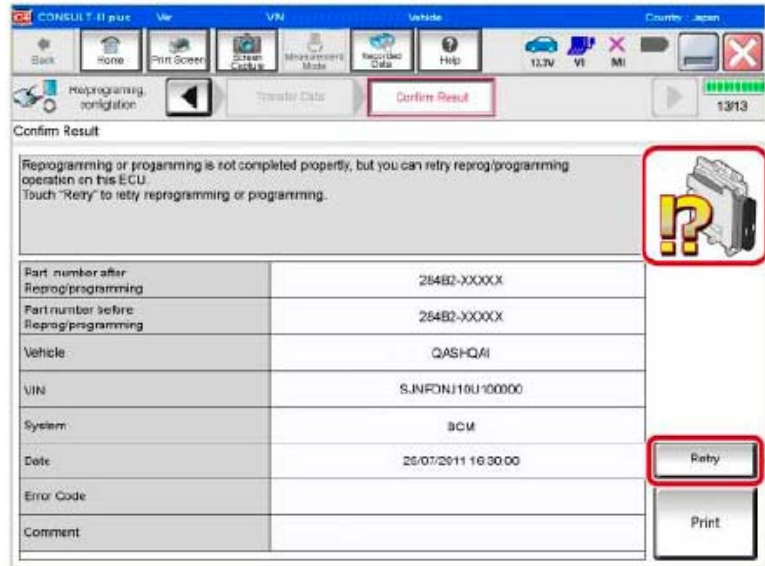
Figure 5

If reprogramming does not complete and the "!" icon displays as shown in Figure 5:

- Check battery voltage (12.0–15.5 V).
- Ignition is ON, engine OFF.
- External Bluetooth® devices are OFF.
- All electrical loads are OFF.
- Select retry and follow the on screen instructions.
- "Retry" may not go through on first attempt and can be selected more than once.

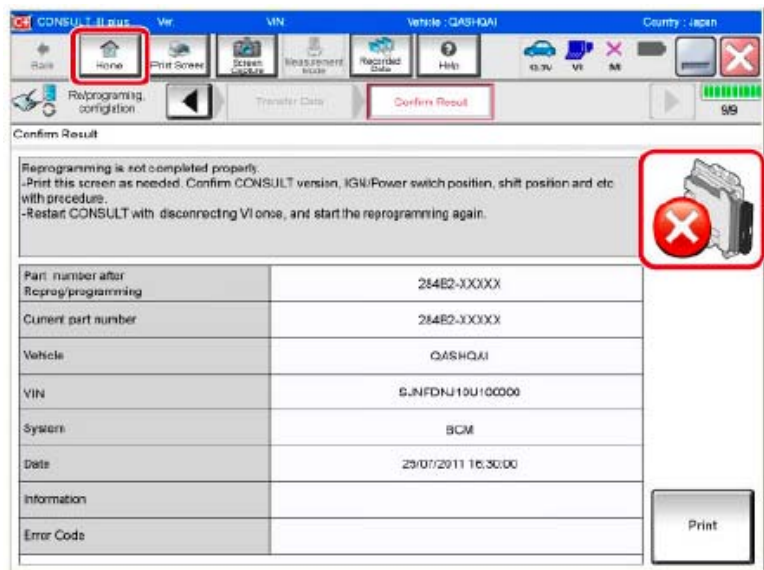
Figure 6

If reprogramming does not complete and the "X" icon displays as shown in Figure 6:

- Check battery voltage (12.0 – 15.5 V).
- CONSULT A/C adapter is plugged in.
- Ignition is ON, engine OFF.
- Transmission is in Park.
- All C-III plus / VI cables are securely connected.
- All C-III plus updates are installed.
- Select Home, and restart the reprogram procedure from the beginning.
