AT12-003c

ITB12-027c

August 29, 2012

2009 - 2012 G37; SHIFT RESPONSIVENESS ISSUES

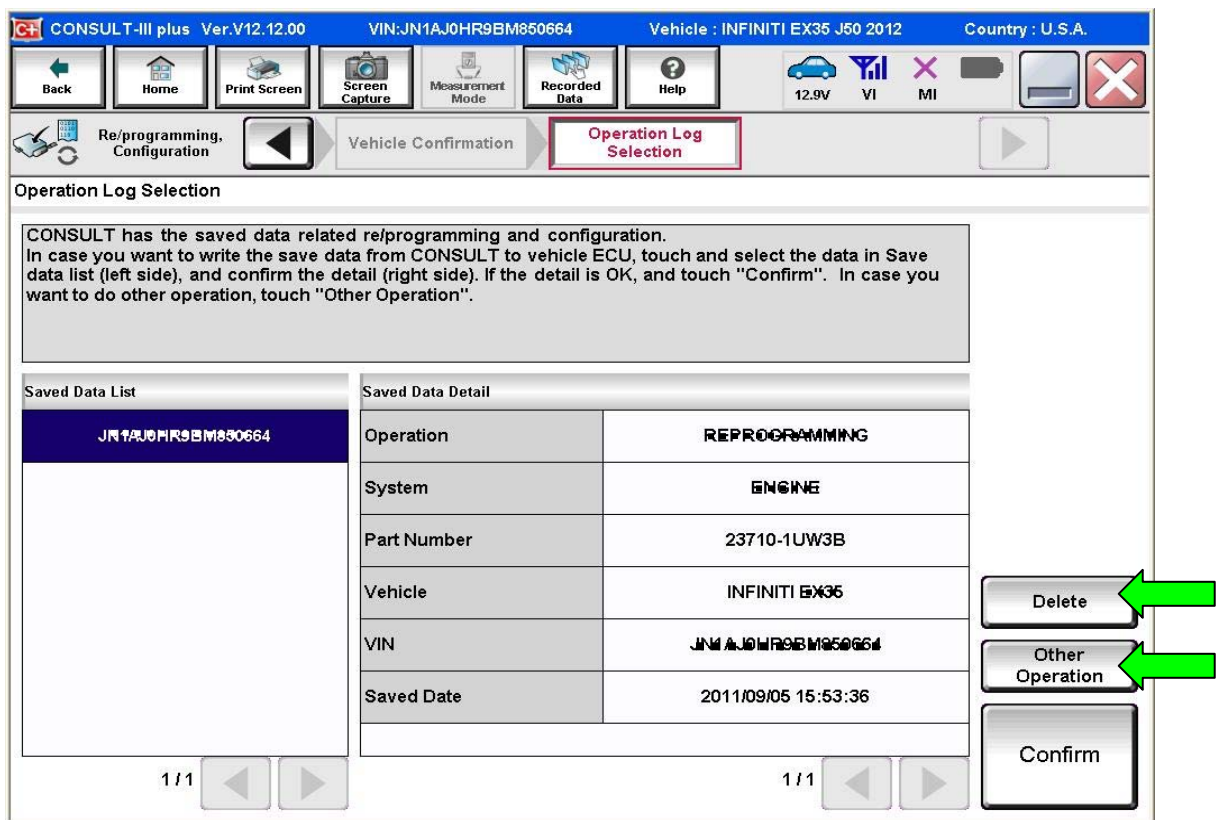
While navigating C-III plus, if the screen in Figure 1A displays, select **Delete** and then **Other Operation**.

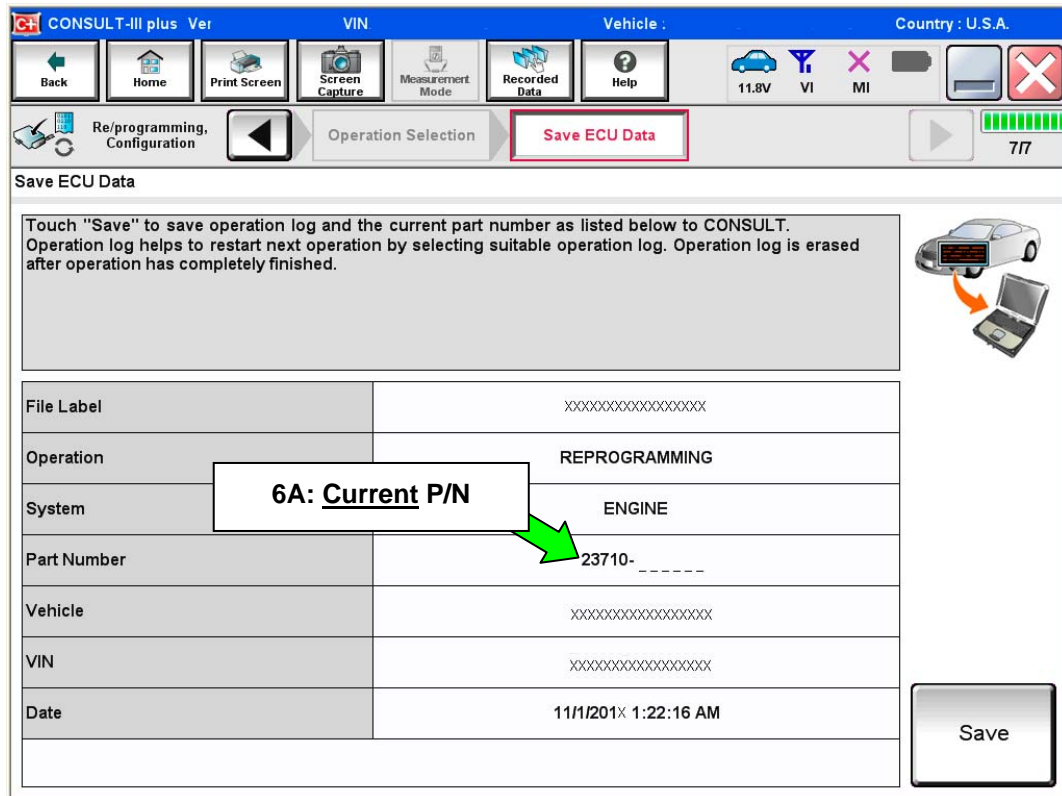
Figure 2

6. When you get to the screen shown in Figure 2, confirm this bulletin applies as follows:

A. Find the ECM or TCM **Part Number** and write it on the repair order.

B. Compare the P/N you wrote down to the numbers in the **Current ECM Part Number** column in **Table A** on page 6 and 7, and **TCM Part Number** column in **Table B** on page 8.

- If there is a match, this bulletin applies. Continue with the reprogramming procedure.
- If there is not a match, reprogramming does not apply. Make sure to check both ECM and TCM for a match.

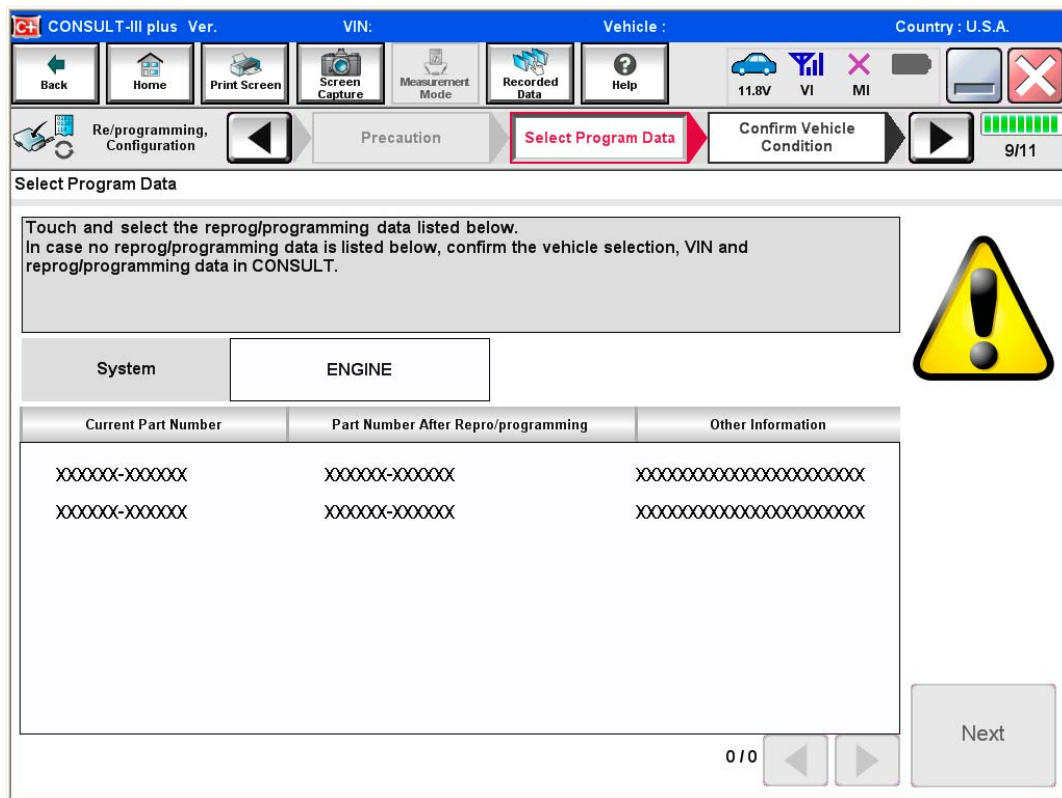
- In some cases, more than one new P/N for reprogramming is available.
 - In this case, the screen in Figure 3 displays.
 - Select and use the reprogramming option that **does not** have the message “Caution! Use ONLY with ITBXX-XXX”.
- If you get this screen and it is blank (no reprogramming listed), it means there is no reprogramming available for this vehicle.

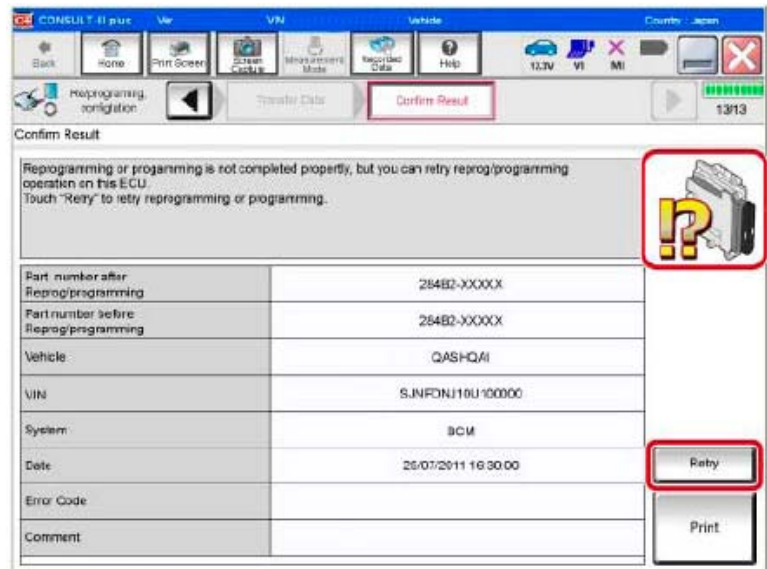
Figure 5

If reprogramming does not complete and the “!” icon displays as shown in Figure 5:

- Check battery voltage (12.0–15.5 V).
- Ignition is ON, engine OFF.
- External Bluetooth® devices are OFF.
- All electrical loads are OFF.
- Select **retry** and follow the on screen instructions.
- “Retry” may not go through on first attempt and can be selected more than once.

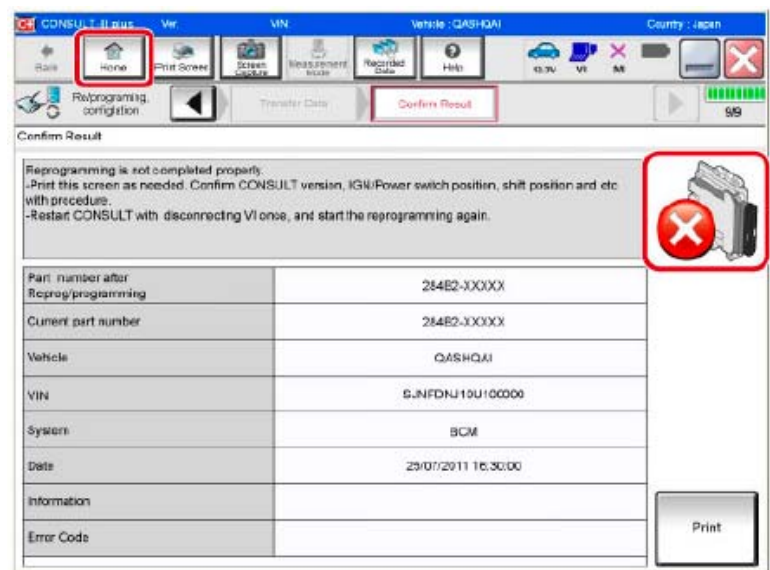
Figure 6

If reprogramming does not complete and the “X” icon displays as shown in Figure 6:

- Check battery voltage (12.0 – 15.5 V).
- CONSULT A/C adapter is plugged in.
- Ignition is ON, engine OFF.
- Transmission is in Park.
- All C-III plus / VI cables are securely connected.
- All C-III plus updates are installed.
- Select **Home**, and restart the reprogram procedure from the beginning.
