EL12-062c

November 27, 2012

WITH NAVIGATION SYSTEM HANDS-FREE PHONE POOR SOUND QUALITY

APPLIED VEHICLES: 2011 – 2013 M37, M56, and M Hybrid (Y51 & HY51)
 2013 JX35 (L50)
 2010 – 2012 FX35 and FX50 (S51)
 2010 – 2012 EX35 (J50)
 2011 – 2012 QX56 (Z62)
 2010 – 2012 G37 Sedan, Coupe, and Convertible
 (V36, CV36, & HV36)

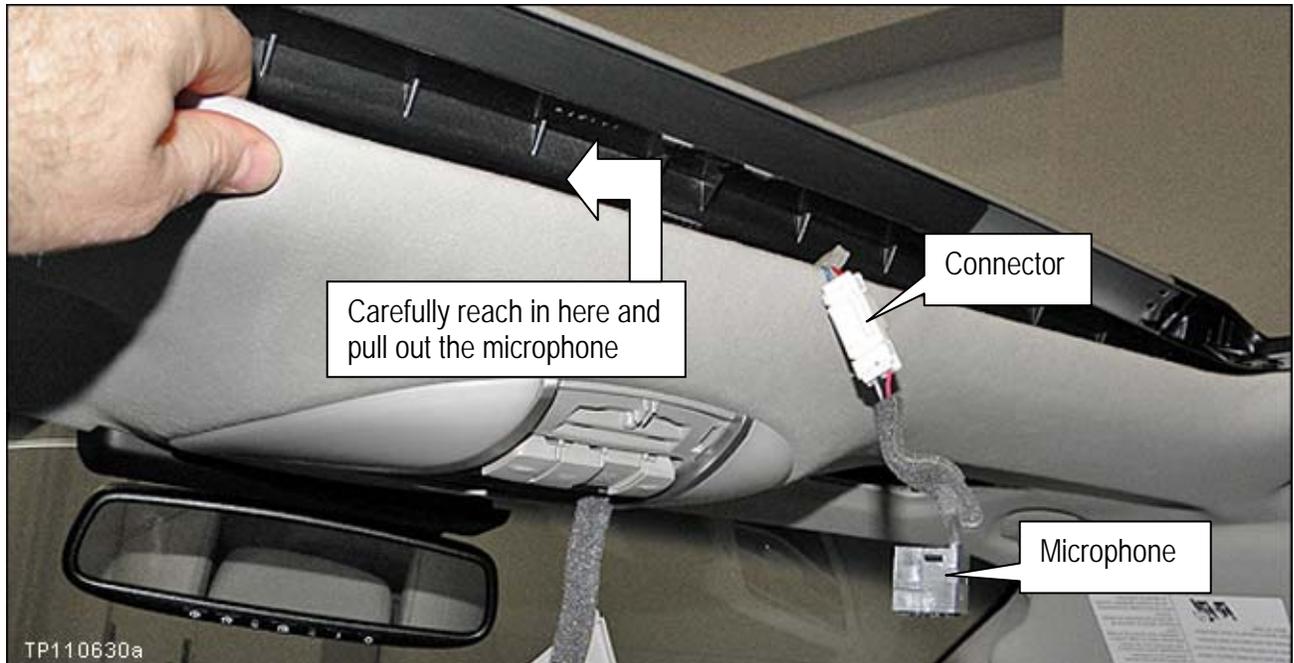
Figure M9

IMPORTANT: Make sure the microphone is firmly snapped into place. If the microphone is loose, it could pick up extra noise from an unintended source.

10. **Carefully** reach in above the headlining and pull out the microphone.

11. Disconnect the old microphone and discard.

12. Install the new microphone in reverse order.

- Make sure to use the new microphone listed in the Parts Information.
- Make sure to use the new map lamp finisher listed in the Parts Information.
