EC13-019

December 13, 2013

2012 G25; MIL "ON" WITH DTC P0101 AND/OR P010B

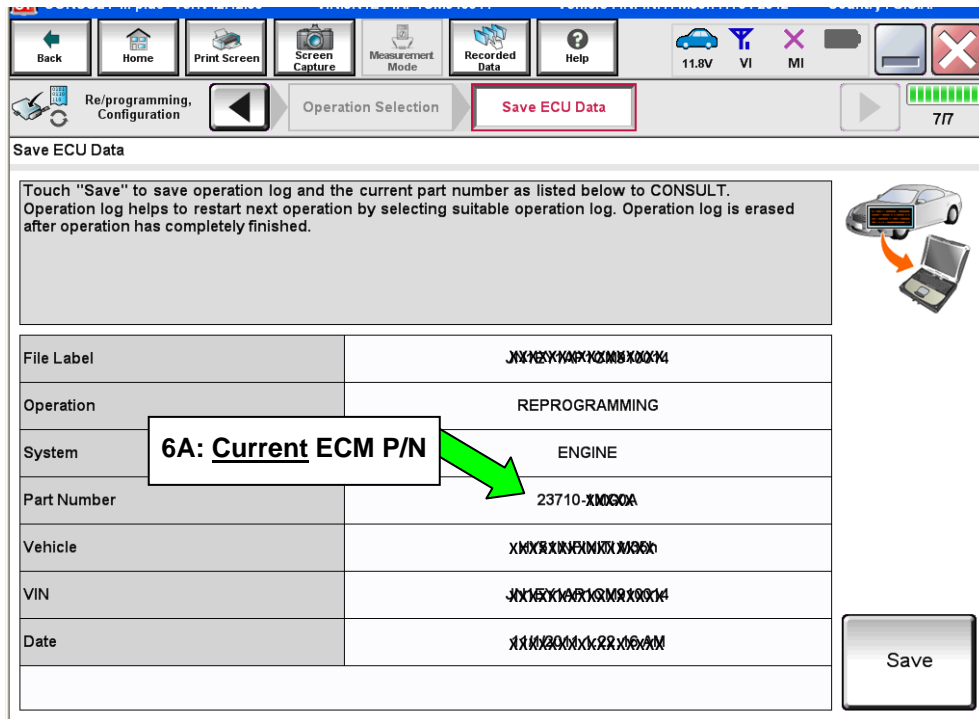
Figure 2

6. When you get to the screen shown in Figure 2, confirm this bulletin applies as follows.

A. Find the ECM **Part Number** and write it on the repair order.

B. Compare the P/N you wrote down to the numbers in the **Current ECM Part Number** column in **Table A** below.

- If there is a match, this bulletin applies. Continue with the reprogramming procedure.
- If there is not a match, this bulletin does not apply. Close C-III plus and refer to ASIST for further diagnostic information.

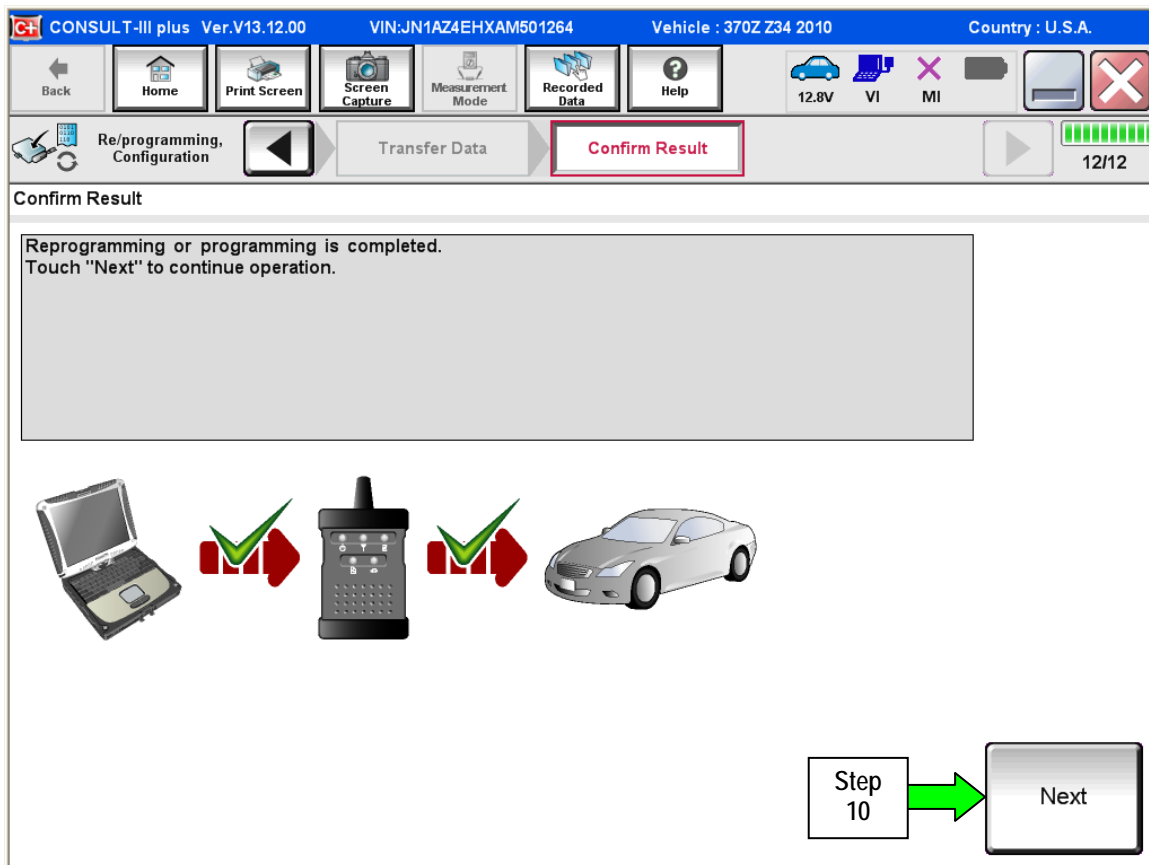
8. When the screen in Figure 4 displays, reprogramming is complete.

NOTE: If the screen in Figure 4 does not display (reprogramming does not complete), refer to ECM recovery on the next page.

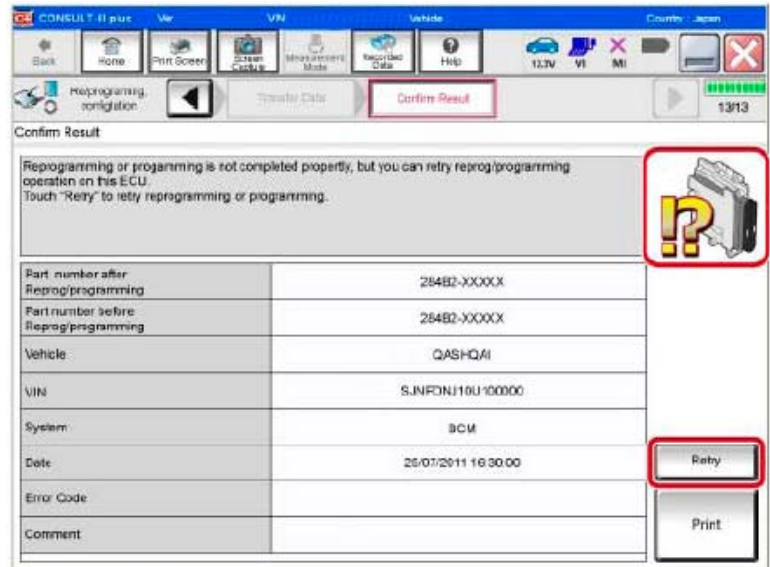
Figure 5

If reprogramming does not complete and the “!?” icon displays as shown in Figure 5:

- Check battery voltage (12.0 - 15.5 V).
- Ignition is ON, engine OFF.
- External Bluetooth® devices are OFF.
- All electrical loads are OFF.
- Select retry and follow the on screen instructions.
- “Retry” may not go through on first attempt and can be selected more than once.

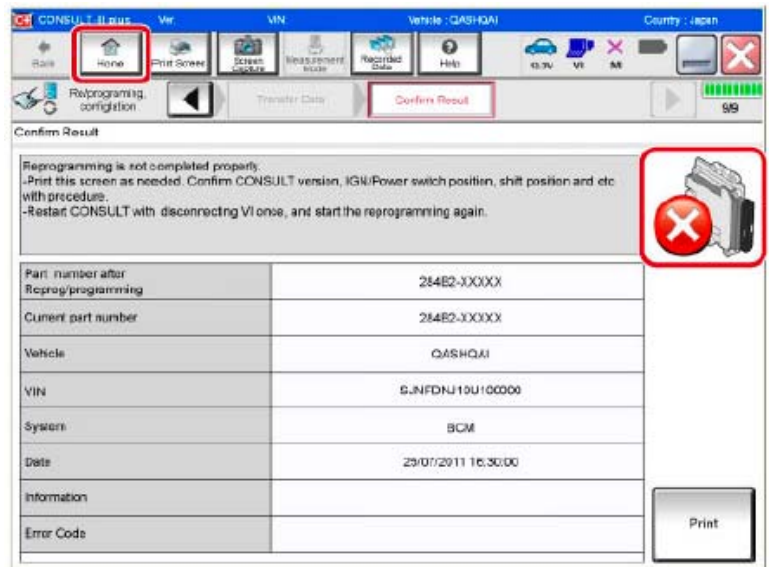
Figure 6

If reprogramming does not complete and the “X” icon displays as shown in Figure 6:

- Check battery voltage (12.0 - 15.5 V).
- CONSULT A/C adapter is plugged in.
- Ignition is ON, engine OFF.
- Transmission is in Park.
- All C-III plus / VI cables are securely connected.
- All C-III plus updates are installed.
- Select Home, and restart the reprogram procedure from the beginning.
