Classification:
EC13-018aReference:
ITB13-056aCOPYRIGHT © NISSAN NORTH AMERICA, INC.
Date:
February 13, 2014

INFINITI; MIL ON WITH DTC P0139 AND/OR P0159 STORED

APPLIED VEHICLES: 2014 Q50 Sedan (V37) 2013 FX37 (S51) with VQ37HR engine only
2014 Q50 Hybrid (V37) 2014 QX70 (S51) with VQ37HR engine only
2012-2013 G37 Sedan (V36) 2013 EX37 (J50)
2012-2013 G37 Coupe (V36) 2014 QX50 (J50)
2012-2013 G37 Convertible (V36) 2013 M37 Sedan (Y51)
2014 Q60 Coupe (V36)
2014 Q60 Convertible (V36)

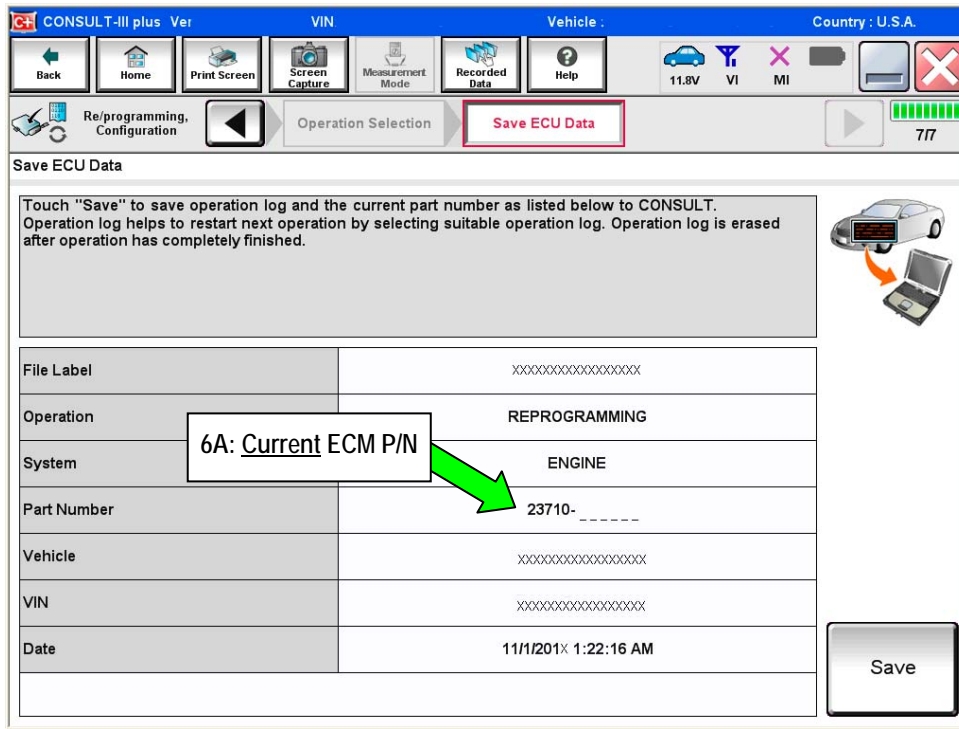
Figure 2

A. Find the ECM **Part Number** and write it on the repair order.

NOTE: This is the current ECM Part Number (P/N).

B. Compare the P/N you wrote down to the numbers in the **Current ECM Part Number** column in **Table A** below and on the next page.

- If there is a match, this bulletin applies. Continue with the reprogramming procedure.
- If there is not a match, this bulletin does not apply. Close C-III plus and refer to ASIST for further diagnostic information.

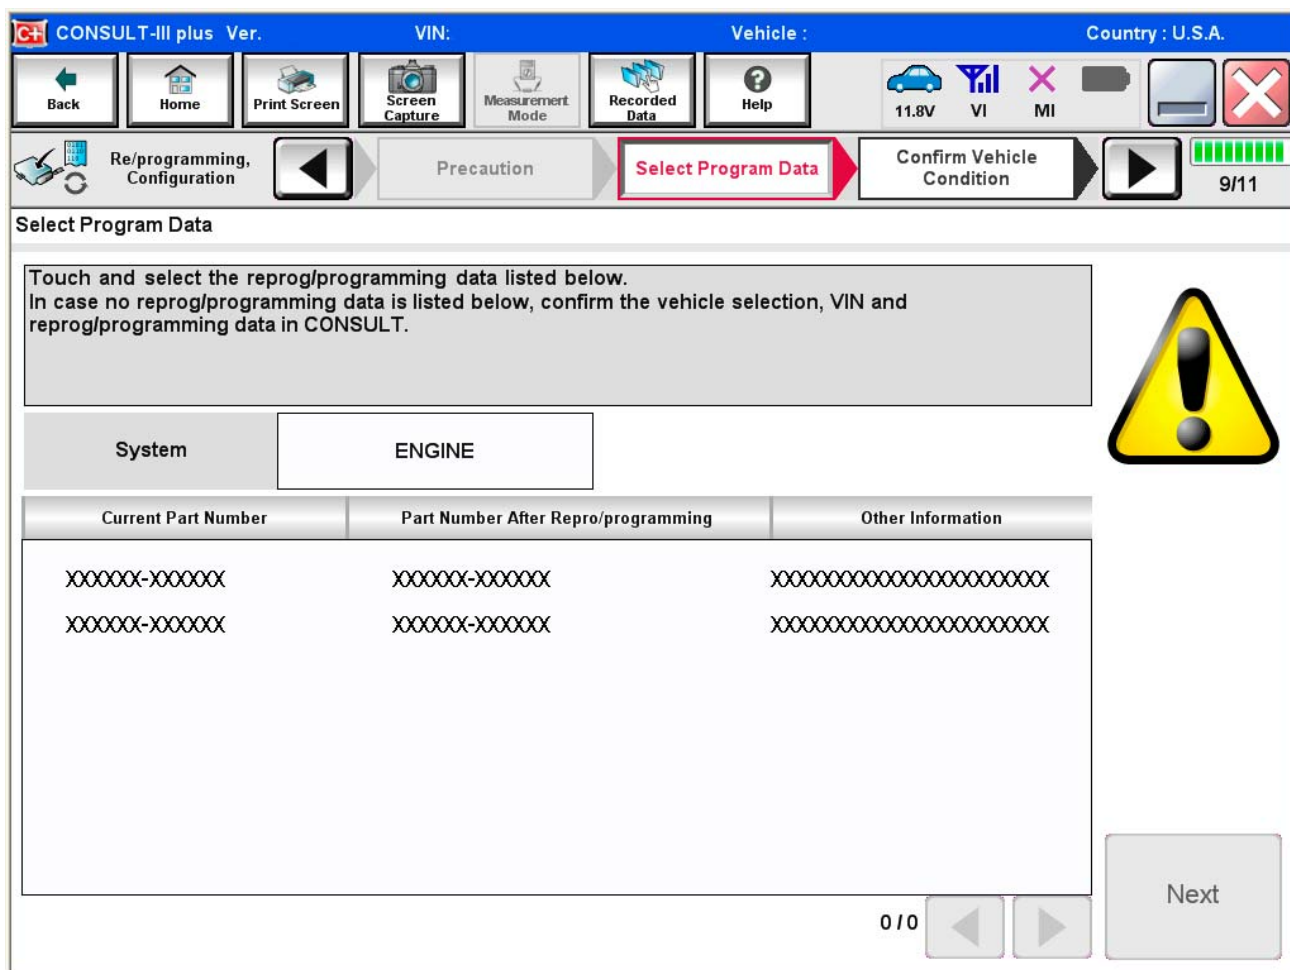
- In some cases, more than one new P/N for reprogramming is available.
 - In this case, the screen in Figure 3 displays.
 - Select and use the reprogramming option that **does not** have the message "Caution! Use ONLY with ITBXX-XXX".
- If you get this screen and it is blank (no reprogramming listed), it means there is no reprogramming available for this vehicle. Close C-III plus and refer back to ASIST for further diagnosis.

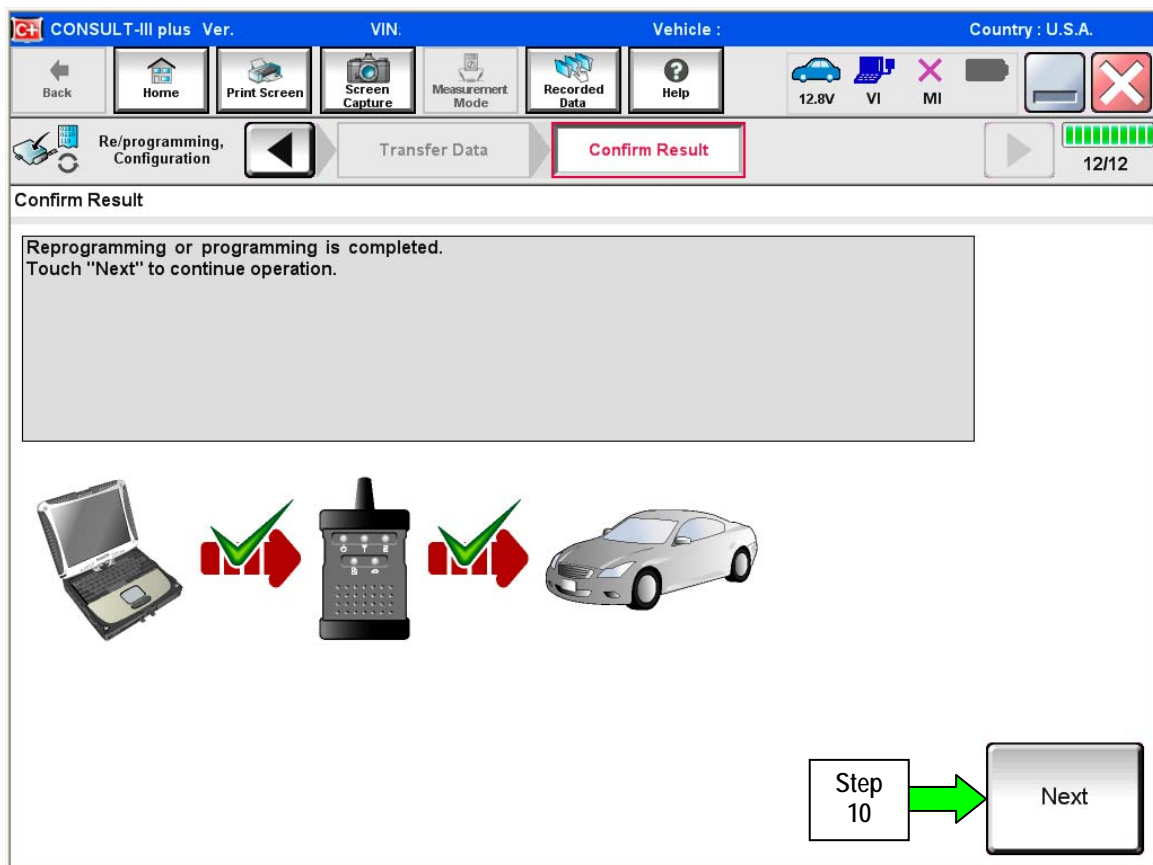
8. When the screen in Figure 4 displays, reprogramming is complete.

NOTE: If the screen in Figure 4 does not display (reprogramming does not complete), refer to the information on page 8.

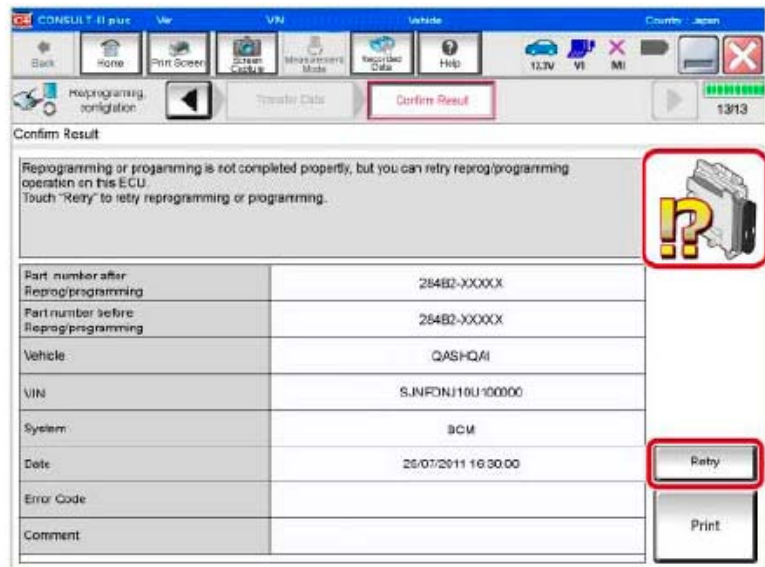
Figure 5

If reprogramming does not complete and the “!?” icon displays as shown in Figure 5:

- Check battery voltage (12.0–15.5 V).
- Ignition is ON, engine OFF.
- External Bluetooth® devices are OFF.
- All electrical loads are OFF.
- Select retry and follow the on screen instructions.
- “Retry” may not go through on first attempt and can be selected more than once.

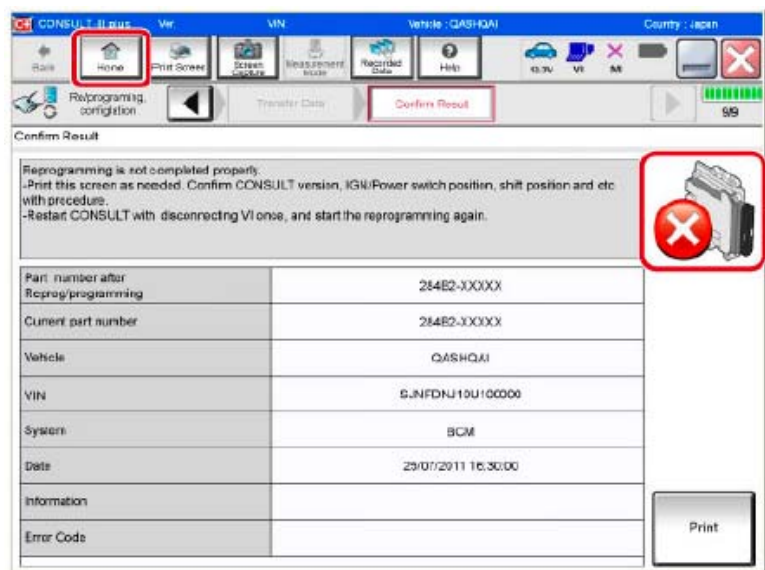
Figure 6

If reprogramming does not complete and the “X” icon displays as shown in Figure 6:

- Check battery voltage (12.0 – 15.5 V).
- CONSULT A/C adapter is plugged in.
- Ignition is ON, engine OFF.
- Transmission is in Park.
- All C-III plus / VI cables are securely connected.
- All C-III plus updates are installed.
- Select Home, and restart the reprogram procedure from the beginning.

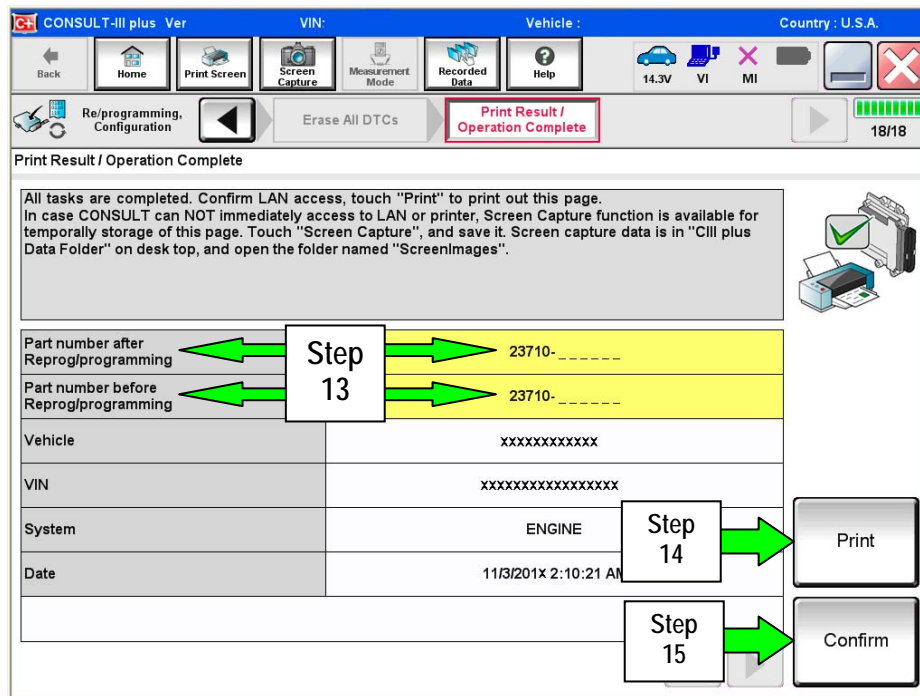
12. When the entire reprogramming process is complete, the screen in Figure 7 will display.
13. Verify the before and after part numbers are different.
14. Print a copy of this screen (Figure 7) and attach it to the repair order for warranty documentation.
15. Select **Confirm**.
