BT14-012

## G37 AND Q60 CONVERTIBLES; CONVERTIBLE TOP SERVICE INFORMATION

**APPLIED VEHICLES:** 2009 – 2013 G37 Convertible (V36)  
2014 Q60 Convertible (V36)

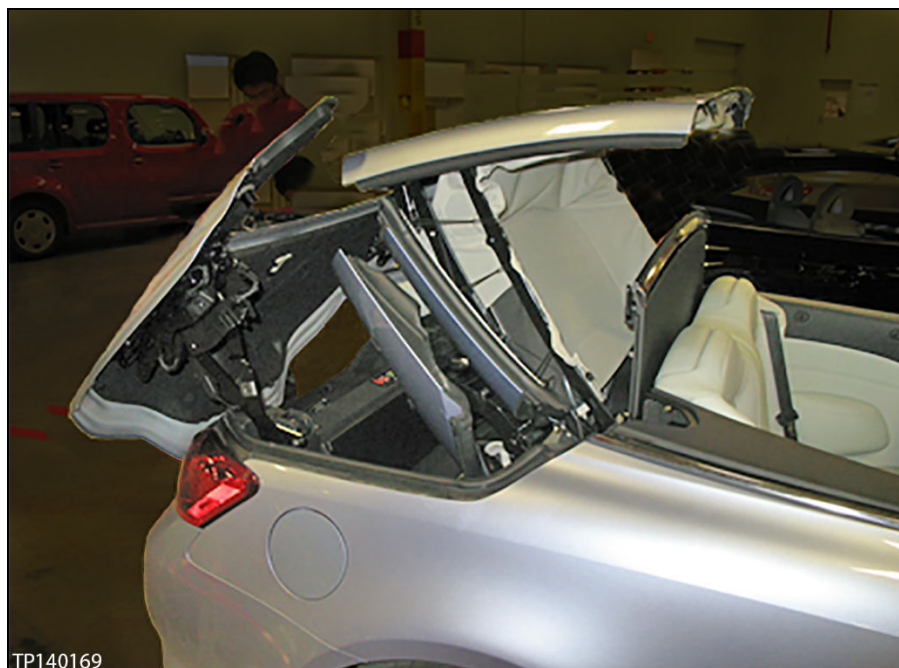
Figure 1

If the hydraulic unit assembly (pump assembly) needs to be tested for any reason, the convertible top should not “sink” or drop further than 250 mm (9.84 inches) within one (1) minute or less when opened as shown in Figure 1.

- If the convertible top sinks further than 250 mm (9.84 inches) within one (1) minute or less – the pump assembly needs to be replaced.
- If the convertible top does not sink further than 250 mm (9.84 inches) within one (1) minute or less – the pump assembly is OK.

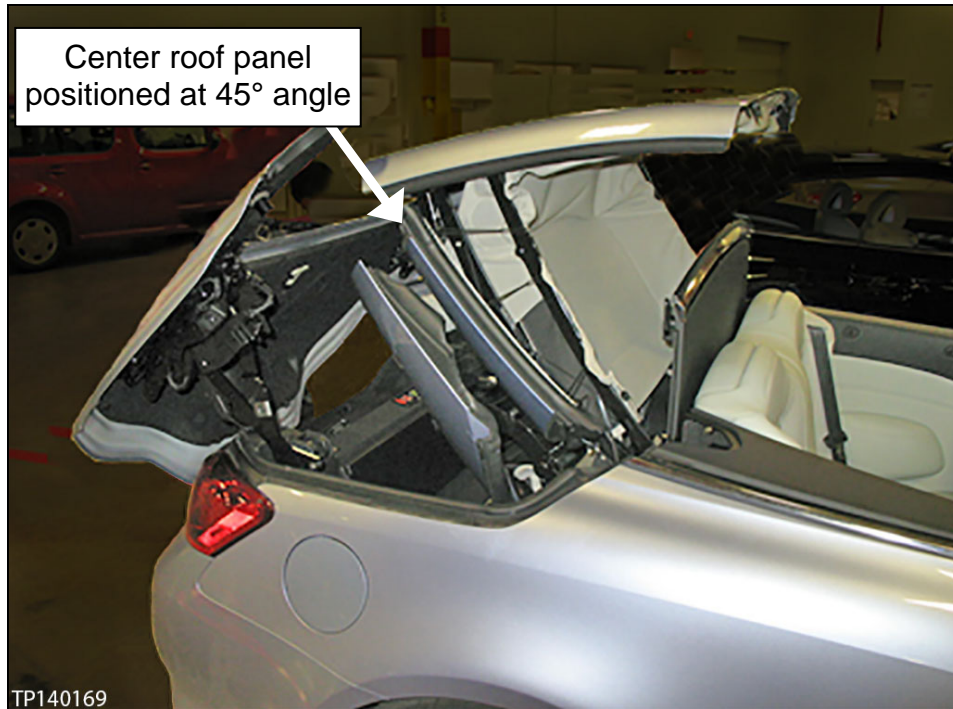
Figure 2

1. To check for excessive "sinking", open the convertible top in the position shown in Figure 2.

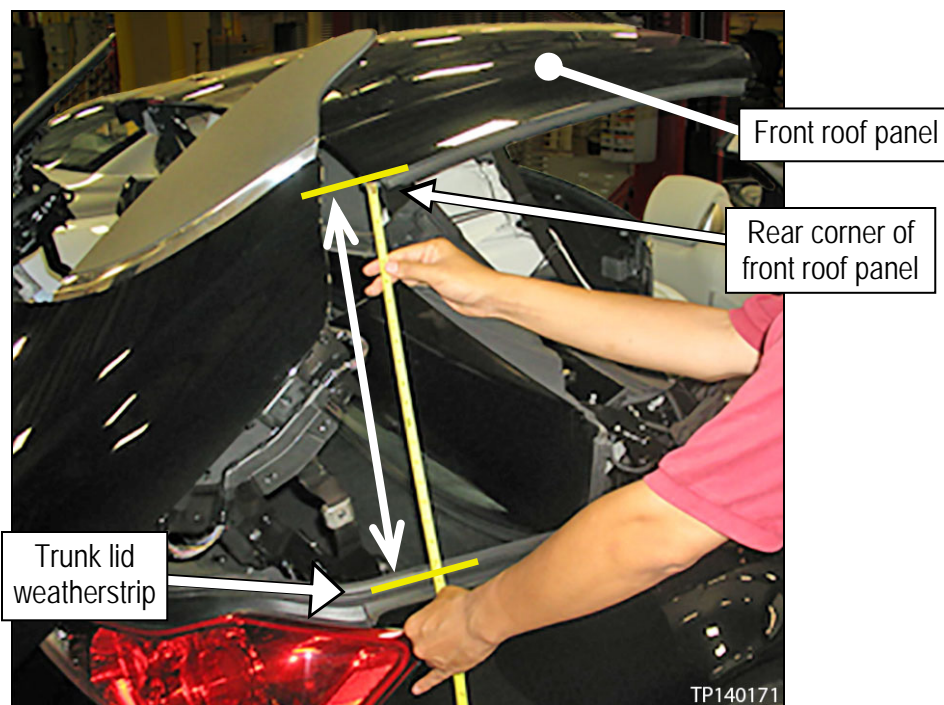
Figure 3

2. One (1) minute after the convertible top position is set, measure where shown in Figure 3.
  - a. If the convertible top sinks further than 250 mm (9.84 inches) within one (1) minute or less following the measurement taken in step 2– the pump assembly needs to be replaced.
  - b. If the convertible top does not sink further than 250 mm (9.84 inches) within one (1) minute or less following the measurement taken in step 2– the pump assembly is OK.
