BT07-039

ITB07-043

## 2008 G37 COUPE; QUARTER GLASS MOLDING IS NOT FLAT

**APPLIED VEHICLE:** 2008 G37 Coupe (CV36)

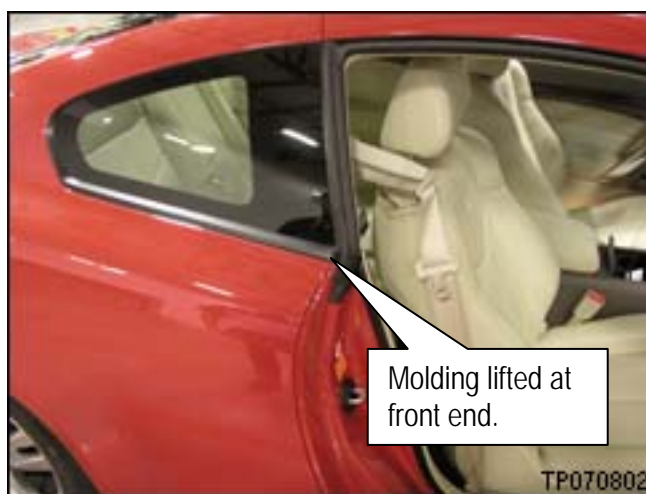
Figure 1

The front end of the quarter glass molding is lifted and will not stay flat to the body (left and/or right side).

Cut about 1/16 inch (2 mm) off of the front edge of the molding as shown in the Service Procedure.
