ITB08-011

2008 G37; RELAY BOX UPPER COVER REPLACEMENT

APPLIED VEHICLE: 2008 G37 (CV36)
APPLIED DATE: Vehicles built before August 31, 2007
APPLIED VIN: Vehicles built before JNKCV64E(*)8M106604

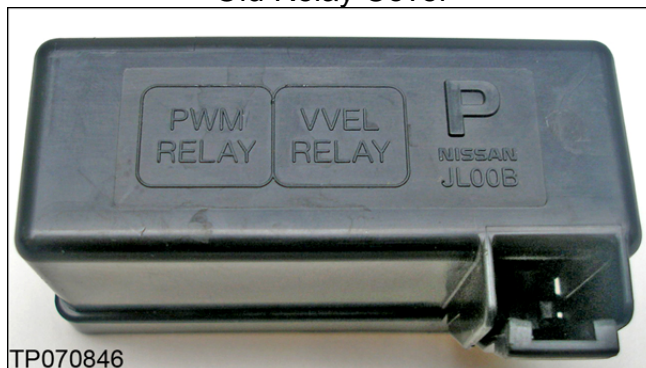
If you are diagnosing issues related to the VVEL system or power to the radiator fans, be advised the relay cover is incorrectly labeled as shown in Figure 1. Refer to Figure 2 for the correct relay cover.

Old Relay Cover

NOTE: Remove and replace the relay box upper cover shown in Figure 1 with the relay box upper cover listed in the Parts Information section of this bulletin and displayed in Figure 2.

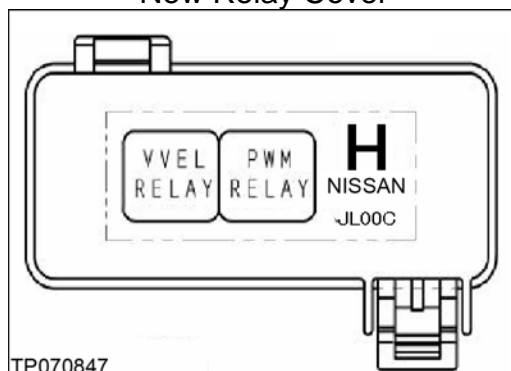
Figure 2

New Relay Cover

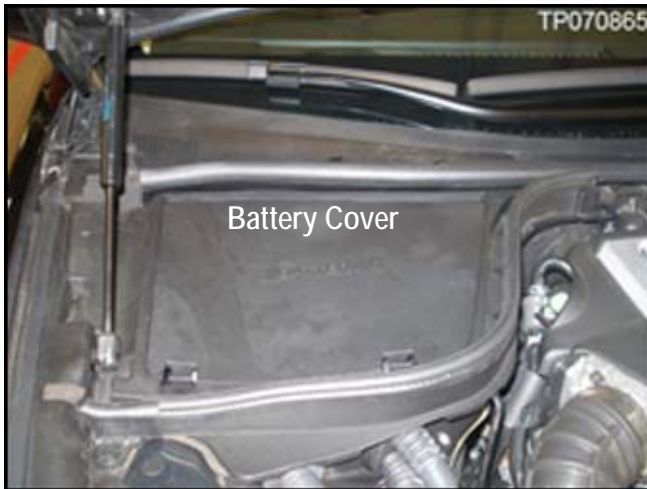
Figure 3

1. Remove the battery cover. See Figure 3.
2. Remove 5 clips (A) located on the hood lid cover (B). See Figure 4.
3. Remove the hood lid cover.

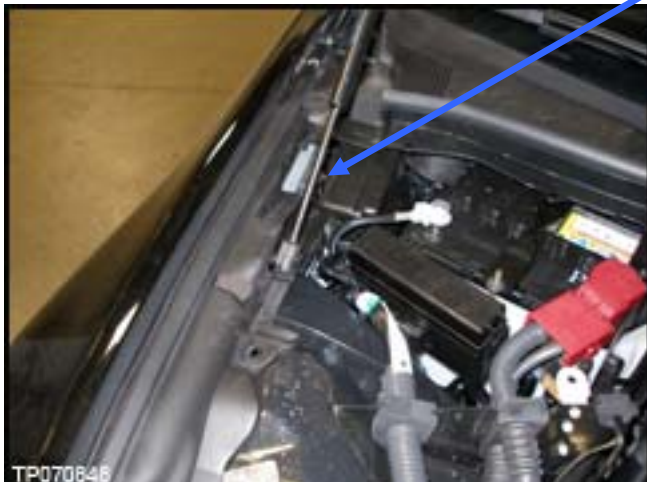
Figure 5

4. Refer to Figures 5 and 6 to locate the relay box upper cover.

Relay box upper cover

5. Remove and replace the relay box upper cover.
6. Re-install the hood lid, clips, and battery cover in reverse order of removal.
