EL09-006

ITB09-026

PARKING BRAKE LIGHT SWITCH REPAIR PROCEDURE

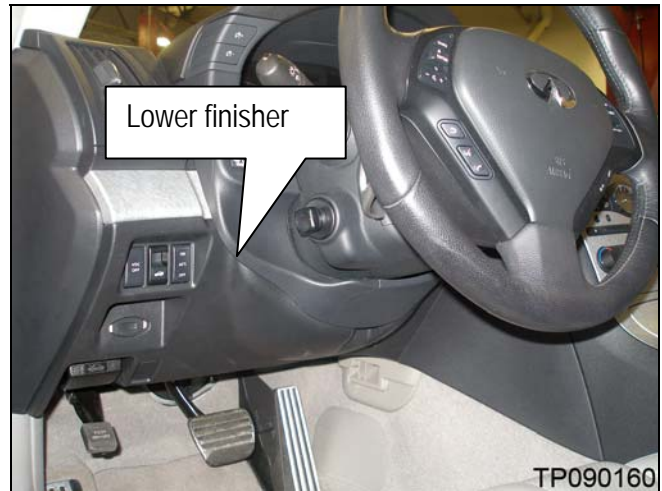
Figure1

1. Remove the LH lower finisher.

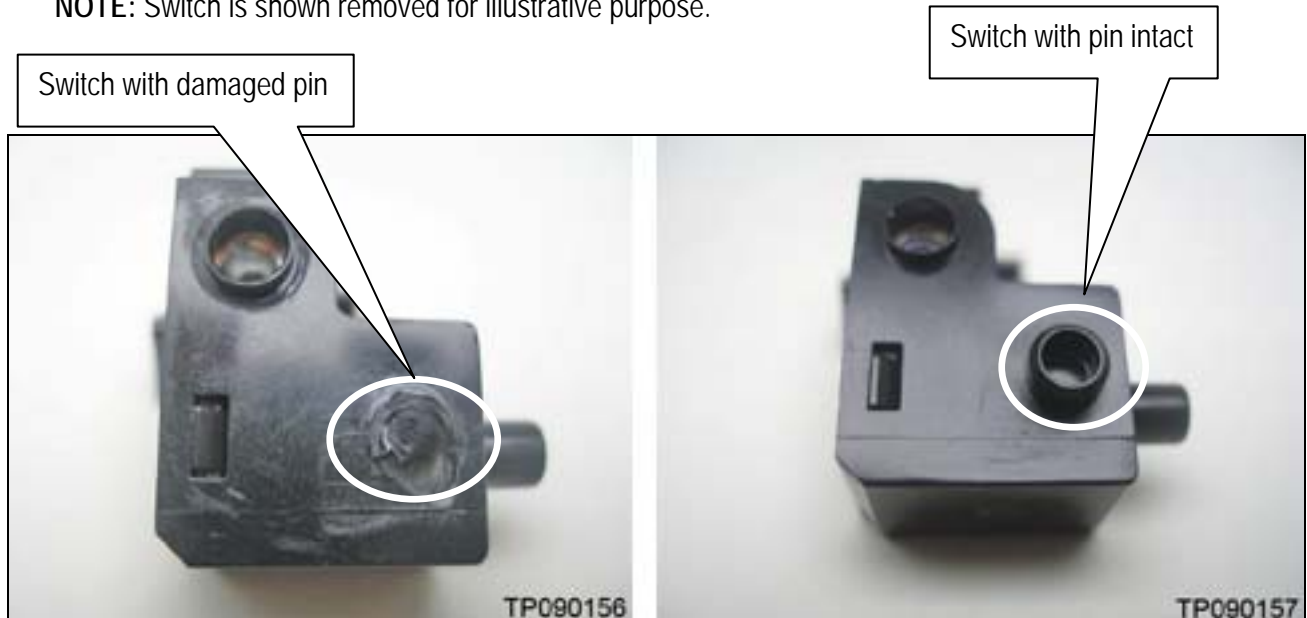
Figure 2

2. Inspect the foot-operated parking brake switch:

- Lightly check to see if the switch rotates loosely. If the switch rotates loosely, the pin is damaged. This bulletin applies. Proceed to step 3.
- If the switch is not loose and does not rotate, this bulletin does not apply. Return to ASIST for further diagnostic assistance.

NOTE: Switch is shown removed for illustrative purpose.

- Replace the parking brake pedal assembly with the one listed in Parts Information.
- Refer to the Service Procedure in this bulletin.

- Do **NOT** replace the switch alone. Instead, REPLACE the ENTIRE PEDAL ASSEMBLY.
- The parking brake cables DO NOT need to be removed for this procedure.
- The new parking brake pedal assembly comes with a new switch.

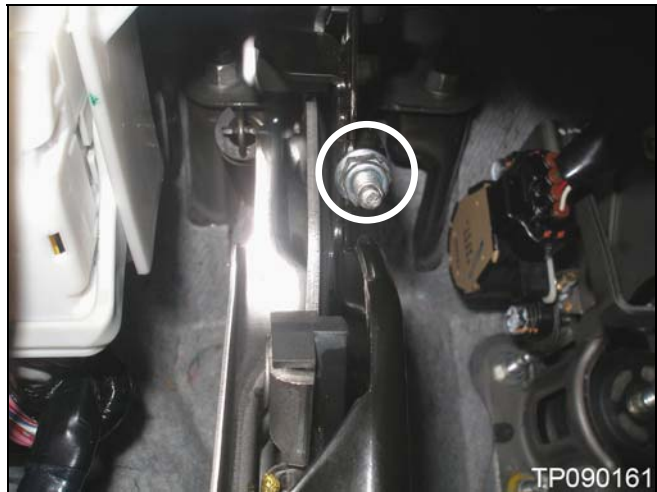
Figure 3

3. Remove parking brake adjusting nut located at the top of the parking brake assembly.

CAUTION: Do NOT reuse adjusting nut after replacing PEDAL. Replace adjusting nut with a new one listed in Parts Information.

NOTE: The parking brake cables DO NOT need to be removed for this procedure.

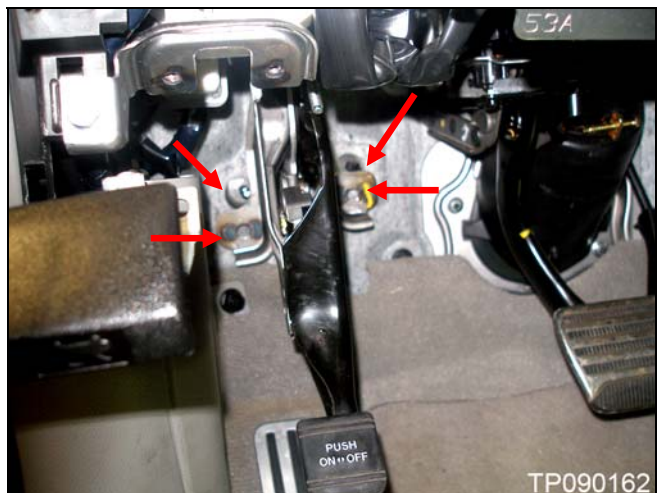
Figure 4

4. Disconnect parking brake switch harness connector.

5. Remove 4 bolts attaching the device assembly to the bulkhead.

6. Remove pedal assembly.
7. Install a new pedal assembly in reverse order of removal.

NOTE: Refer to the appropriate section of the Electronic Service Manual for pedal assembly mounting nut torque specifications for the vehicle.
