Classification:
 BT09-078a

G35 SEDAN AND G37 SEDAN, COUPE, AND CONVERTIBLE; A/T SHIFTER VINYL BOOT COMING OFF

APPLIED VEHICLES: 2007-2008 G35 Sedan (V36) with A/T only
 2009-2010 G37 Sedan (V36) with A/T only
 2007-2010 G37 Coupe (CV36) with A/T only
 2009-2010 G37 Convertible (HV36) with A/T only

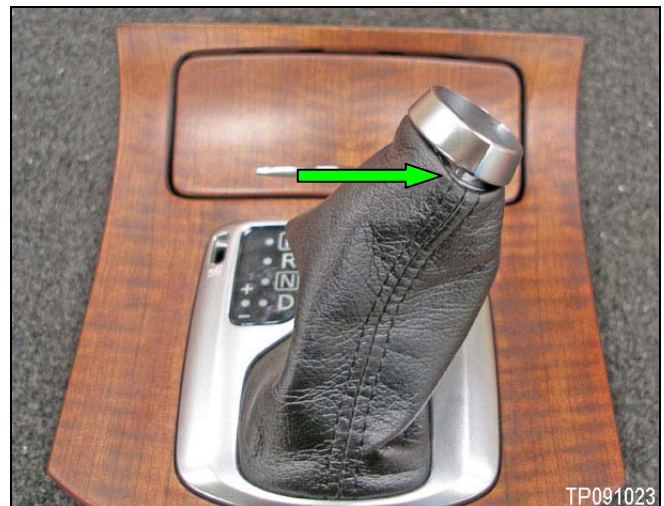
The A/T insert finisher (boot) is separating or has come off the trim ring (see Figure 1).

NOTE: Selector lever knob removed in Figure 1 for clarity.

Re-secure the boot to the trim ring with a tie strap.

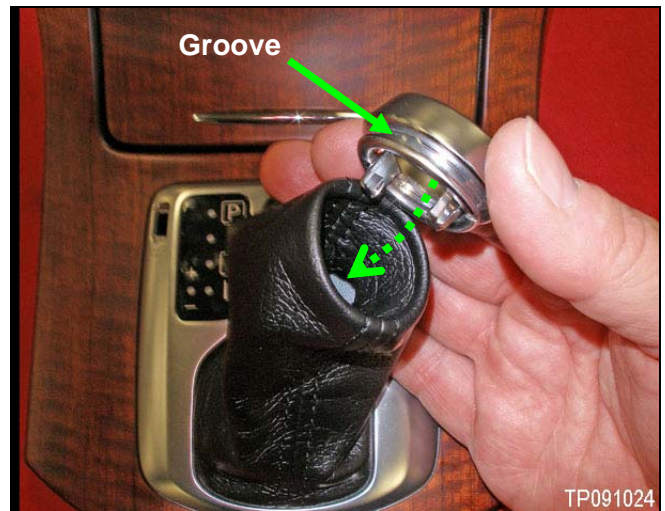
3. Insert the trim ring into the top of the boot (see Figure 3).

- The tie strap must be no more than 3.6 mm wide, and should be about 150 mm long (see Figure 6).
- When installed properly, the tie strap will "seat" the boot into the groove in the trim ring (groove shown in Figure 3 on Page 2).

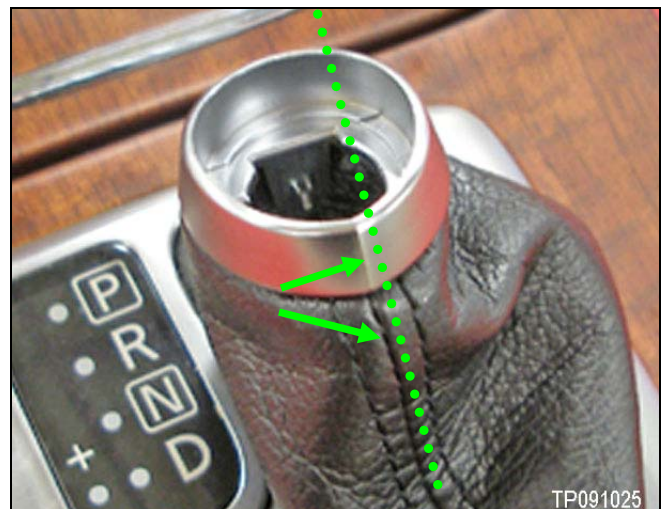
- Align the "point" of the trim ring with the seam of the boot (see Figure 4).

6. Push the trim ring and boot back through to its normal position (see Figure 7).
 - If necessary, twist the trim ring to align its "point" with the seam of the boot (see Figure 4 on Page 2 for alignment).
