BT07-027c ITB07-034c November 18, 2008

2007-2008 G35 SEDAN & 2008 EX; DOOR WEATHERSTRIP LOOSE

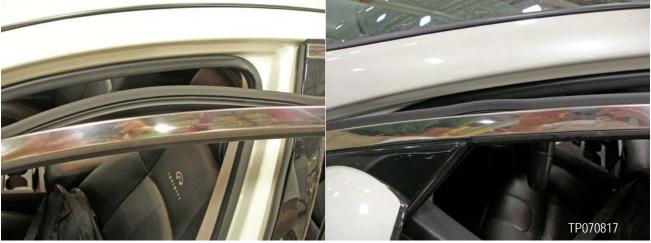
Figure 1

The front or rear door weatherstrip has pulled out or loose a little or a lot (see Figure 1).

Reattach the weatherstrip using the Service Procedure of this bulletin.

Do not replace the weatherstrip for this issue, if it should occur.

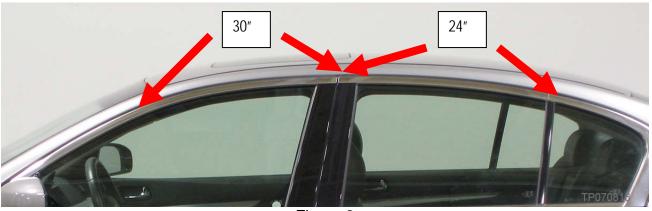
Figure 2

NOTE: You will be applying either a 30" long tape strip to the front door, or a 24" long tape strip to the rear.

- 1. Peel off the weatherstrip of the affected door so the range shown in Figure 2, above, is exposed.
- 2. Wipe clean the exposed weatherstrip channel and weatherstrip underside.
- 3. Apply 3M[™] Adhesion Promoter P/N 06396 to the weatherstrip channel and weatherstrip underside.
- 4. Cut an appropriate length strip of Duck® Products Indoor/Outdoor Moisture Resistant double-sided Carpet Tape P/N 00-07196 to ½" (12.7mm) width.

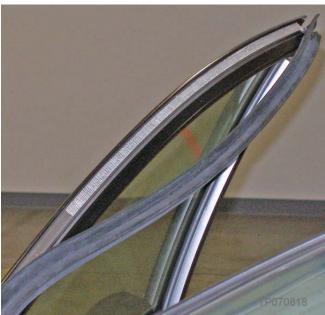
Figure 3

5. Apply the tape you cut in step 4 into the appropriate weatherstrip door channel.

NOTE: RH frond door shown, other doors similar.

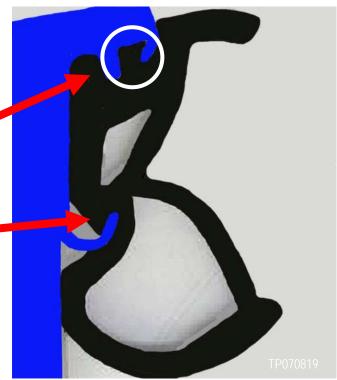
NOTE: Figure 4 shows an enlarged cutaway view of correct weatherstrip (black) fit into the door channel (blue).

- In the area circled, this weatherstrip ridge must be fully fitted into the door channel FIRST.
- After that is fully inserted, then roll this ridge into the J-shaped channel area.
- Each step below must be done along the entire length of the area to be reseated.

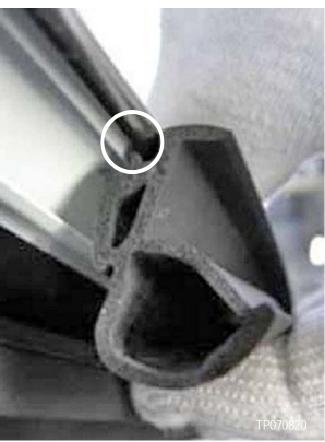
Figure 5

6. Fit the weatherstrip ridge into the door channel (weatherstrip cut for illustration purposes only)

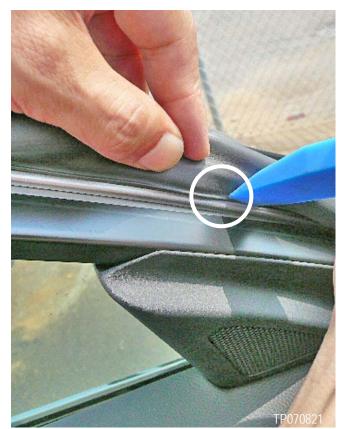
Figure 6

7. While maintaining upward tension on the weatherstrip to keep it in the channel, use a plastic "finesse stick" or similar trim tool to push the other ridge over and into the J-shaped channel area.

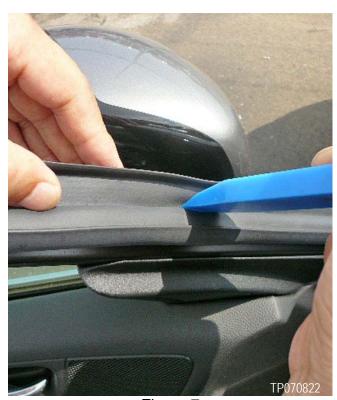
Figure 7

8. Using a plastic "finesse stick" or similar trim tool, push on the mid-section area to fully seat the weatherstrip.

Run your finger down this area to feel for any high spots. High spots will indicate where the weatherstrip ridge is not fully seated. Reseat as needed.

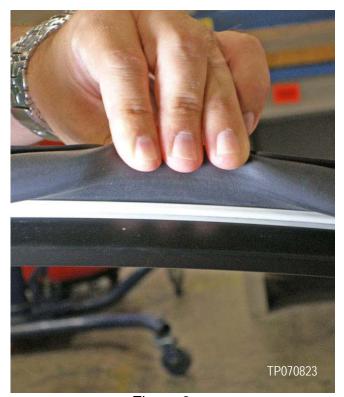
9. Carefully lift the weatherstrip slightly to see if it is fully seated. Reseat as needed.

Figure 8 shows an **OK** condition.
