EC10-011

AWD WARNING LIGHT "ON" WITH DTC C1204 AND/OR C1205 STORED

APPLIED VEHICLES: 2009 G37 Coupe and Sedan (C/V36) – with AWD
2009 FX35 and FX50 (S51) – with AWD

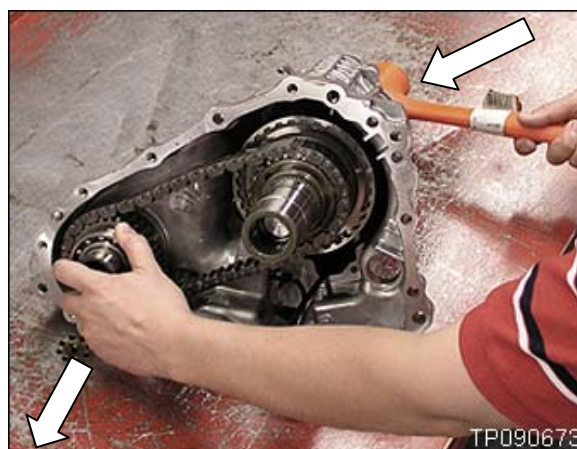
The drive chain, front drive shaft, main shaft, and coupler assembly are removed together:

- Use a rubber mallet to tap on the rear of the main shaft, while
- pulling outward on the front drive shaft.

NOTE: Move the front drive shaft and the main shaft alternately, a little at a time.
