EL10-042

ITB10-066

NAVIGATION / BLUETOOTH / VOICE RECOGNITION FUNCTION ISSUES

APPLIED VEHICLES: 2010-2011 EX35 (J50)
2010-2011 FX35/FX50 (S51)
2010-2011 G37 Coupe, Convertible, Sedan (C/H/V36)
2011 M37/M56 (Y51)
2011 QX56 (Z62)

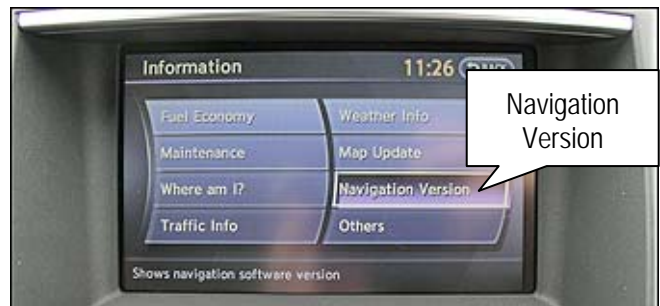
Figure 1

5. Select **Navigation Version** on the display screen.

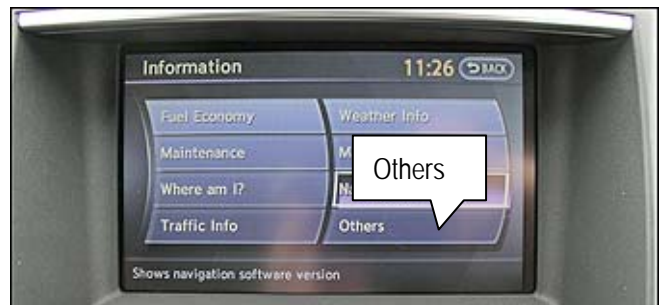
Figure 2

6. Check the **Program Version**.
 - If the Program Version is not **X1U72001** or **X2U32001**, continue with Step 7 on the next page.
 - If the Program Version is **X1U72001** or **X2U32001**, this bulletin does not apply. Refer to ASIST for further diagnostic information.

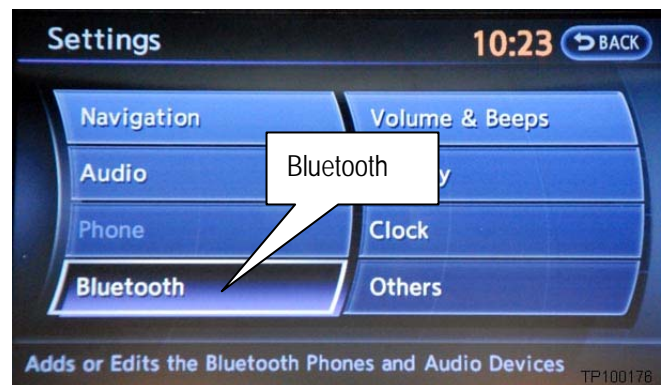
Figure 5

1. Press the "SETTING" button on the switch panel.

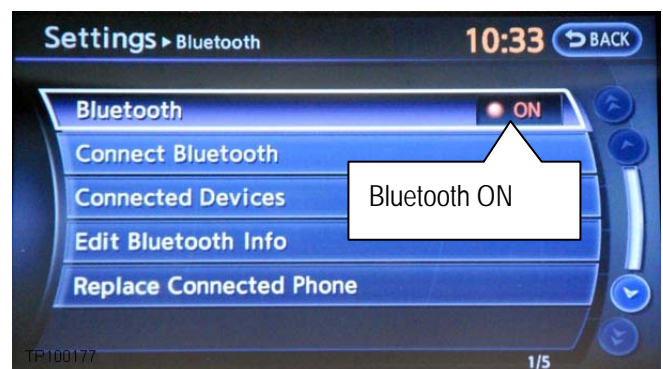
Figure 6

3. Take note of the current setting (ON or OFF) for **Bluetooth**. See Figures 6 and 7.

- This preference will need to be reset in a later step.
- Bluetooth is ON when the ON indicator displays in orange.
- Bluetooth is OFF when the ON indicator is "grayed" out.

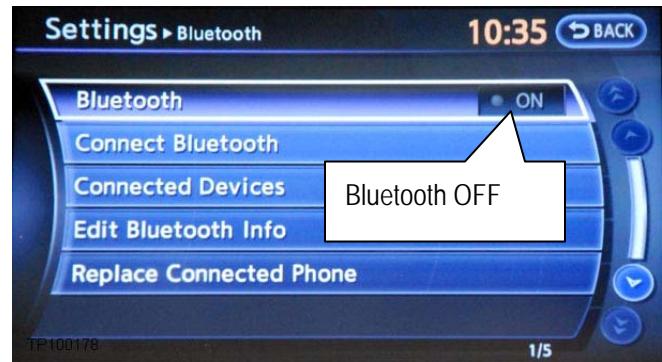
Figure 7

4. Make sure Bluetooth is OFF.
 - Selecting **Bluetooth** will change the setting from ON to OFF or OFF to ON.
5. Turn the ignition OFF and wait 10 seconds.

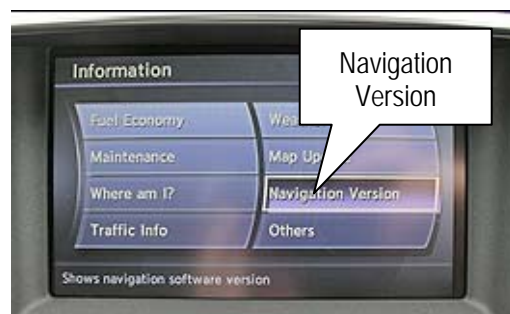
Figure 9

- c. The Program Version should be **X1U72001** or **X2U32001**.
 - If the Program Version is not **X1U72001** or **X2U32001**, perform the Load Reprogramming Software DVD procedure again.

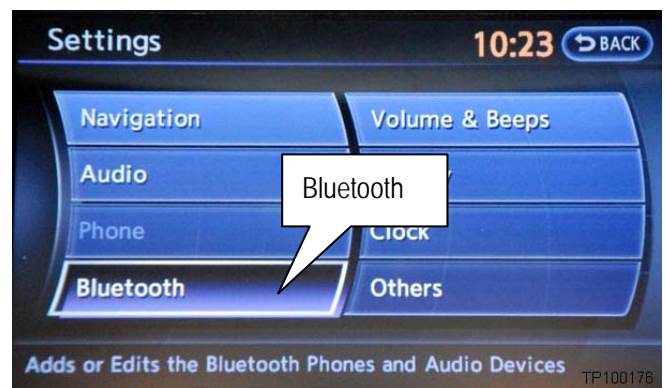
Figure 11

3. Select **Bluetooth**.

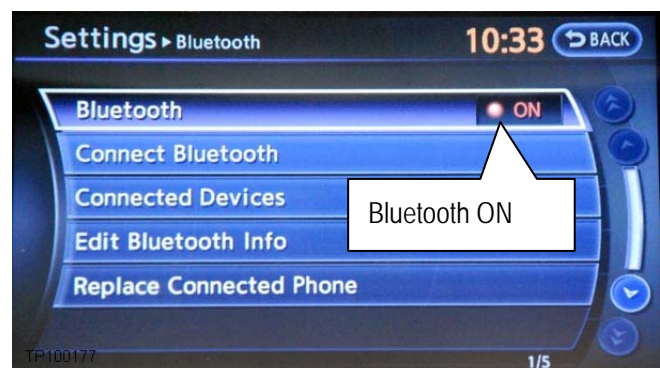
Figure 12

4. Select **Bluetooth** to change the setting to ON.

- Bluetooth is ON when the ON indicator displays in orange.
