EL10-042d

November 3, 2011

## NAVIGATION SOFTWARE UPDATE

**VEHICLES:** 2011 EX35 (J50) built **after** September 6, 2010  
2011 FX35/FX50 (S51) built **between** August 20, 2010 and August 1, 2011  
2011 G37 Sedan (V36) built **after** August 17, 2010  
2011 G37 Coupe & Convertible (C/HV36) built **after** Sept. 20, 2010  
2011 QX56 (Z62) built **after** September 8, 2010  
2012 QX56 (Z62) built **before** August 1, 2011  
2012 M37/M56 (Y51) built **between** February 9, 2011 and August 1, 2011  
2012 M35h Hybrid (Y51HV) / built **between** February 8, 2011 and August 1, 2011

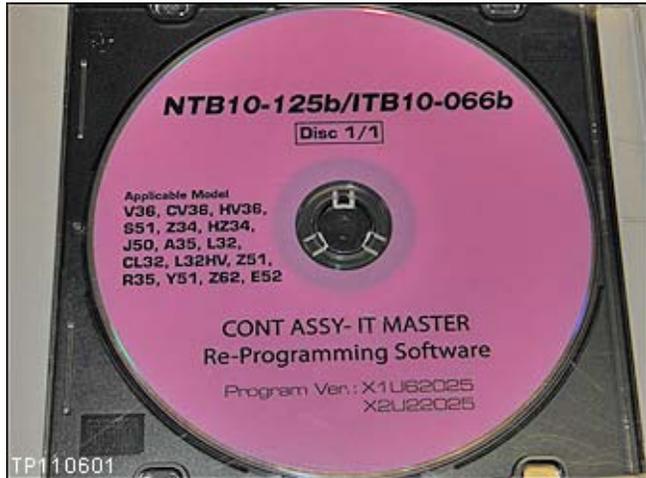
Figure A

- Each dealer has been mailed one NTB10-125b/ITB10-066b Reprogramming Software DVD, free of charge, from Clarion.
- Should you require an additional NTB10-125b/ITB10-066b Reprogramming Software DVD due to loss or damage, it can be ordered free of charge by contacting Clarion toll free at 1-800-347-8933.
- Discard the previous version of this Reprogramming Software DVD (NTB10-125/ITB10-066).

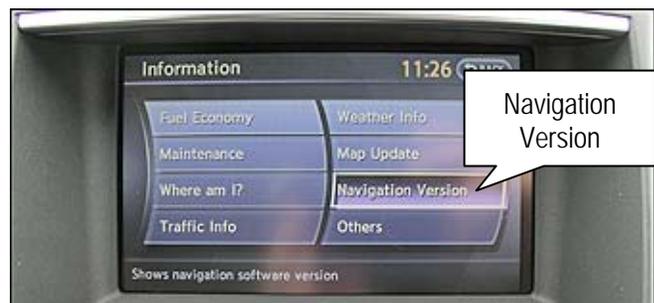
Figure 1

5. Select **Navigation Version** on the display screen.

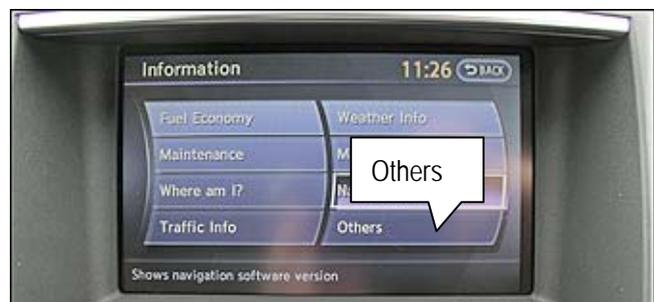
Figure 2

**NOTE:** On some vehicles you will need to select **Others** to find **Navigation Version**.

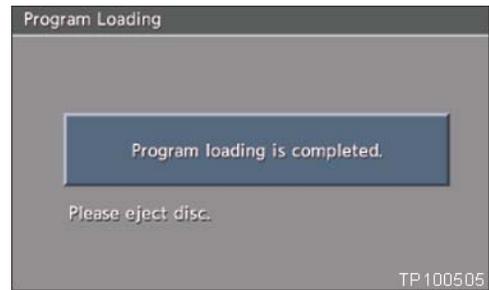
Figure 4

3. Wait for the program to load (a progress bar will display).
4. When the program has finished loading:
  - The Reprogramming Software DVD will automatically eject.
  - "Program loading is completed" will display.

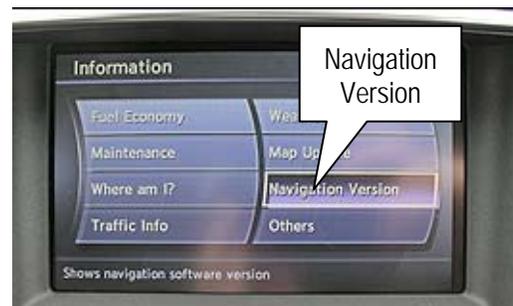
Figure 5

- b. Select **Navigation Version** on the display screen.

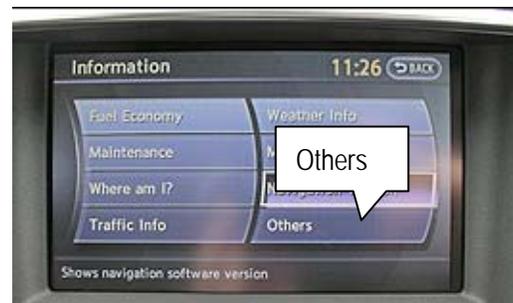
Figure 6

**NOTE:** On some vehicles you will need to select **Others** to find **Navigation Version**.

- c. The Program Version should be **X1U62025**.
- If the Program Version is not X1U62025, perform the Load Reprogramming Software DVD procedure again.
