BT11-022

June 13, 2011

G37 CONVERTIBLE; RATTLE OR RUBBING NOISE FROM ROOF AREA

APPLIED VEHICLE: 2009 - 2011 G37 Convertible (HV36)

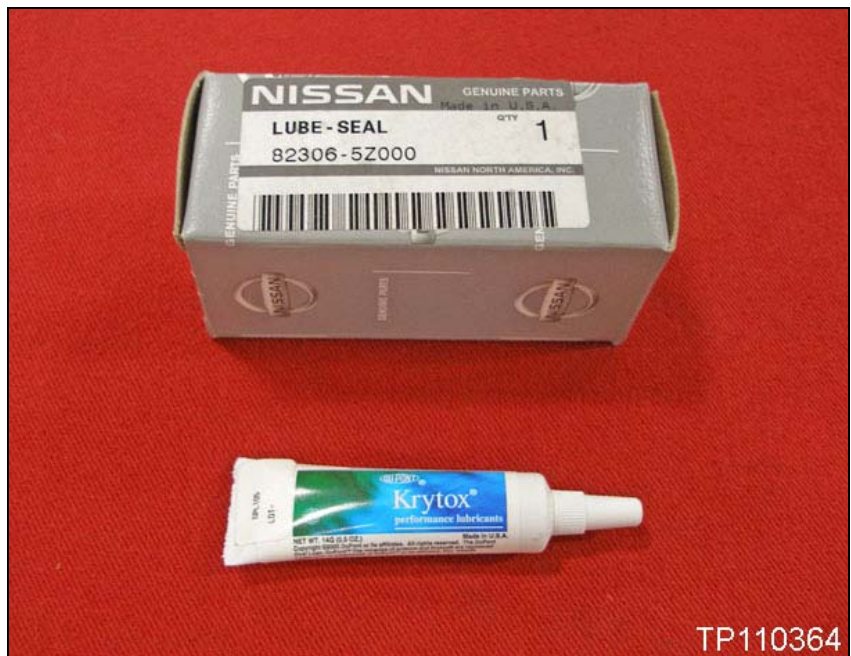
TP110364

Lubricant

3. Using your finger, apply a thin coat of DuPont Krytox® Lubricant (see **PARTS INFORMATION**) on all cleaned weather-strip contact surfaces.
 - Make sure to apply lubricant on both surfaces of seals with two (2) contact surfaces. See Figure 9 for example.
 - For cleanliness, it is recommended to use latex or similar type gloves.
