EC12-010a

ITB12-026a

May 23, 2012

2010 - 2012 G37 AND M37; MIL ON WITH DTC P0106 STORED

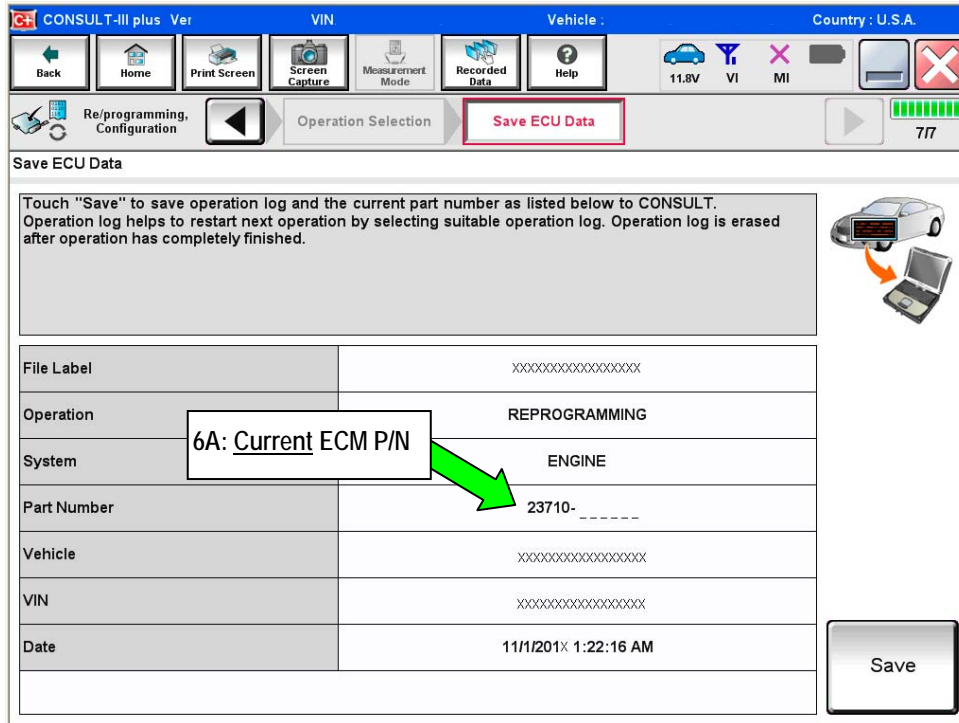
Figure 2

6. When you get to the screen shown in Figure 2, confirm this bulletin applies as follows.
- A. Find the ECM Part Number and write it on the repair order.

NOTE: This is the current ECM Part Number (P/N).

- B. Compare the P/N you wrote down to the numbers in the Current ECM Part Number column in Table A on the next page.
- If there is a match, this bulletin applies. Continue with the reprogramming procedure.
 - If there is not a match, this bulletin does not apply. Close C-III plus and refer to ASIST for further diagnostic information.
