Classification:

AT10-008a

2009-2011 G37 AND 2011 G25; TRANSMISSION SHIFT ISSUES AND/OR A/T DTC STORED

APPLIED VEHICLES: 2009-2011 G37 Sedan, Coupe, and Convertible (V36, CV36, and HV36)
2011 G25 Sedan (V36)

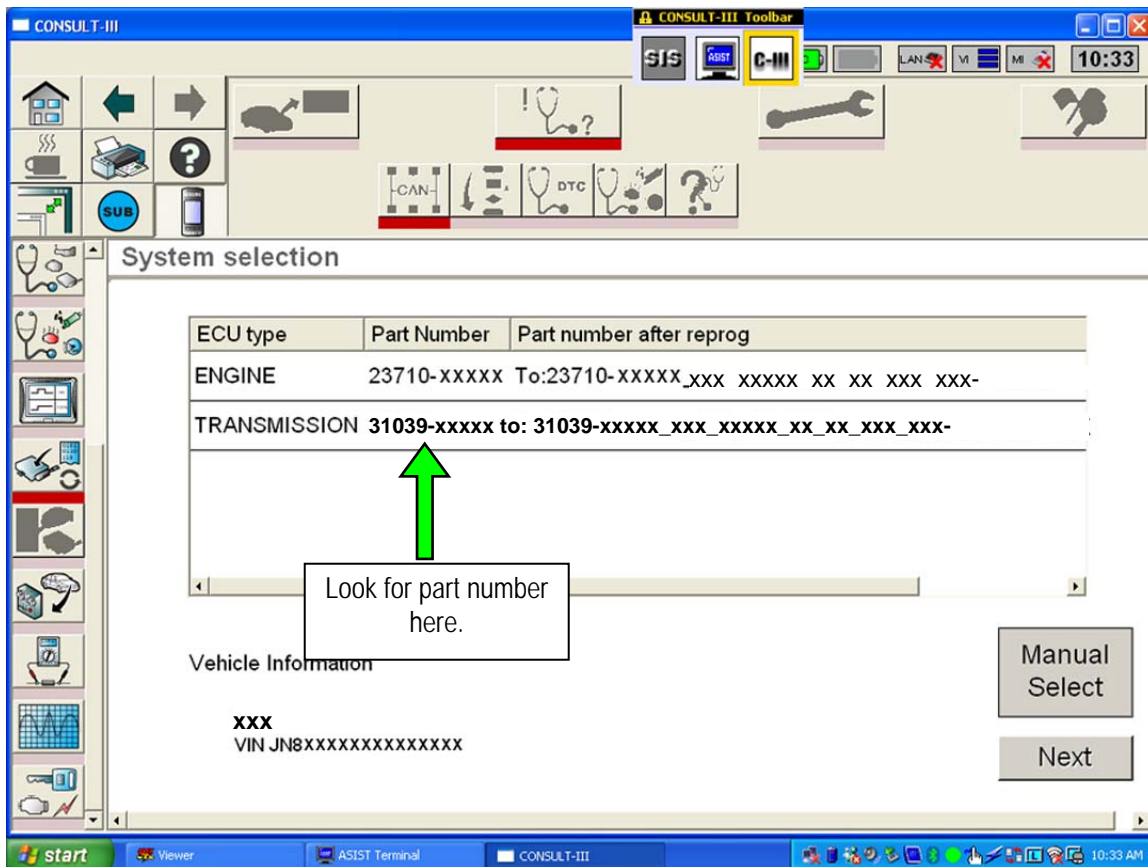
3. On your C-III screen, look for a **Transmission Part Number** in the **Part Number** column (see Figure 1 example).

- If there is **no Transmission Part Number** listed, this bulletin does not apply.
- If a Transmission Part Number is listed, write it on the Repair Order and then go to step 4.

2. Navigate C-III to the reprogramming screen shown in Figure 1 example on page 4.

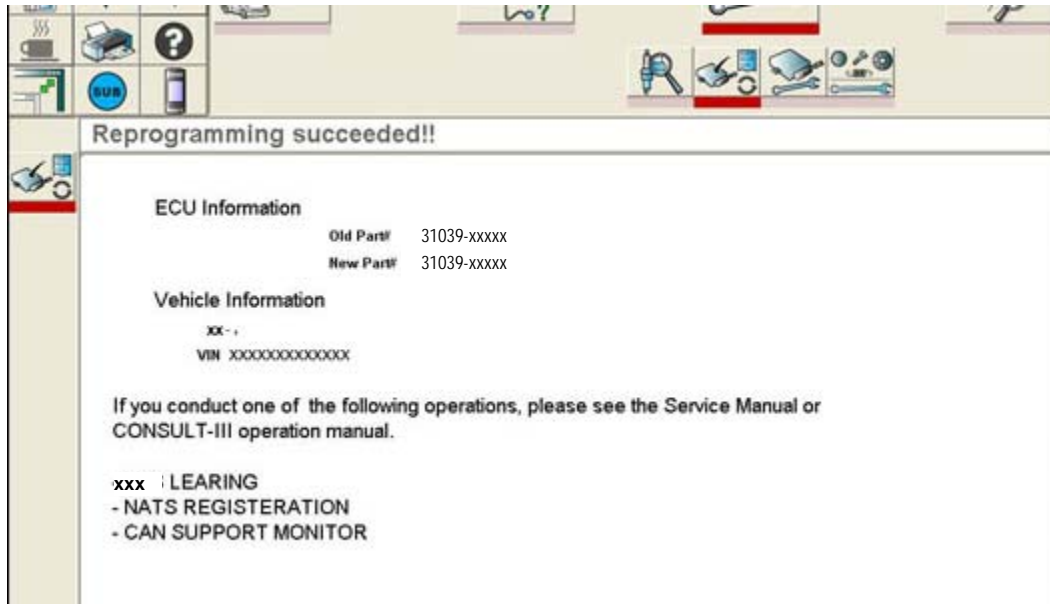
5. If this bulletin applies and you have performed TCM reprogramming; when reprogramming is complete, the screen in Figure 2 displays.

Print this screen and attach it to the Repair Order for warranty documentation.

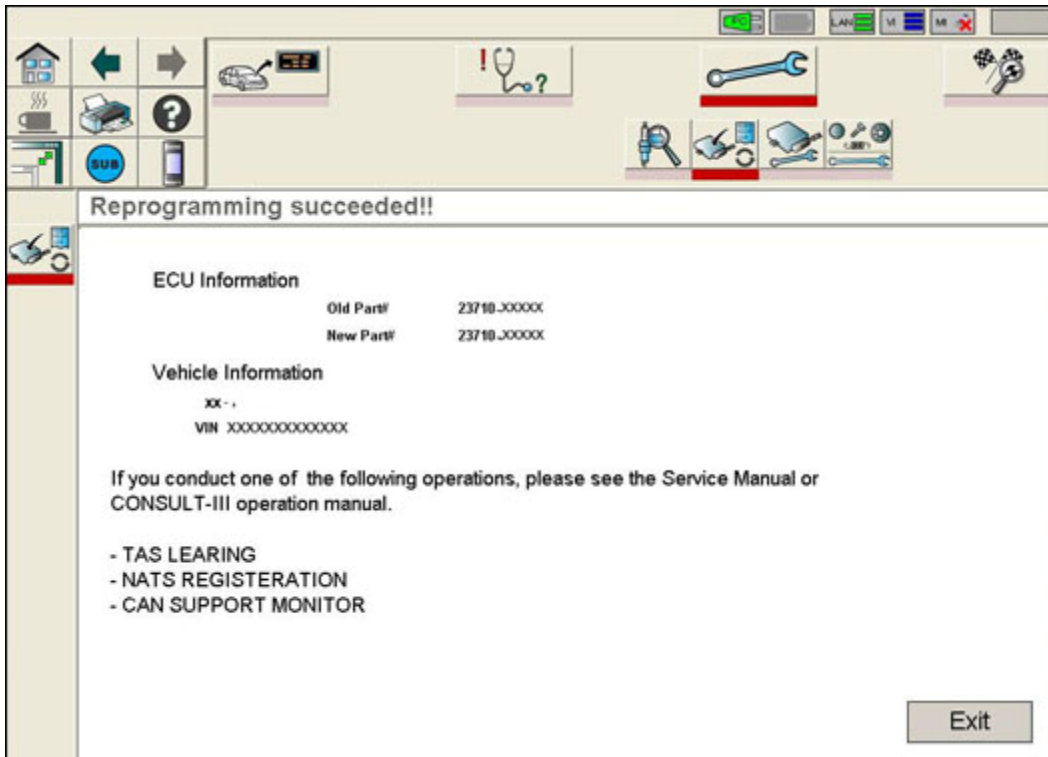
Figure 2A

5. When ECM reprogramming is complete, the screen in Figure 2 displays.

Print this page and attach it to the Repair Order for warranty documentation.
