EC07-017b

2008 G37; INTERMITTENT/SHORT DURATION SMALL RPM INCREASE DURING BRAKING

APPLIED VEHICLE: 2008 G37 (CV36) with Automatic Transmission ONLY
APPLIED DATE: Built before December 6, 2007

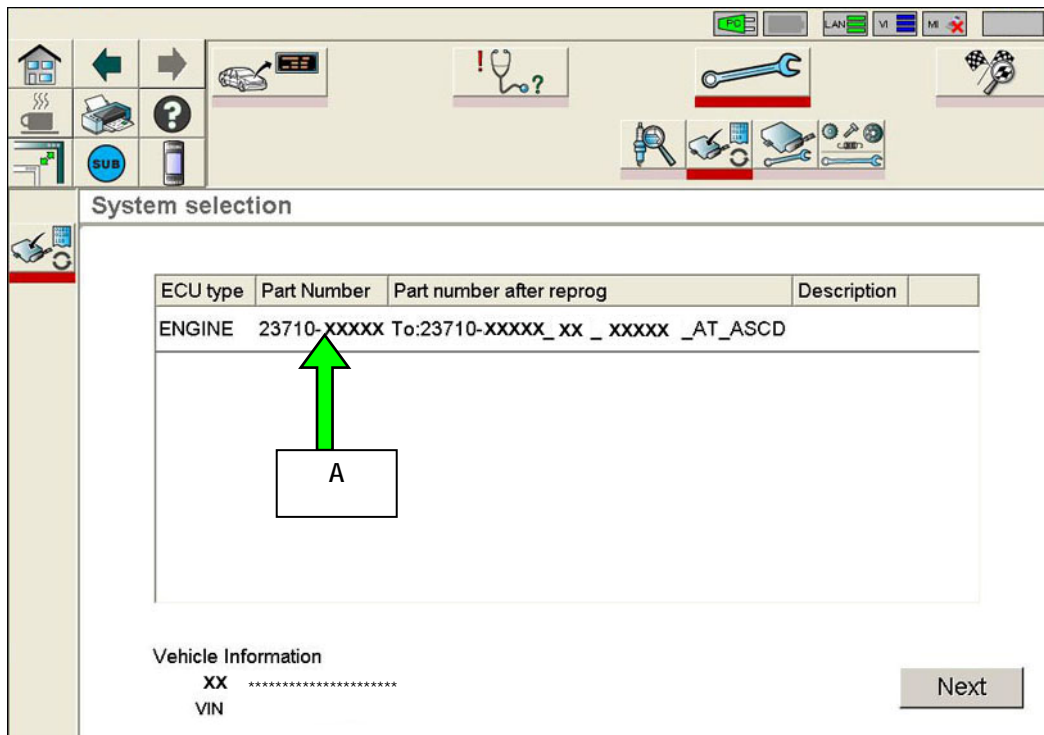
Figure 1

2. When you get to the ECM Reprogramming screen shown in Figure 1, confirm this bulletin applies as follows:

A. On your C-III screen, look at the **Part Number** column (see Figure 1):

- If this column is **blank** (no part number listed), this **bulletin does not apply**. Close C-III and refer to ASIST for further diagnostic information.
- If a Part Number is listed, write it on the Repair Order.

B. Compare the Part Number you wrote down to the numbers in the **Current ECM Part Number** column in Table A.

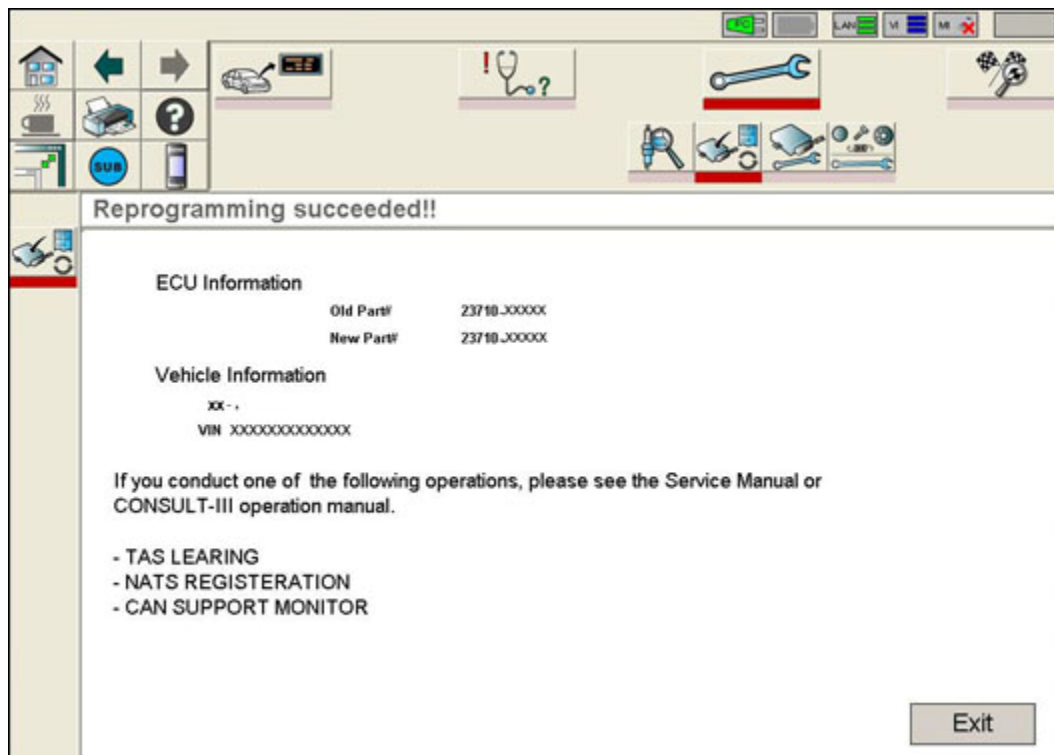
3. If this bulletin applies and you have performed ECM reprogramming, the screen in Figure 2 appears when reprogramming is complete.

Print this screen and attach it to the Repair Order for Warranty documentation.
