Classification:
EL08-025a

Reference:
ITB09-004a

Date:
February 9, 2009

EX35, G35, G37, M, QX56; NAVIGATION SYSTEM LOCKS UP / SCREEN FREEZES

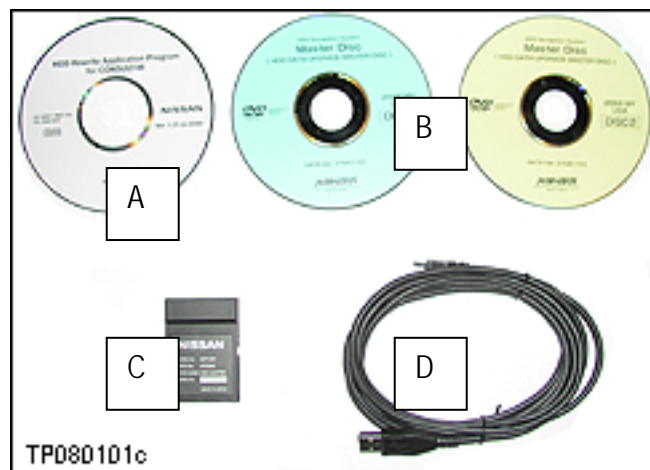
Figure B

HDD update kit contents

- HDD Rewrite software (obsolete; now available via ASIST synchronization)
- 07-08 HDD Data Upgrade Master Disc 1 & 2 (superseded by 08-09 discs)
- CF (Compact Flash) Adapter
- USB cable
 - These items can be purchased from TECH-MATE at 1-800-662-2001

NOTE: The HDD update kit was assembled prior to the availability of ASIST download for the HDD rewrite software. The kit also includes the 07-08 Upgrade Master Discs which have been superseded by the 08-09 Map Data Master Discs. Discs "A" and "B" above are no longer needed.

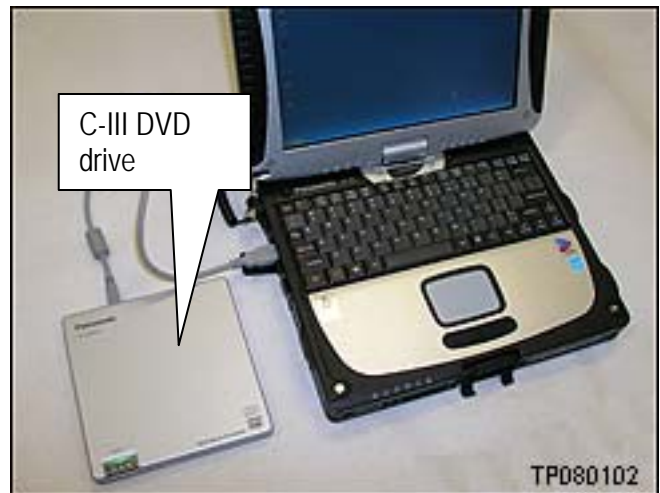
Figure 1-1

1. Connect the C-III DVD drive to the C-III computer with the USB cable.
2. Turn ON the C-III computer.
3. Open / start ASIST.

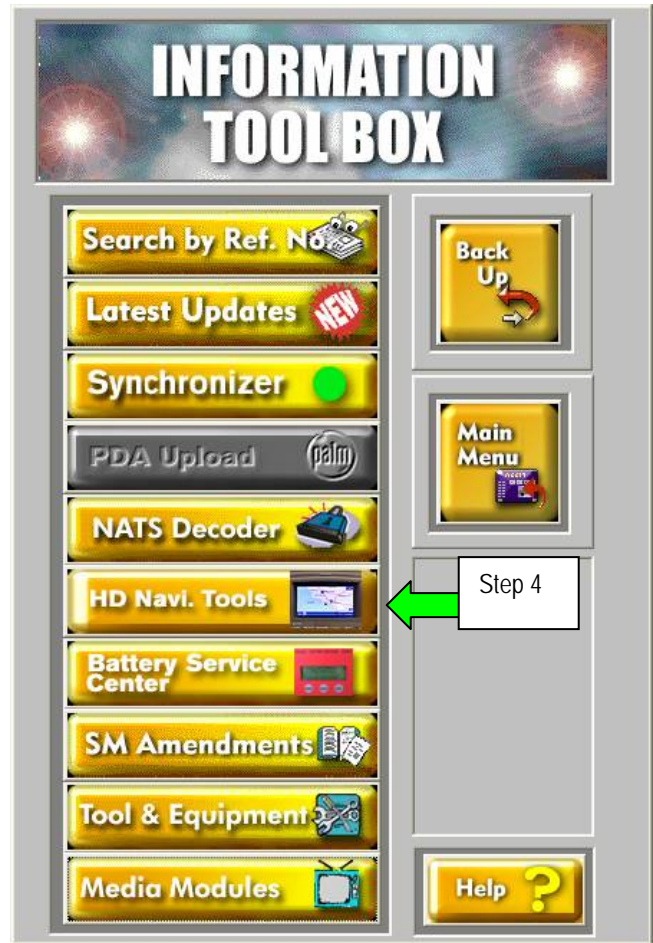
Figure 1-2

4. Select Information Tool Box and HD Navi. Tools.

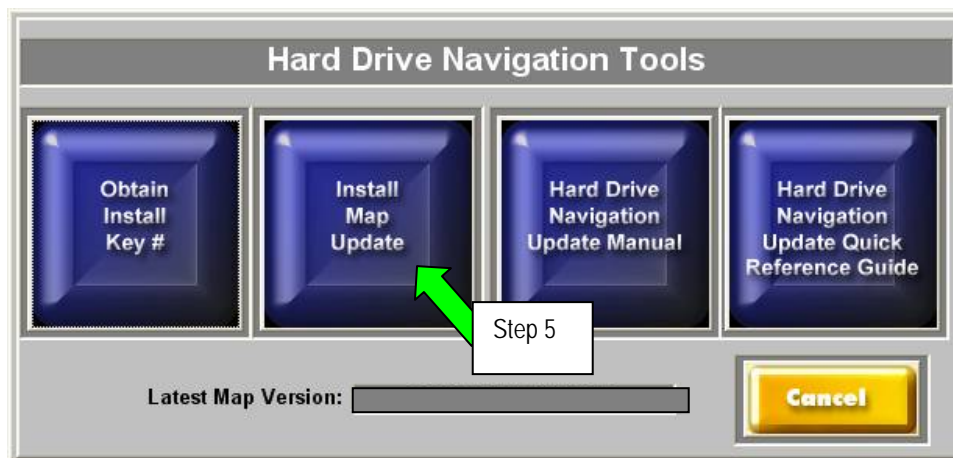
Figure 1-3

5. Select Install Map Update

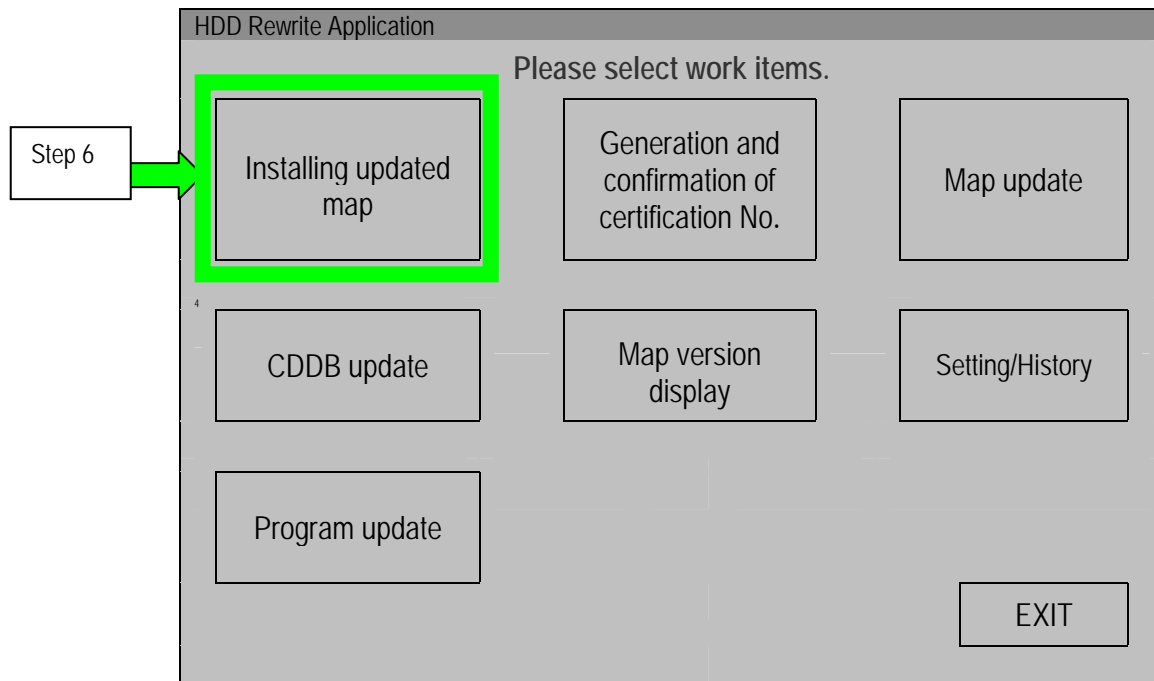
Figure 1-4

6. Select **Installing updated map**

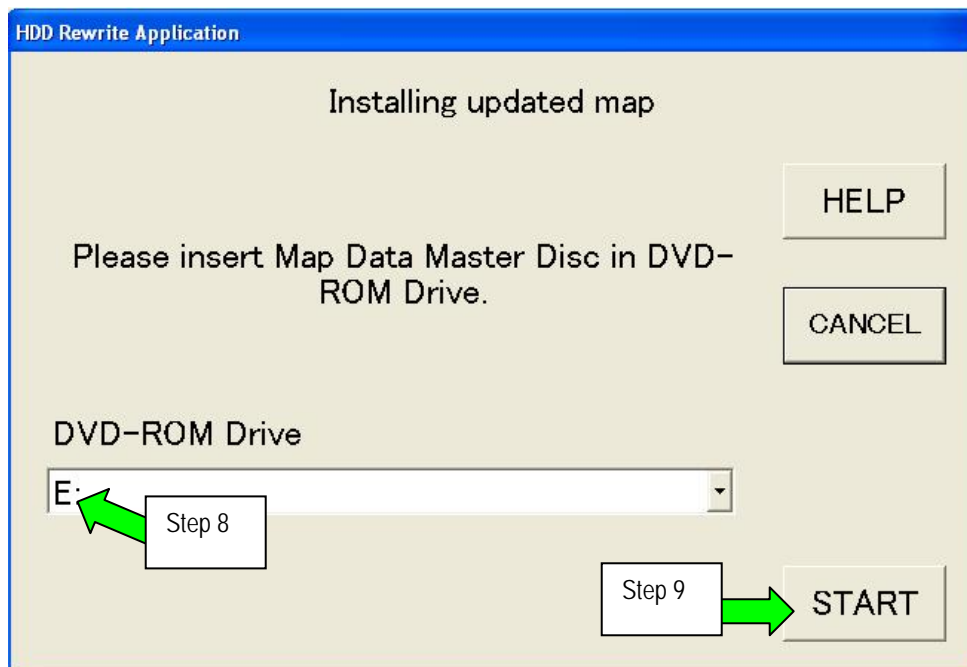
Figure 1-5

8. Confirm the correct name of the DVD drive is displayed (see Figure 1-5).

- "E" is likely the correct name for the DVD drive.
- The DVD drive name may be different depending on the drive configuration of your C-III computer.

9. Select **START**

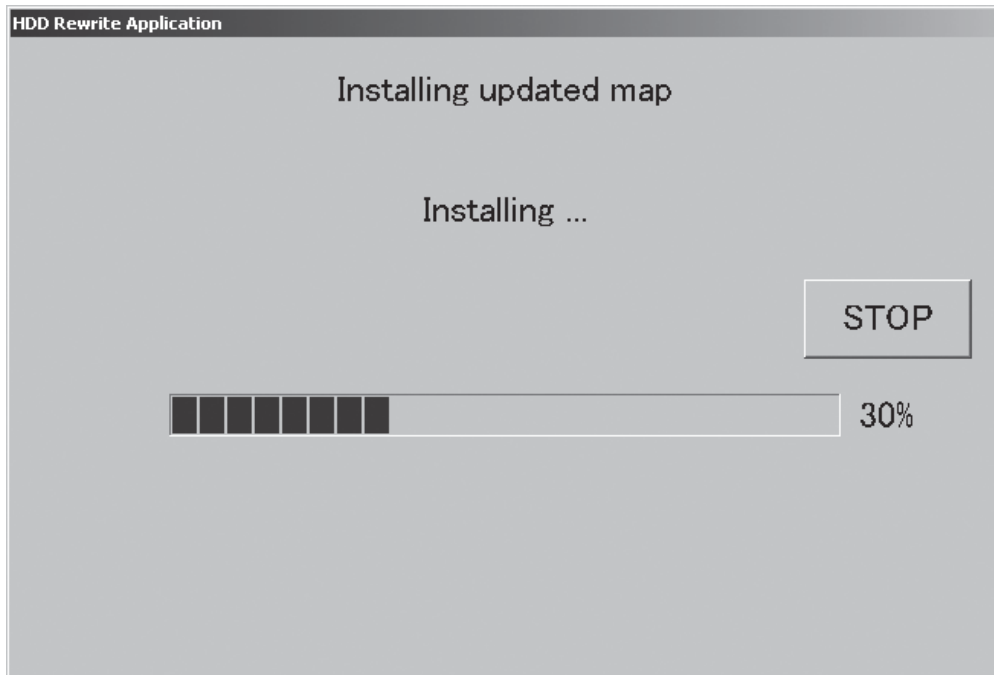
Figure 1-6

- Installation of the update map will start and a progress screen will display.
- Installation will take several minutes.

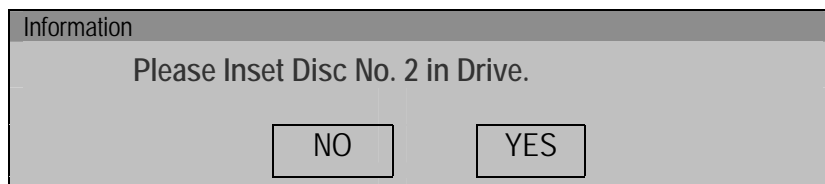
Figure 1-7

- At about 35% this message will display:

- When you get the above message, remove Disc 1; install Disc 2; then select YES.

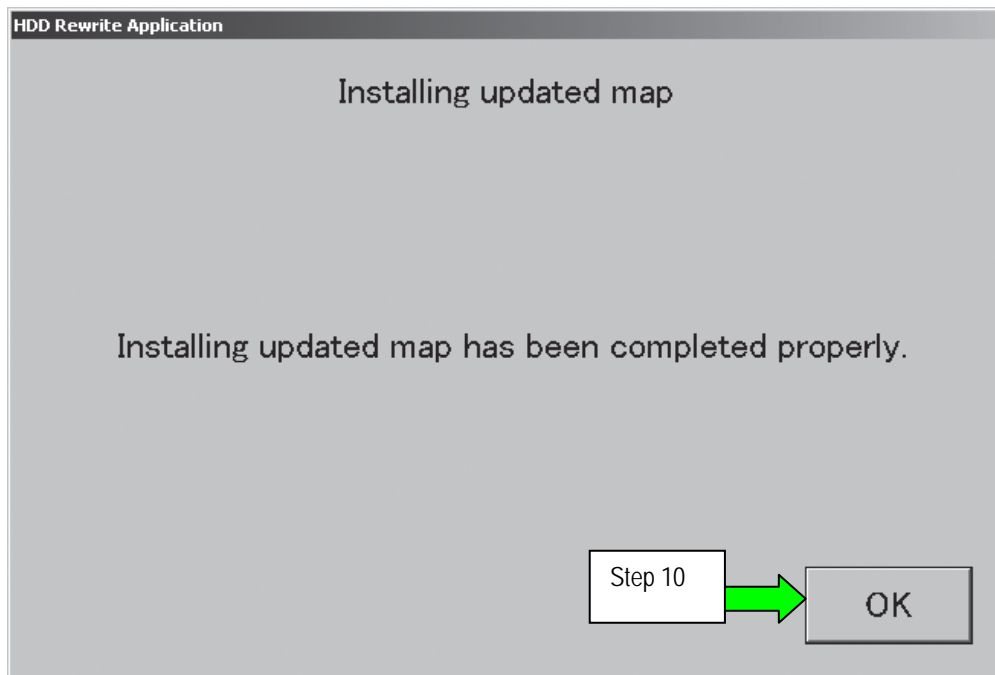
- When installation is complete the screen shown in Figure 1-8 will display.

10. Select **OK**.

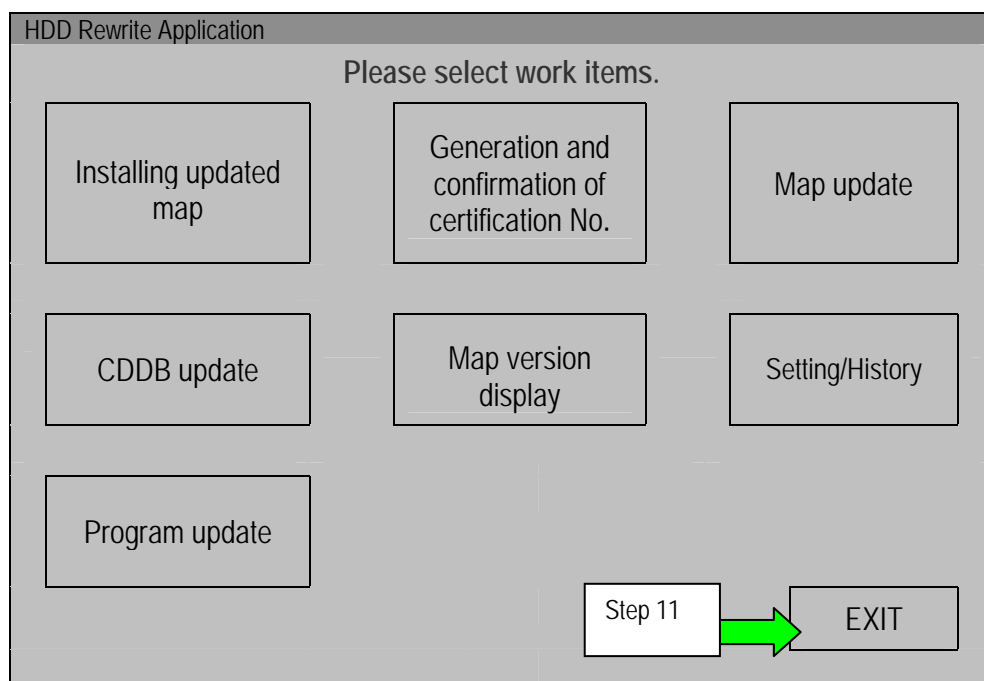
Figure 1-9

11. Select **EXIT**

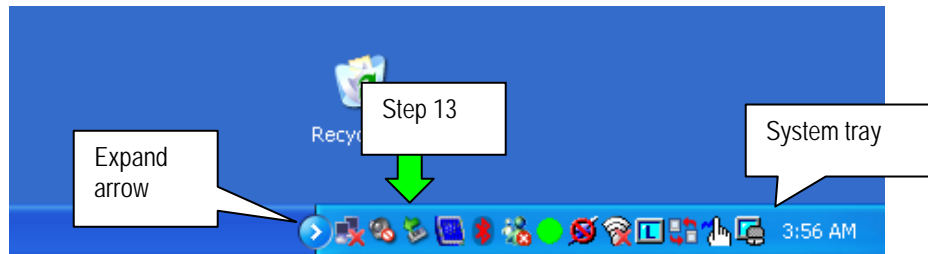
Figure 1-10

13. Select the **Safely Remove Hardware** icon on the “system tray” which is displayed in the bottom right of the C-III computer screen.

- You may need to click on the “expand arrow” to expand the icon selections.

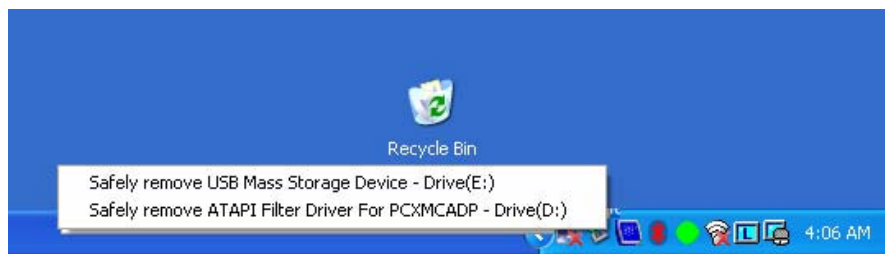
Figure 1-11

14. Select **Safely remove USB Mass Storage Device - Drive (E:)**

- The drive name will likely be E, but may be different depending on the drive configuration of your C-III computer.

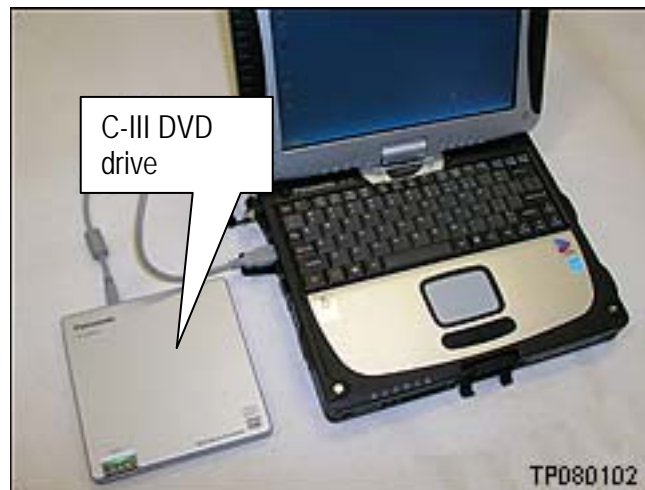
Figure 1-12

15. Disconnect the C-III DVD drive from the C-III computer.

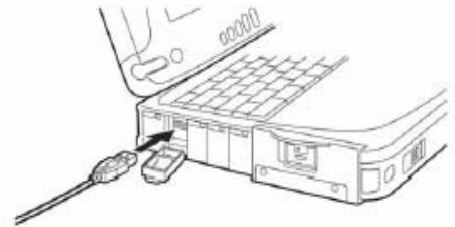
Figure 2-1

1. Make sure the ignition is OFF.
2. Close any applications that are running on the C-III computer.
 - If the C-III computer is OFF, leave it OFF for now.
3. Connect USB cable to the C-III computer.
 - Make sure connector is fully inserted.

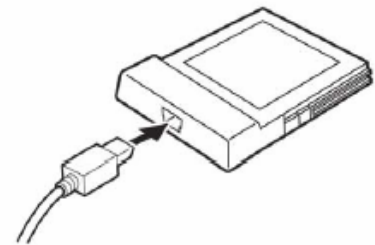
Figure 2-2

4. Connect the other end of the USB cable to the CF (Compact Flash) adapter.
 - Make sure connector is fully inserted.

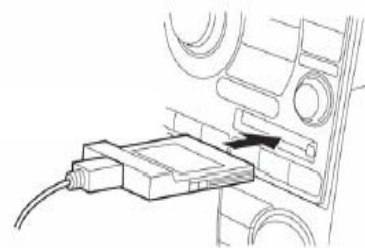
Figure 2-3

5. Carefully insert the CF adapter into the CF card slot of the vehicle audio/navigation system.
 - Label side UP.
 - Insert it all the way (firmly), to its stop.

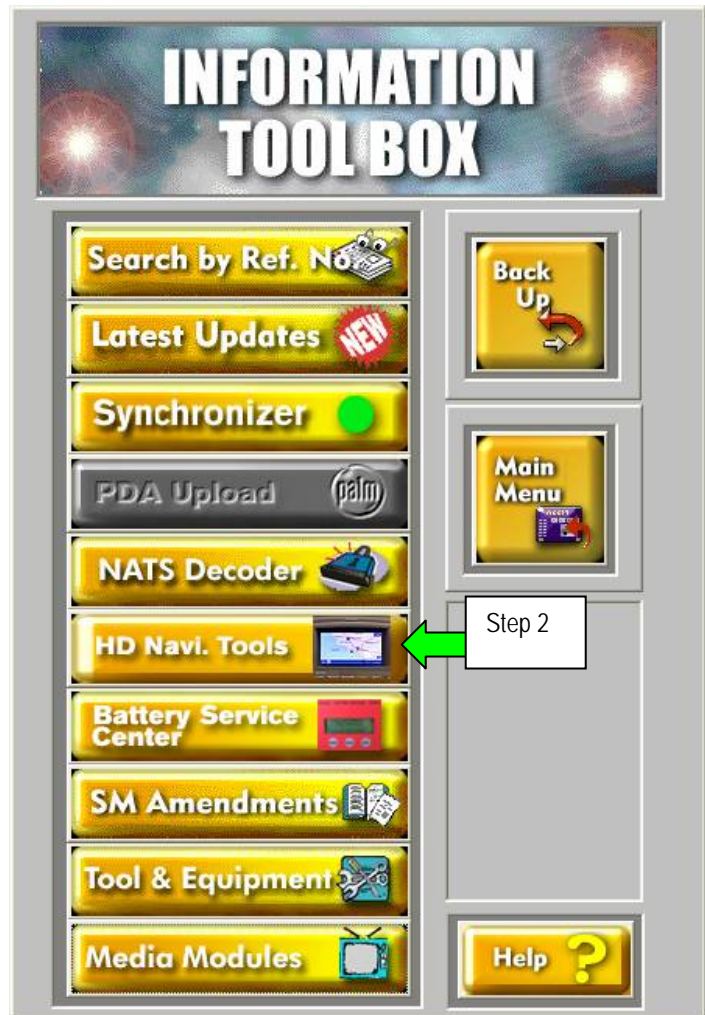
Figure 3-1

2. In ASIST, select Information Tool Box and HD Navi. Tools.

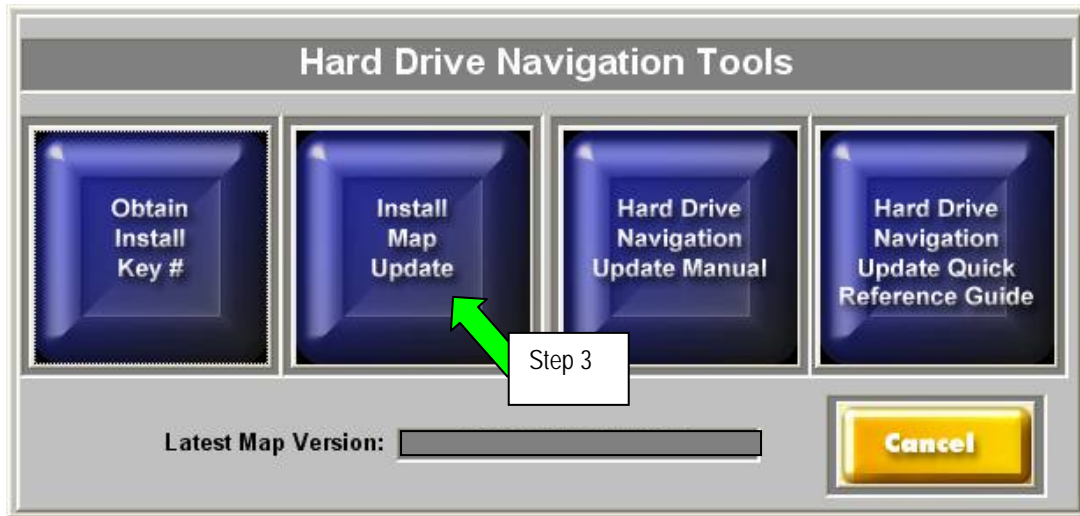
Figure 3-2

3. Select Install Map Update

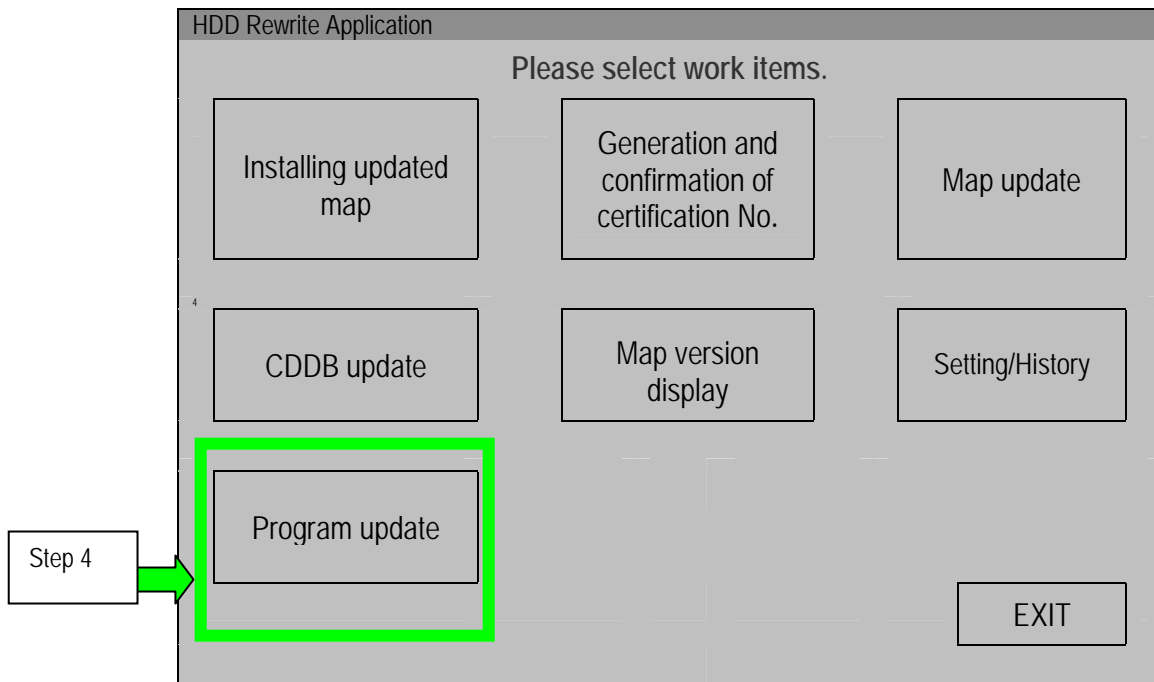
Figure 3-3

4. Select Program update

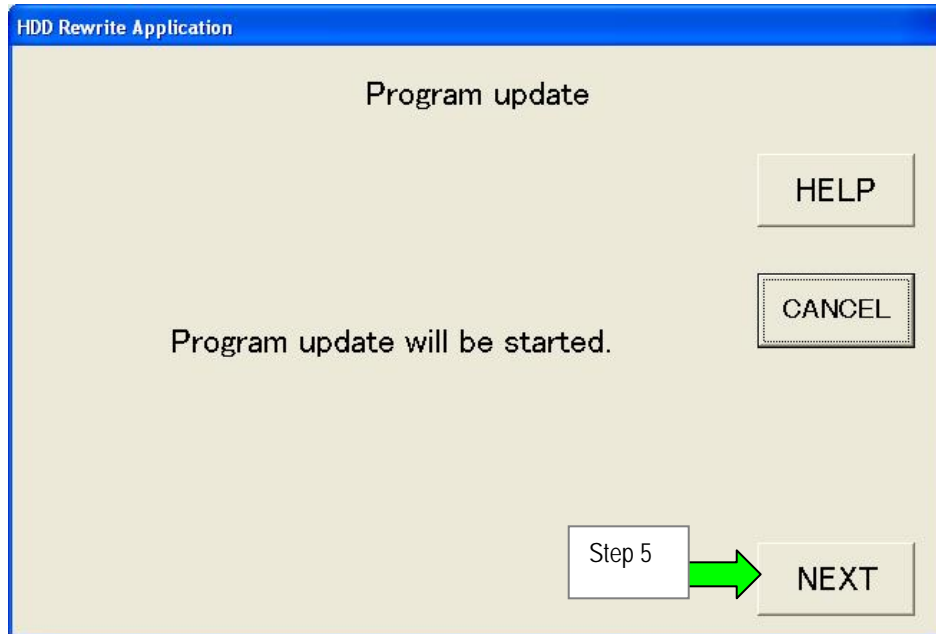
Figure 3-4

5. Select **NEXT**

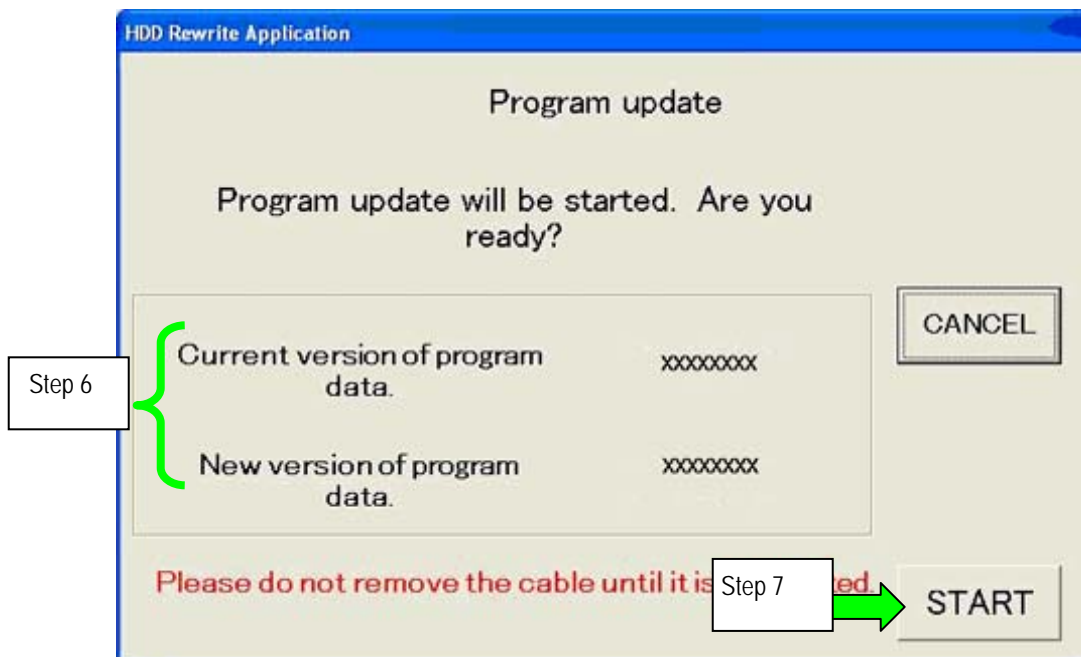
Figure 3-5

6. Confirm the version number of "New version of program data" is higher than "Current version of program data".

7. Select **START**

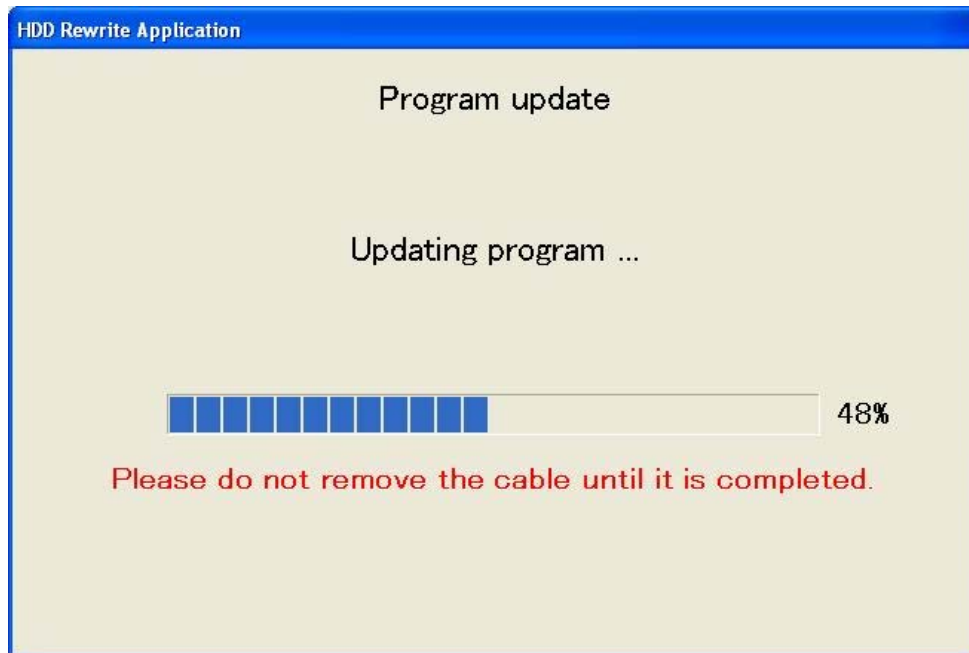
Figure 3-6

- Audio system update will begin and a progress bar will be displayed as shown in Figure 3-6.

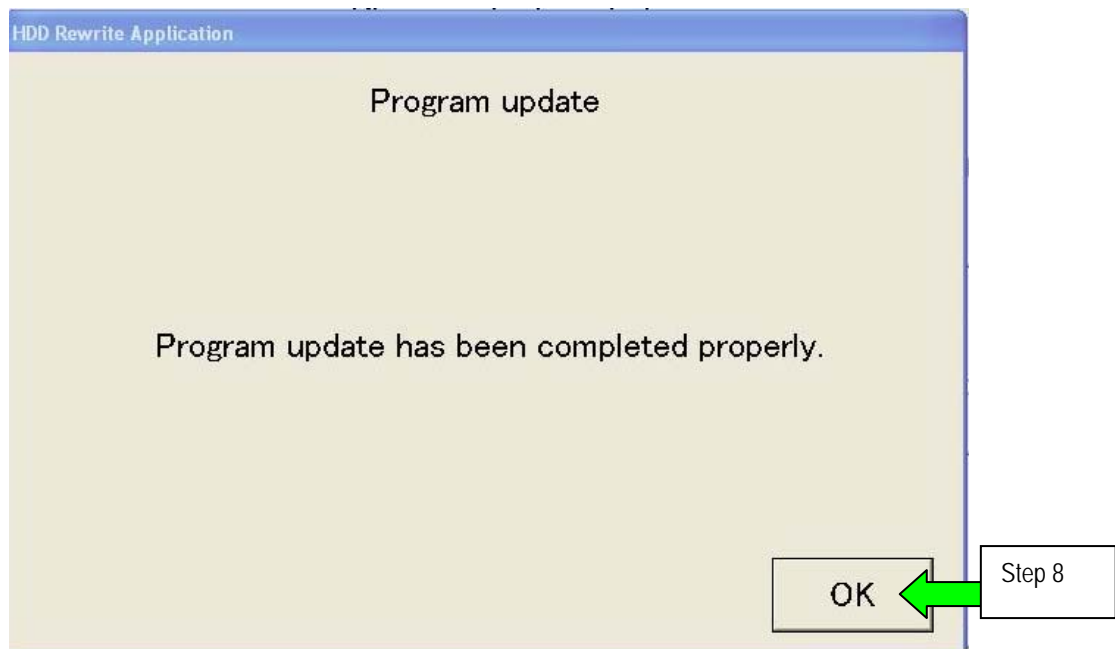
- When update is complete the screen in Figure 3-7 will display.

8. Select OK

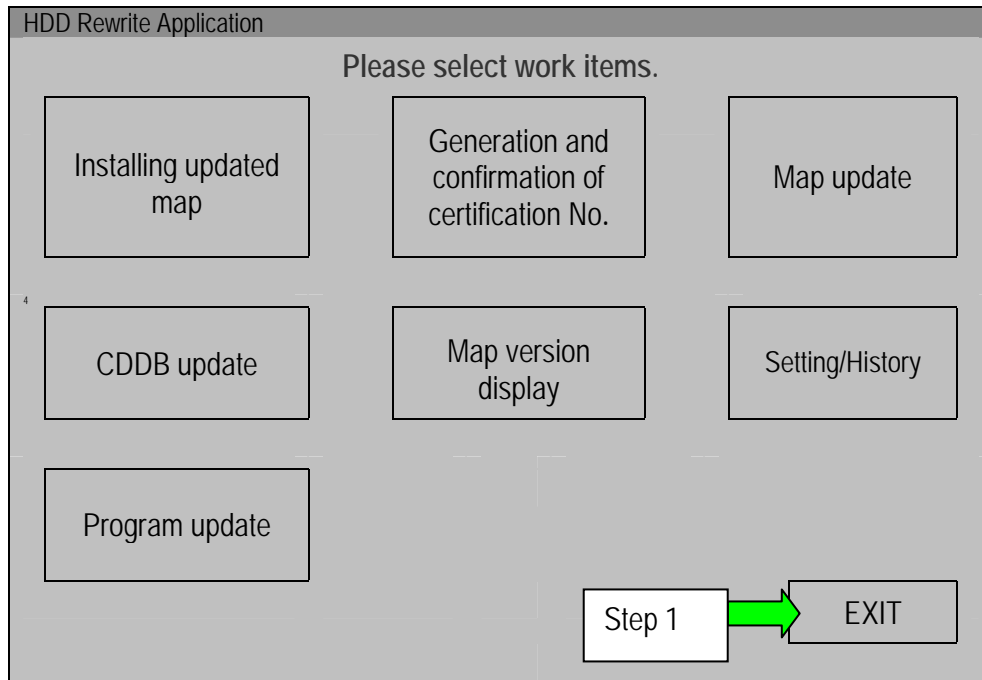
Figure 4-1

1. Select **EXIT**

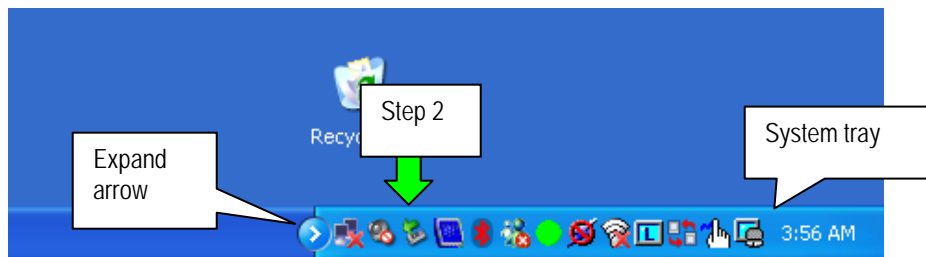
Figure 4-2

2. Select the **Safely Remove Hardware** icon on the "system tray" which is displayed in the bottom right of the C-III computer screen.
 - You may need to click on the "expand arrow" to expand the icon selections.

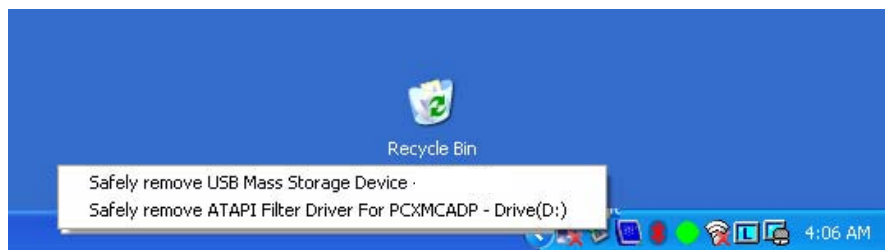
Figure 4-3

3. Select **Safely remove USB Mass Storage Device**

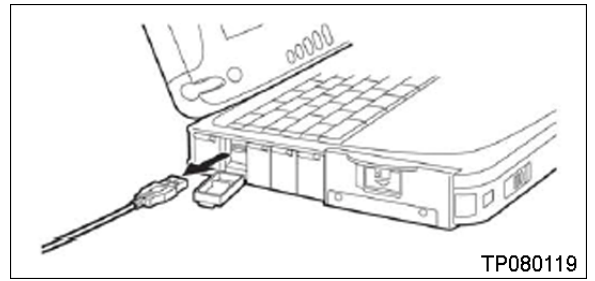
Figure 4-4

4. After the message "Safe to Remove Hardware" is displayed, disconnect the USB cable from the C-III computer.

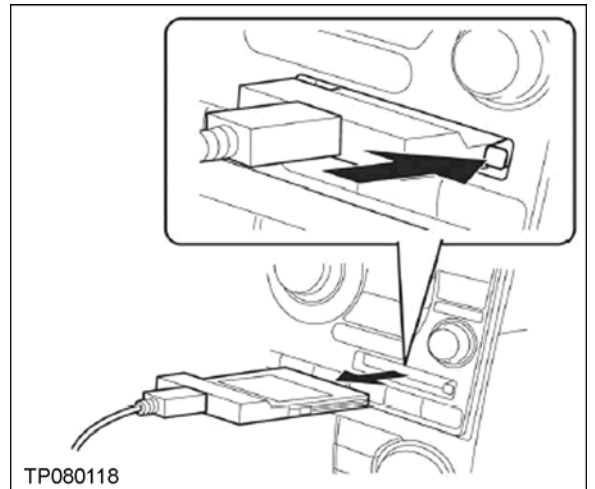
Figure 4-5

5. Push the Eject button at the right of the CF card slot and carefully remove the CF adapter.

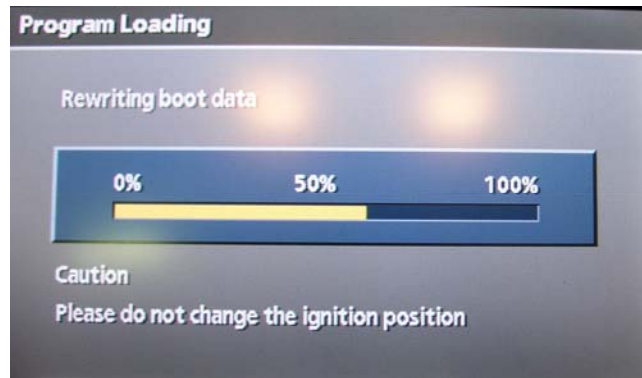
- Make sure the CF adapter is disconnected from the navigation system before performing the following steps.
1. Turn the ignition ON.
 - If the ignition is already ON, turn it OFF and then back ON.
 2. The Program Loading screen as shown in Figure 5-1 will display.
 - This process may take only a few seconds to complete or it may take a few minutes.
