EL10-042b

ITB10-066b

NAVIGATION / BLUETOOTH / VOICE RECOGNITION FUNCTION ISSUES

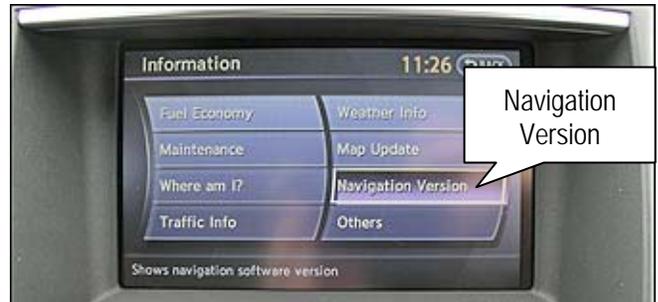
Figure 1

5. Select **Navigation Version** on the display screen.

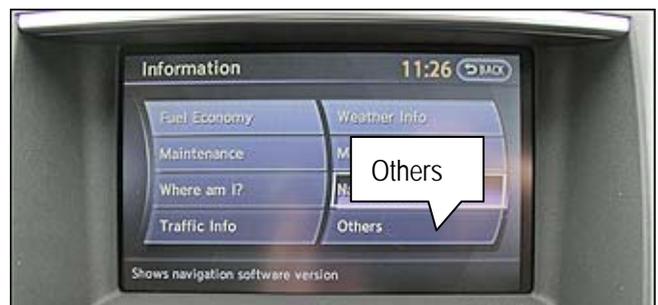
Figure 2

NOTE: On some vehicles you will first need to select **Others** to find **Navigation Version**.

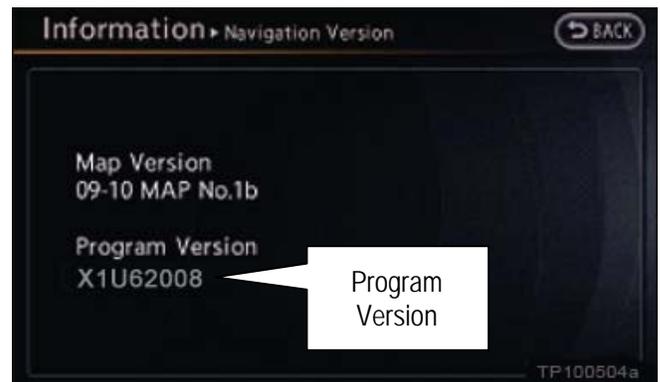
Figure 3

6. Check the **Program Version**.

If the Program Version is:

- X1U62024 or lower

OR

- X1U72001

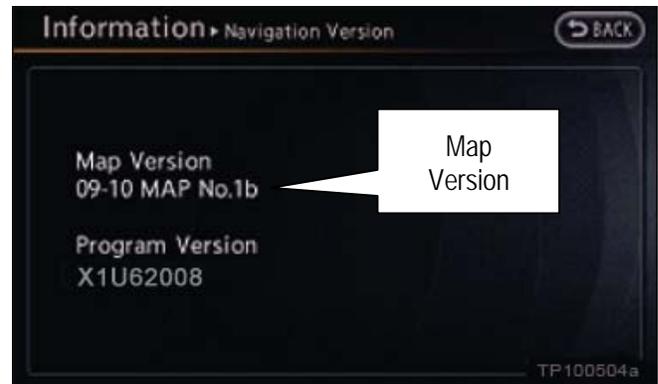
Figure 4

7. Check the **Map Version**.

- If the Map Version is not **09-10 MAP No. 1**, continue with the next section of the Service Procedure (“Load Reprogramming Software DVD”).
- If the Map Version is **09-10 MAP No. 1**, first perform the procedure in ITB10-031. Once complete, continue with the next section of the Service Procedure (“Load Reprogramming Software DVD”).

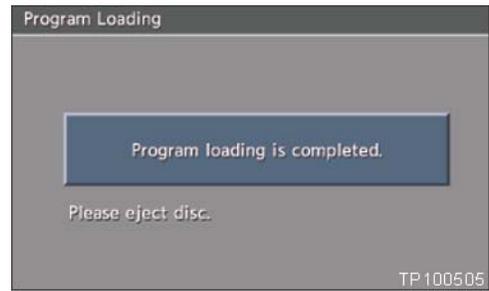
Figure 5

4. When the program has finished loading:
 - The Reprogramming Software DVD will automatically eject.
 - "Program loading is completed" will display.

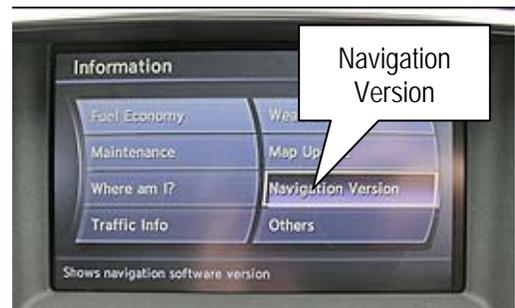
Figure 6

6. Make sure the new program has loaded.
 - a. Press the "INFO" button on the switch panel.
 - b. Select **Navigation Version** on the display screen.

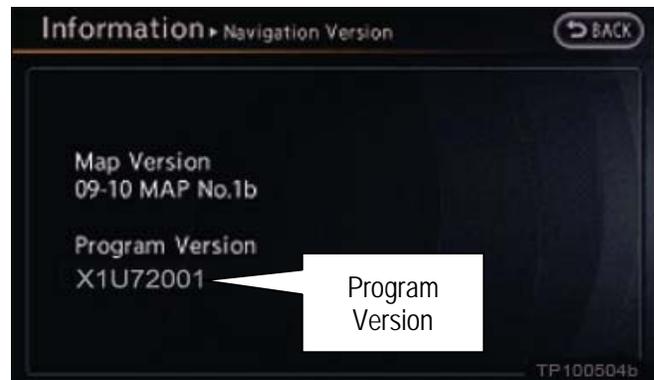
Figure 7

- c. The Program Version should be **X1U62025**.
 - If the Program Version is not X1U62025, perform the Load Reprogramming Software DVD procedure again.
