AT10-008

## 2009 – 2011 G37 AND 2011 G25 TRANSMISSION SHIFT ISSUES AND/OR A/T DTC STORED

**APPLIED VEHICLES:** 2009 – 2011 G37 (V36, CV36, and HV36)  
2011 G25 (V36)

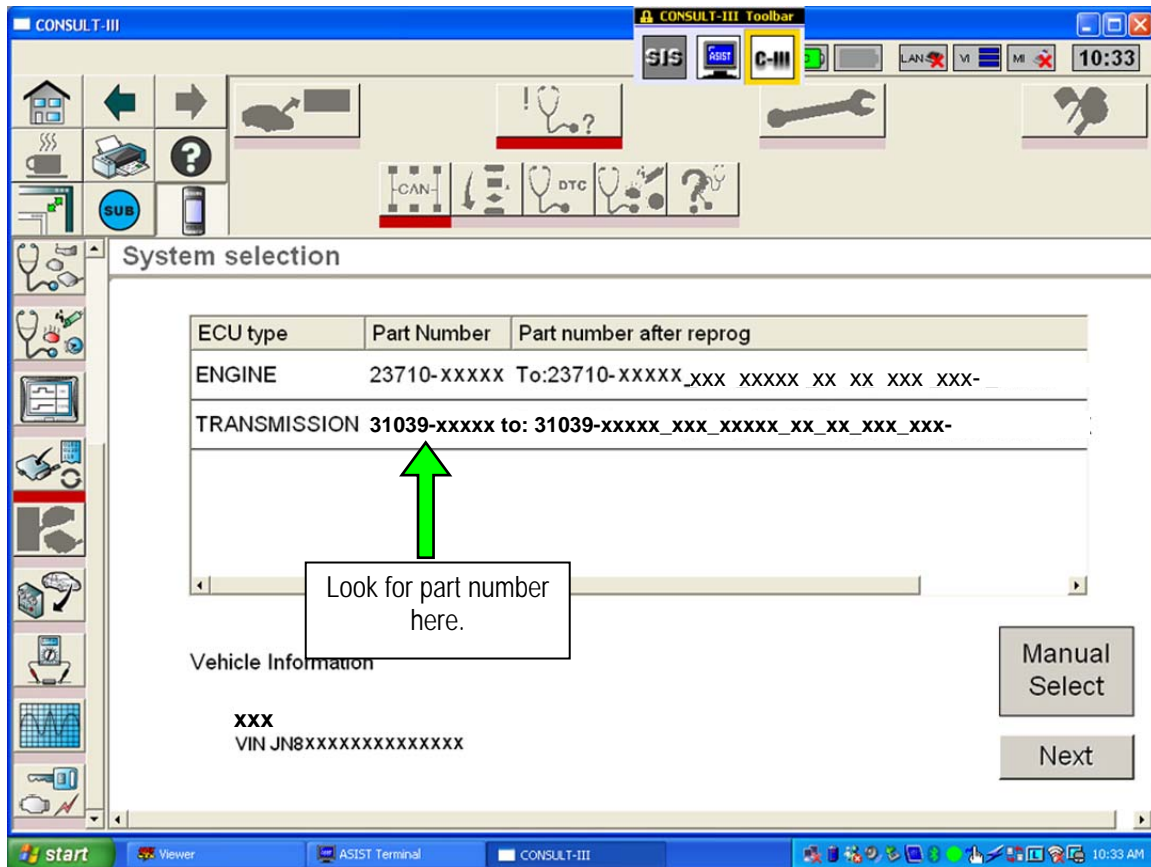
2. Navigate C-III to the reprogramming screen shown in Figure 1 example below.

3. On your C-III screen, look for a **Transmission Part Number** in the **Part Number** column (see Figure 1 example).

- If there is **no Transmission Part Number** listed, this **bulletin does not apply**.
- If a Transmission Part Number is listed, write it on the Repair Order and then go to Step 4.

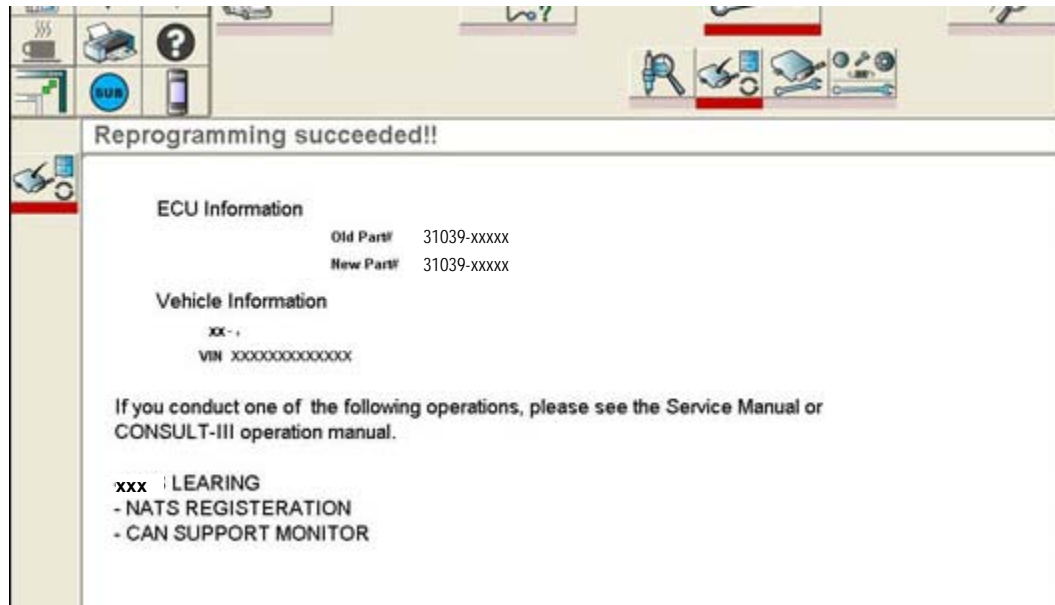
5. If this bulletin applies and you have performed TCM reprogramming; when reprogramming is complete, the screen in Figure 2 displays.

Print this screen and attach it to the Repair Order for warranty documentation.

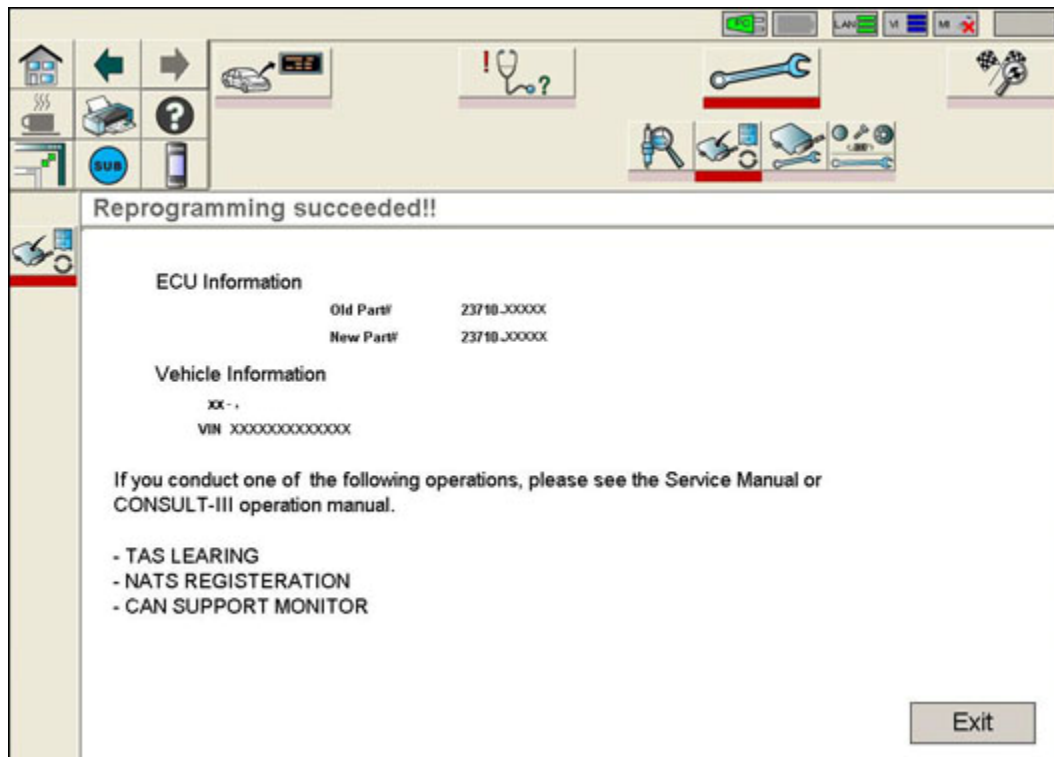
Figure 2A

- When ECM reprogramming is complete, the screen in Figure 2 displays.

**NOTE:** If the screen in Figure 2 does **NOT** display (reprogramming does **NOT** complete), click here. This links to the ECM Reprogram Interruption Recovery General Procedure.

Print this page and attach it to the Repair Order for warranty documentation.
