Classification:

EL11-017b

2010-2011 BLUETOOTH® PHONE SOUND QUALITY

APPLIED VEHICLE: 2010-2011 G37 sedan (V36), G37 coupe (CV36), G37 convertible (HV36), QX56 (Z62) and FX35/50 (S51) **With Navigation only**

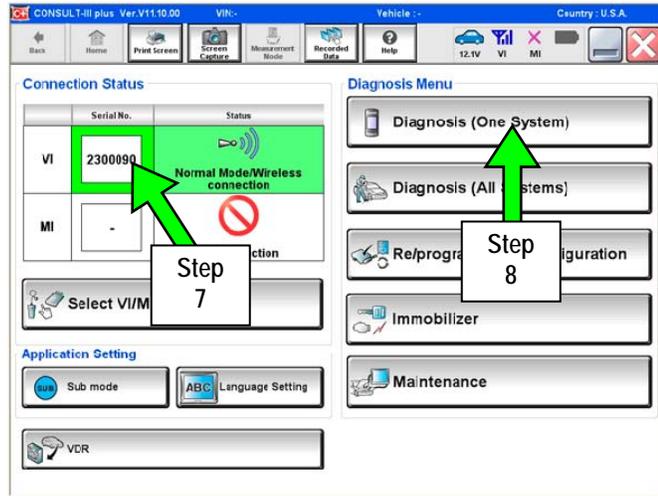
Figure 1

5. Open/start ASIST on the C-III computer, then select CONSULT III plus.
6. Wait for VI to be detected, and status box(s) to turn "green" (Page 4, Figure 1).

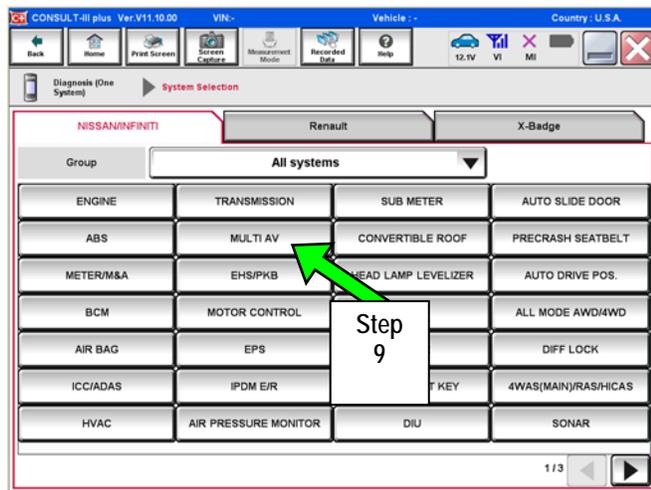
Figure 2

9. Select **MULTI AV**

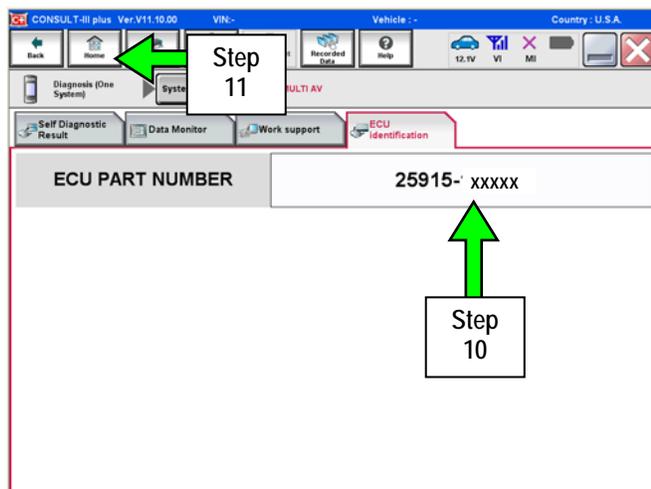
Figure 3

10. Confirm **ECU PART NUMBER** and print, or Write down for Warranty Information.
25915 - _____

11. Select the **Home** button when done.

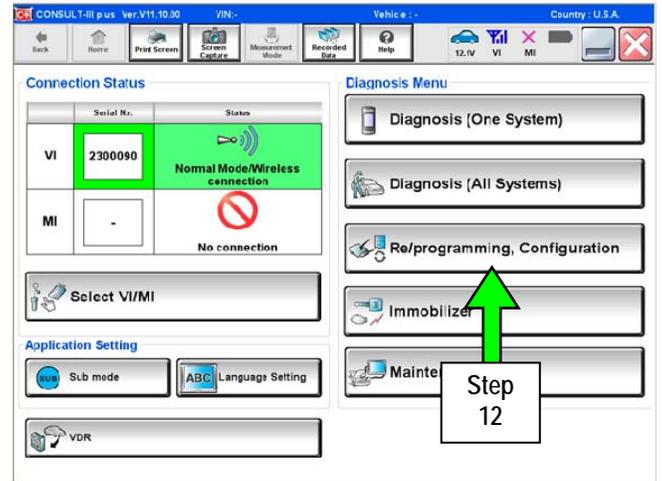
Figure 4

12. Select Re/programming Configuration

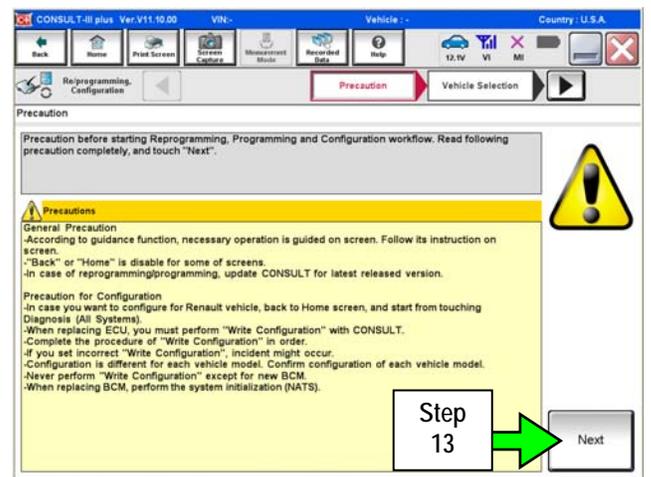
Figure 5

13. Read Precautions, then select Next.

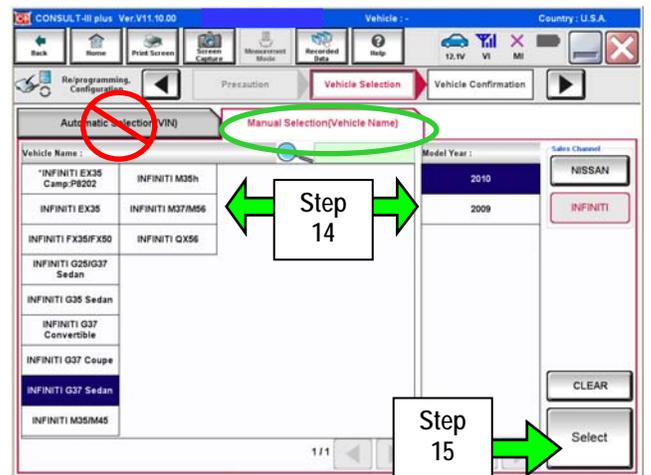
Figure 6

14. Use Manual Selection(Vehicle Name), then select correct Make, Model and Year.

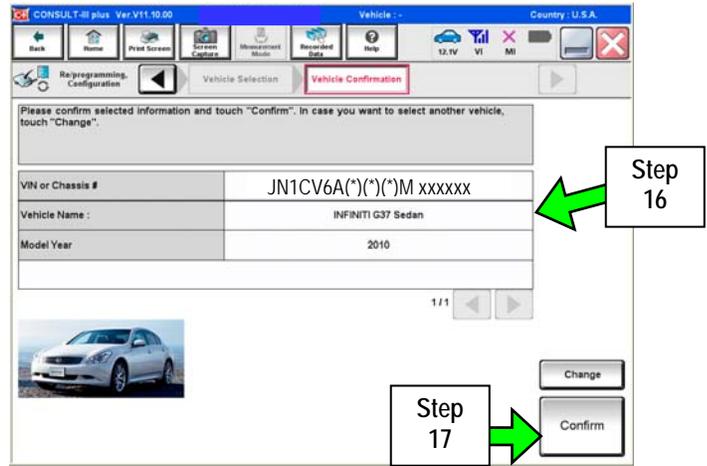
Figure 7

16. Confirm correct VIN, Vehicle Name and Model Year.

17. Select **Confirm**, or change VIN if incorrect.

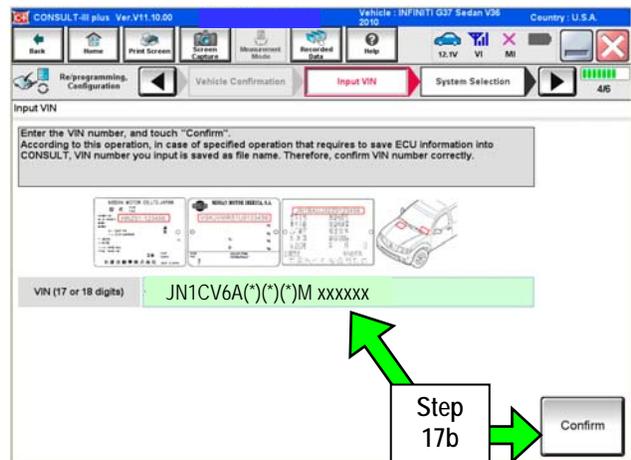
Figure 8

- a. If VIN needs to be changed, refer to Figure 8, after selecting **Change** option.
- b. Correct the VIN, and then select **Confirm**.

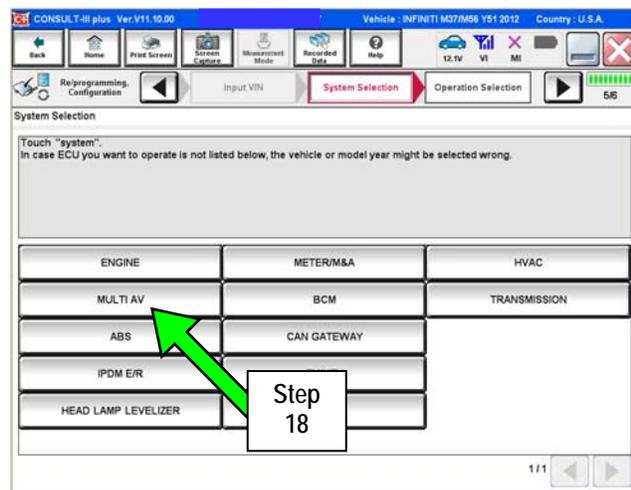
Figure 9

18. After system call completes, select **MULTI AV**.

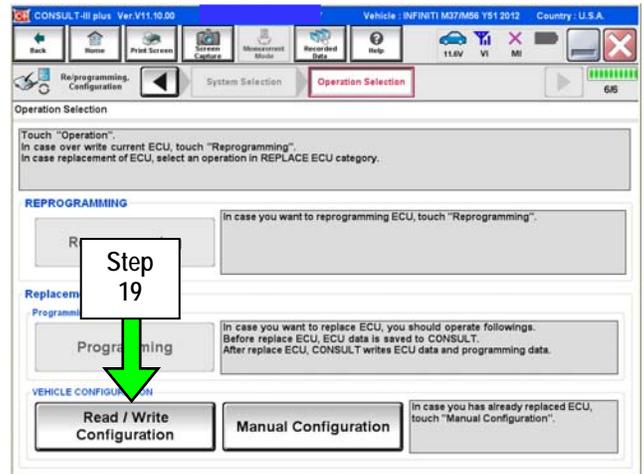
Figure 10

19. Select Read/Write Configuration.

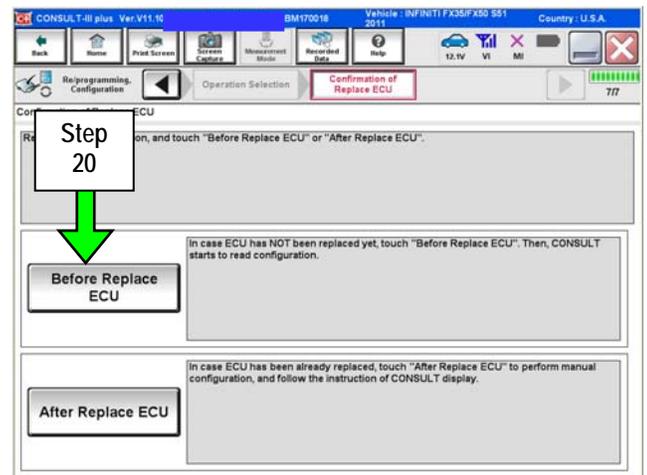
Figure 11

20. Select Before Replace ECU.

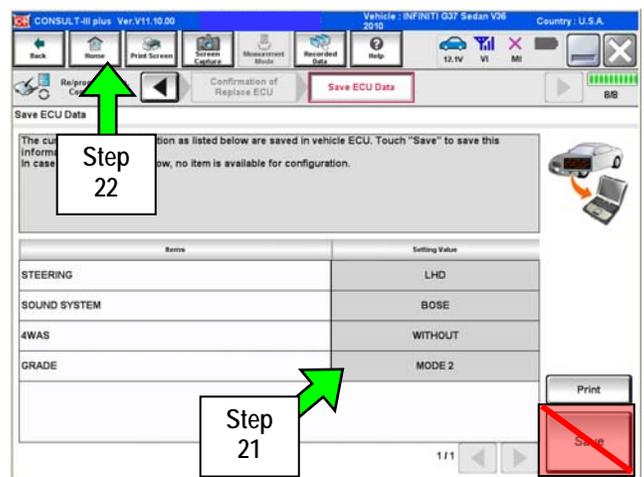
Figure 12

21. Confirm current configuration and write it down.

- Configuration can also be printed with **Print Screen**, or the **Screen Capture** button.

NOTE: Do not use **Save** button at this time.

- Configurable options will differ between models. Your screen may look different.

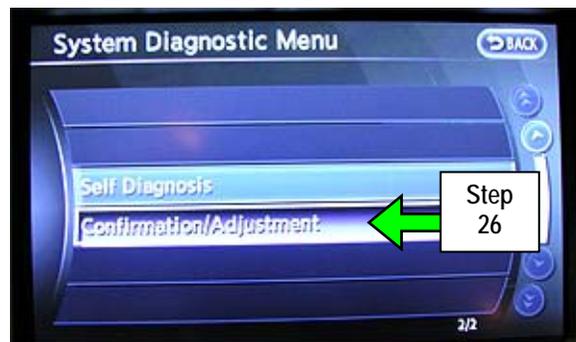
- a. Press and hold the SETTING button.
- b. While holding the SETTING button, turn the volume control knob 40 clicks or more.
 - The volume control knob can be turned either direction.
 - When the system goes into the System Diagnostic Menu, the screen in Figure 14 will display.

26. Select Confirmation/Adjustment

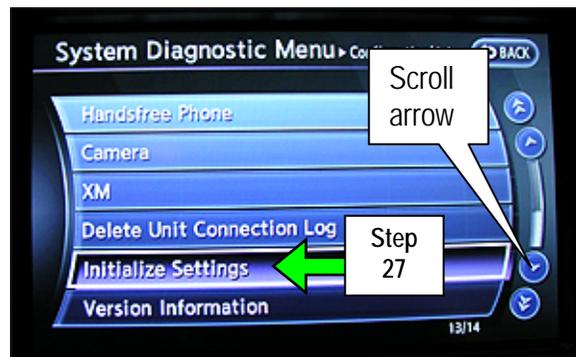
Figure 15

27. Select Initialize Settings

NOTE: Use the scroll arrow to find Initialize Settings.

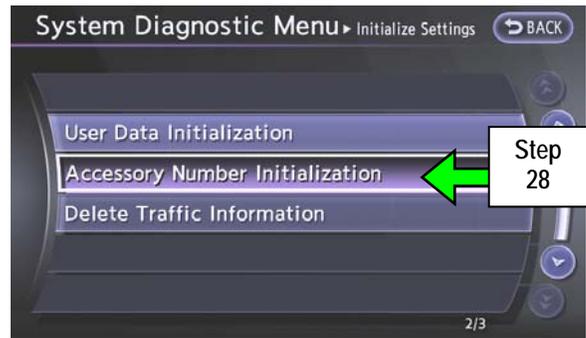
Figure 16

28. Select Accessory Number Initialization.

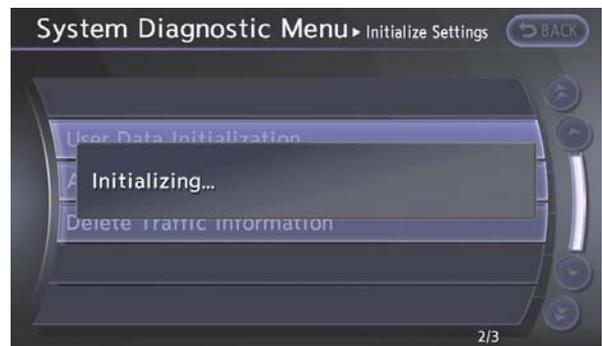
31. The screen in Figure 19 will display while initializing.

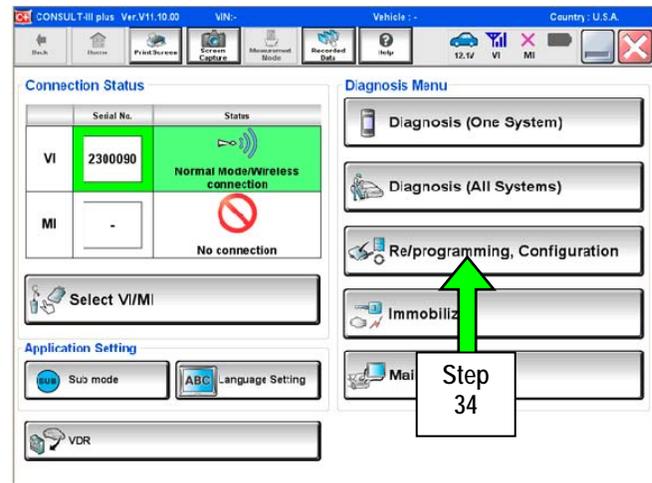
Figure 21

34. Select Re/programming Configuration

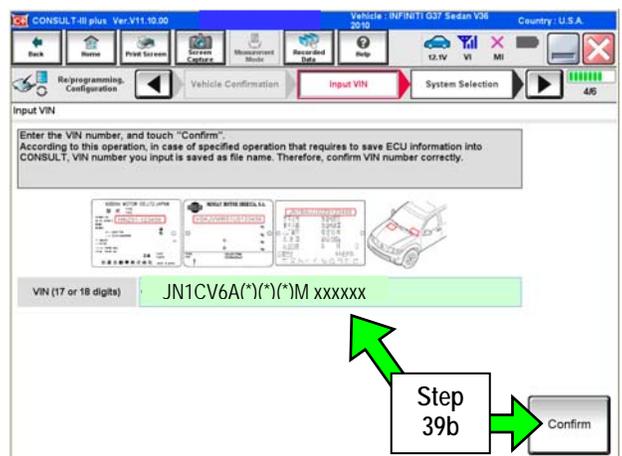
Figure 25

- a. If **VIN** needs to be changed, refer to Figure 25, after selecting **Change** option.
- b. Correct the **VIN**, and then select **Confirm**.

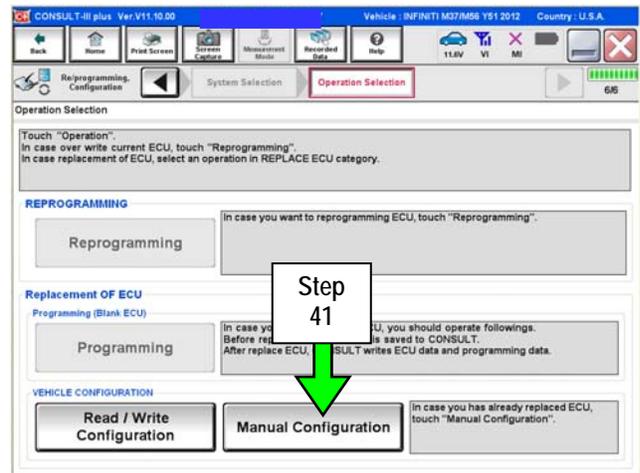
Figure 27

41. Select **Manual Configuration**.

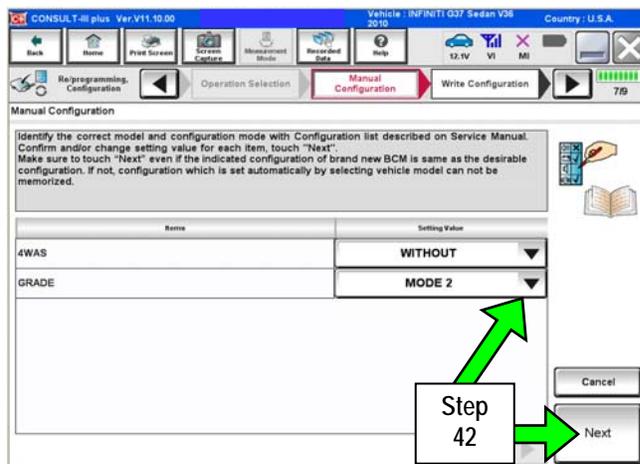
Figure 28

42. Use drop down arrows to select correct **Configuration** options that were printed in step 21, then select **Next**.

- Configurable options will differ between models. Your screen may look different in figures 28 and 29.

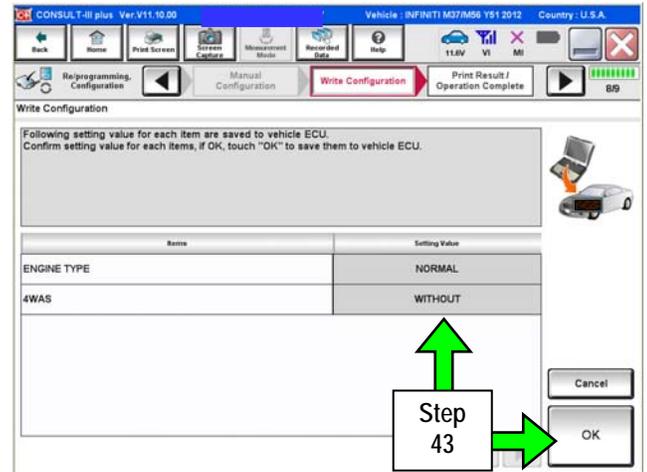
Figure 29

43. Confirm correct **Configuration** then select **OK**

- After C-III plus finishes transferring the configuration to **MULTI AV**, return to **Home** screen.

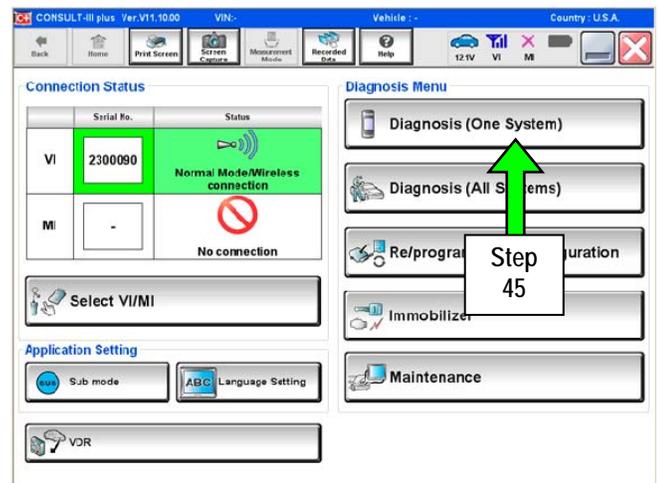
Figure 30

45. Use steps 8 through 10 and make sure the part number has changed.

- Compare the part number you wrote down in Step 10 to the one that is now displayed.
- The part numbers should be different.

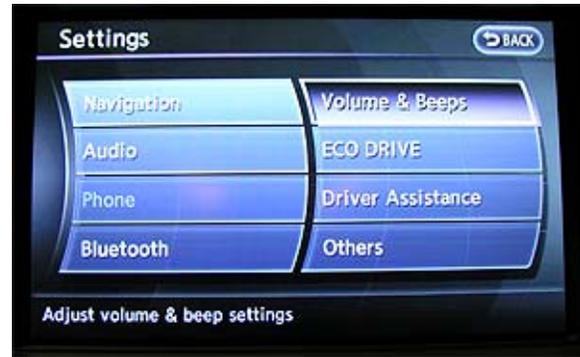
Figure 31

A. Press the SETTING button on the control panel.

B. Select **Volumes & Beeps**

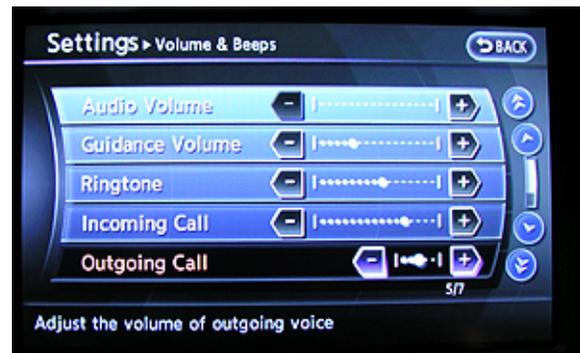
Figure 32

C. Adjust the **Outgoing Call** volume to the customer's preference.

- If extremely loud talker, set to level 1 (-).
- If moderately loud talker, set to level 2.
- If normal loud talker, set to level 3.
- If moderately quiet talker, set to level 4.
- If quiet talker, set to level 5 (+).
