EC12-009

ECM REPLACEMENT PROCEDURES WITH CONSULT III PLUS

APPLIED VEHICLES: All 2004 and later

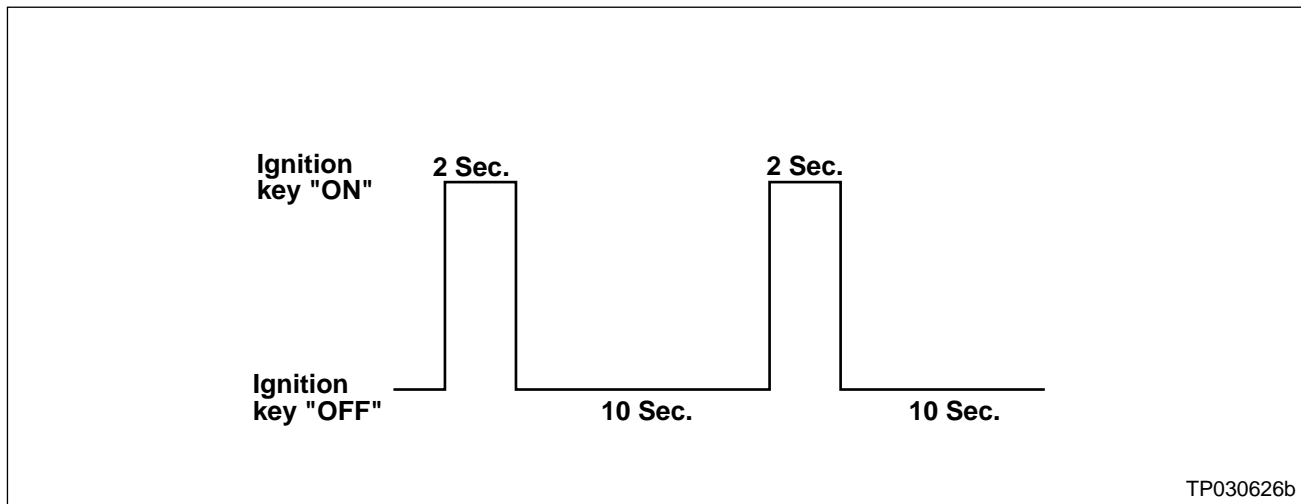
Figure 1

3. Perform the Accelerator Pedal & Throttle Valve Closed Position Learning as follows:
 - a. Make sure the accelerator pedal is fully released.
 - b. Turn the ignition switch "ON" for 2 seconds.
 - c. Turn the ignition switch "OFF" for 10 seconds.
 - d. Turn the ignition switch "ON" for 2 seconds, then
 - e. Turn the ignition switch "OFF" again for 10 seconds (see Figure 1).
 - f. Proceed with step 4 (next page).

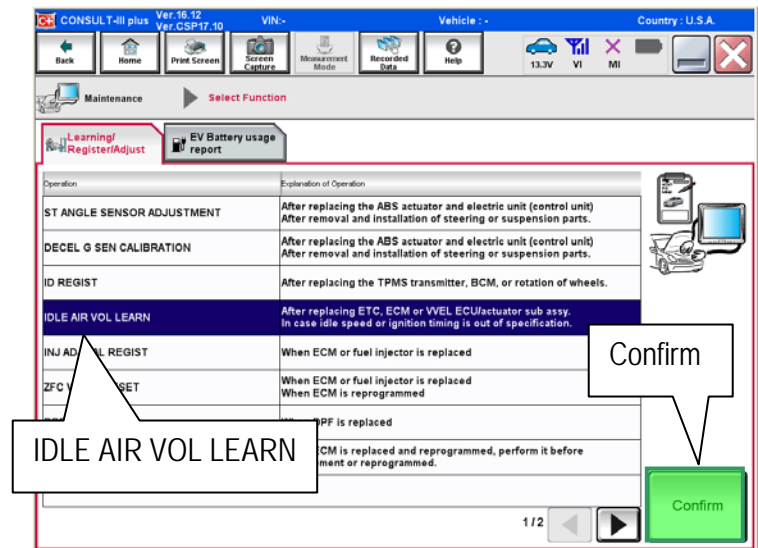
Figure 2

- c. In the CIII plus "Maintenance mode", select "IDLE AIR VOL LEARN" and then "Confirm". See Figure 2.

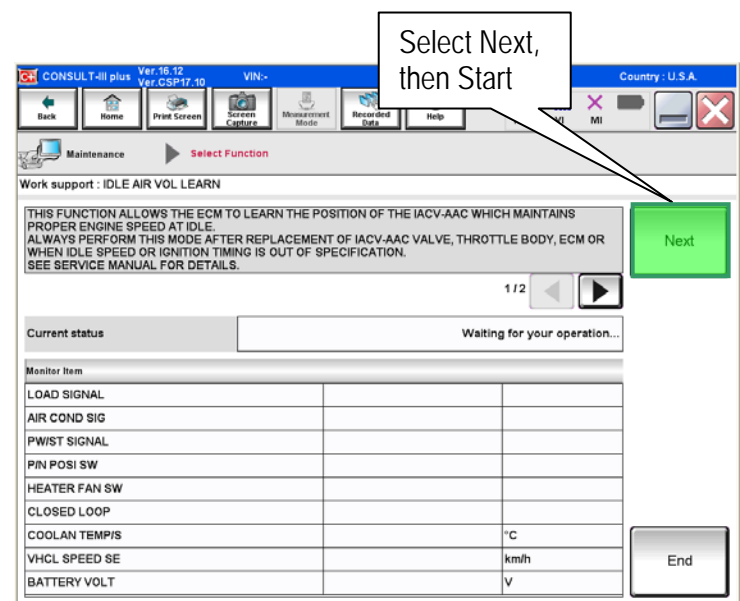
Figure 3

- d. Press "Next" then "Start" on the IDLE AIR VOL LEARN screen. See Figure 3.

- START cannot be selected until all operating conditions have been met.

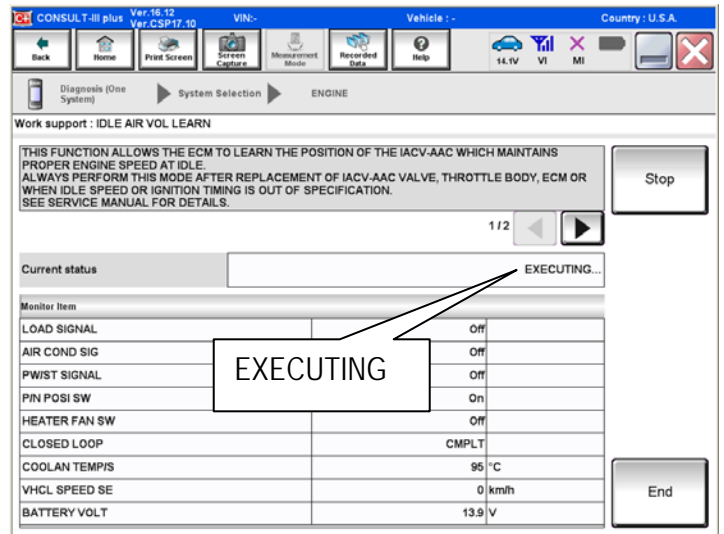
Figure 4

- The IAVL procedure will take several minutes to complete.
- CIII plus will display "EXECUTING" in the "Current status" box while the IAVL procedure is in process. See Figure 4.

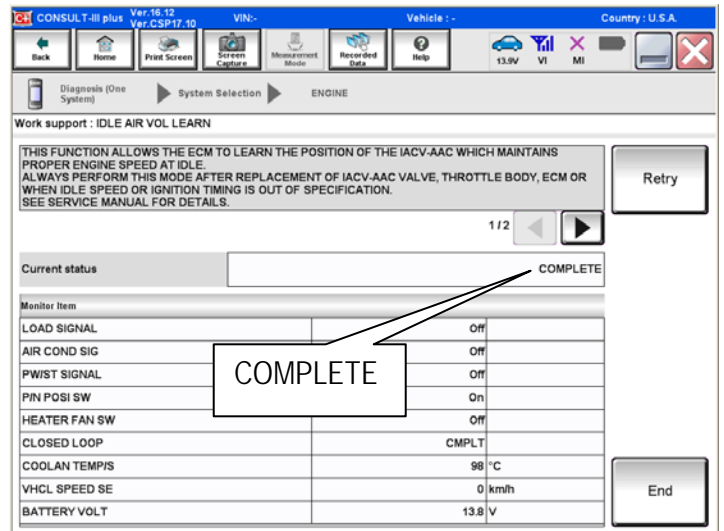
Figure 5

- CIII plus will display "COMPLETE" in the Current status box when the IAVL procedure is finished. See Figure 5.

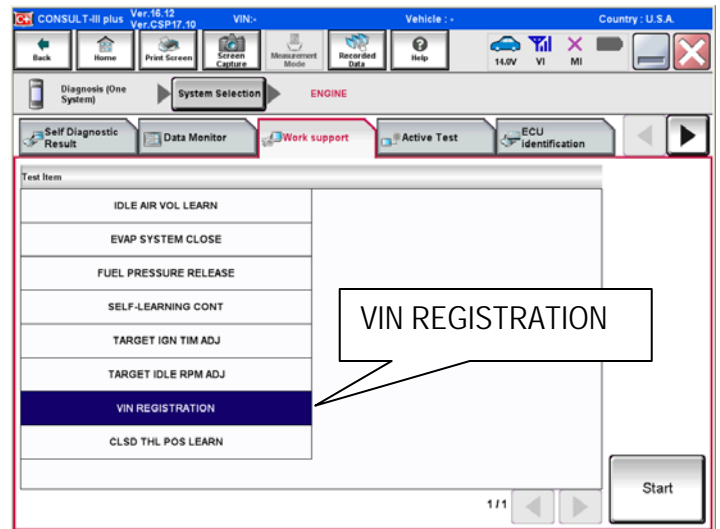
Figure 6

- a. Select "Diagnosis (One System)", "ENGINE", "Work support" and "VIN REGISTRATION". See Figure 6.

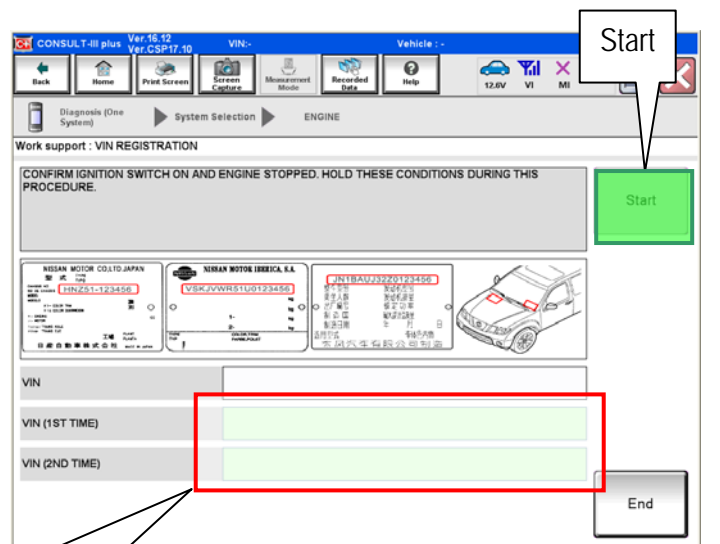
Figure 7

- b. Enter the vehicle VIN in both the VIN (1ST TIME) and VIN (2ND TIME) boxes, then select Start. See Figure 7.

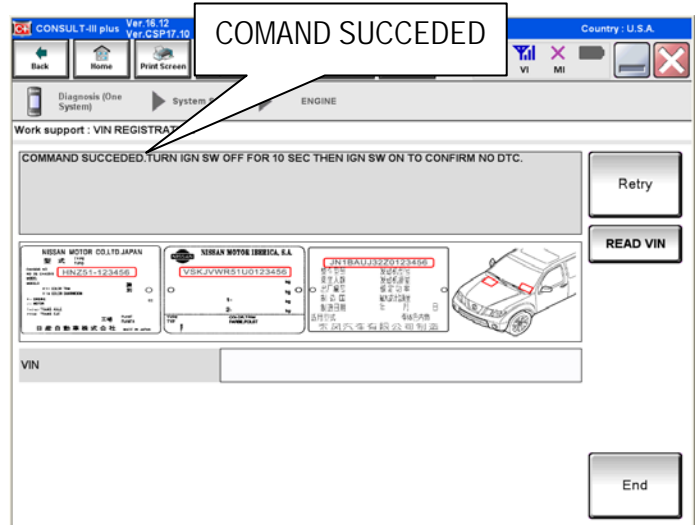
Figure 8

- c. Once completed (COMAND SUCCEEDED; See Figure 8) turn the ignition off for 10 seconds, then back on and check for any DTCs.
- d. Select "READ VIN" and confirm that the VIN is correct.
 - If VIN does not display it can also be checked through the "RE/programming, Configuration" tab.

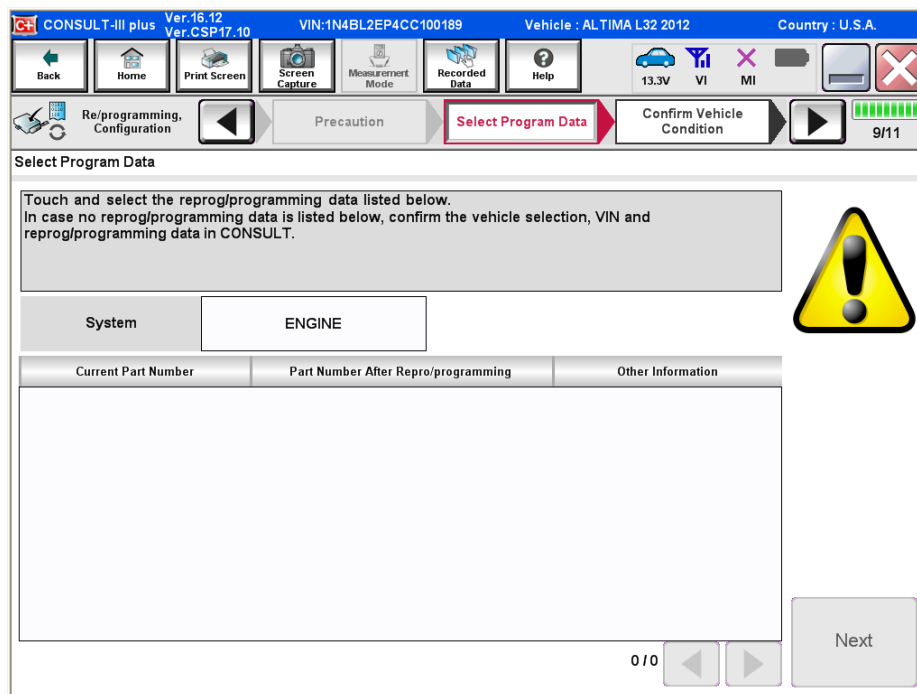
Figure 9

- 6. Check and confirm that ECM is updated to most recent part number and perform reprogram procedure if not most current.
 - Select and use the reprogramming option that **does not** have the message "Caution! Use ONLY with NTBXX-XXX".
 - If you are not familiar with checking for an ECM update or with the reprogramming procedure [click here](#). This will link you to the C-III plus "ECM Reprogramming general procedure".
 - If an update is not listed and a blank screen is displayed (see figure 9), a reprogram is not available for the ECM.
