EL12-061a

ITB12-054a

2010 – 2013; NAVIGATION SYSTEM REBOOTS OR AUDIO CONTROLS WILL NOT RESPOND

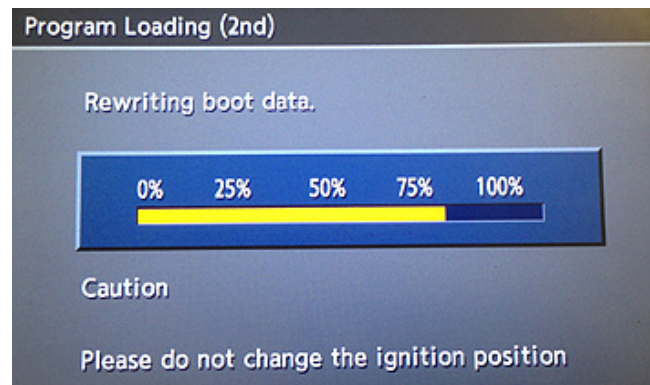
Figure 8

11. "Rewriting boot data" and "Rewriting program data" will be displayed once the DVD is reinstalled.
