**Classification:**  
 EC13-002a

**Reference:**  
 ITB13-019a

## 2013 M37/56 AND G37; MIL "ON" WITH DTC P0710

**APPLIED VEHICLES:**    2013 M37/56 (Y51)  
                                  2013 G37 Sedan (V36)  
                                  2013 G37 Coupe (CV36)  
                                  2013 G37 Convertible (HV36)

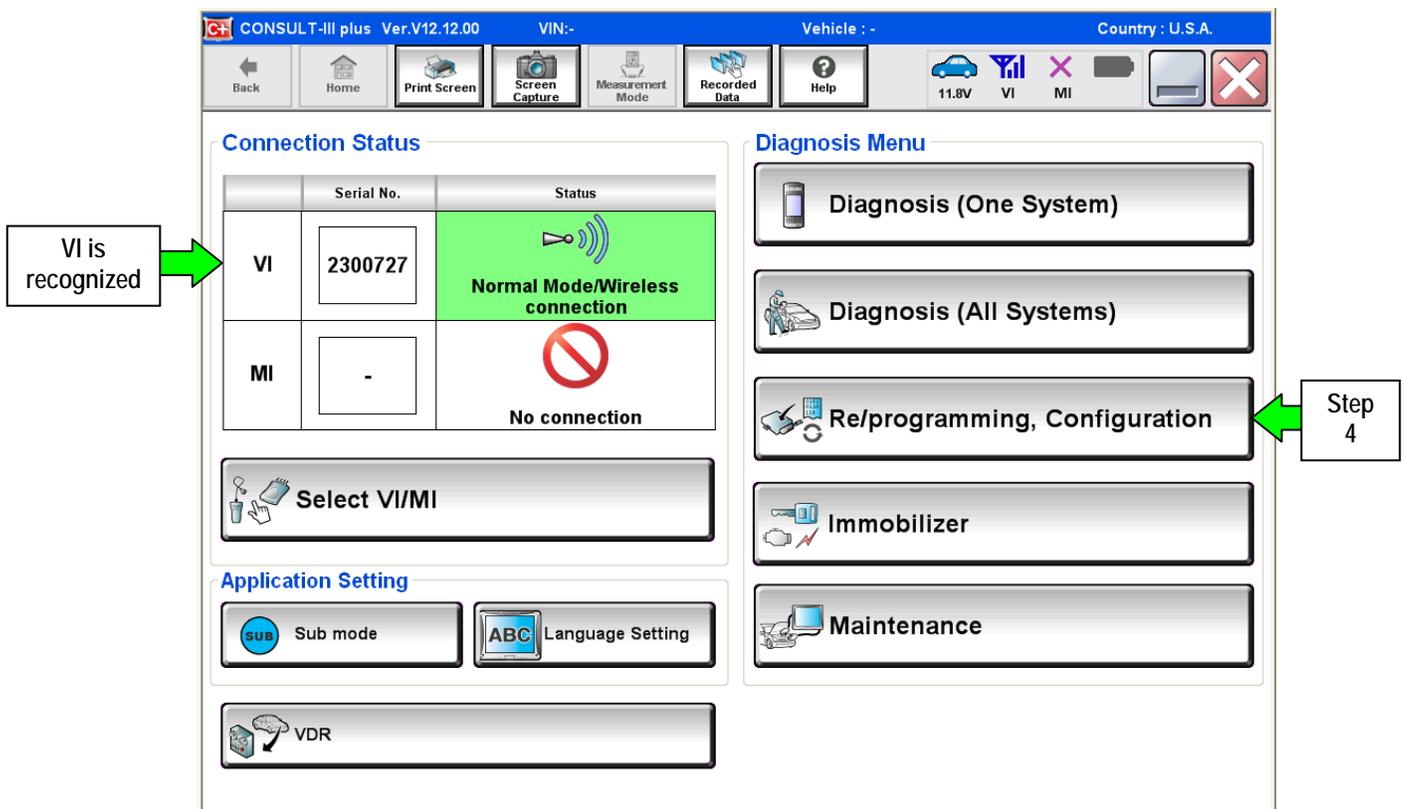
Figure 1

1. Connect the CONSULT PC to the vehicle to begin the reprogramming procedure.
2. Open ASIST on the CONSULT PC and start C-III plus.
3. Wait for the plus VI to be recognized / connected.
  - The serial number will display when the plus VI is recognized / connected.
4. Select **Re/programming, Configuration**.

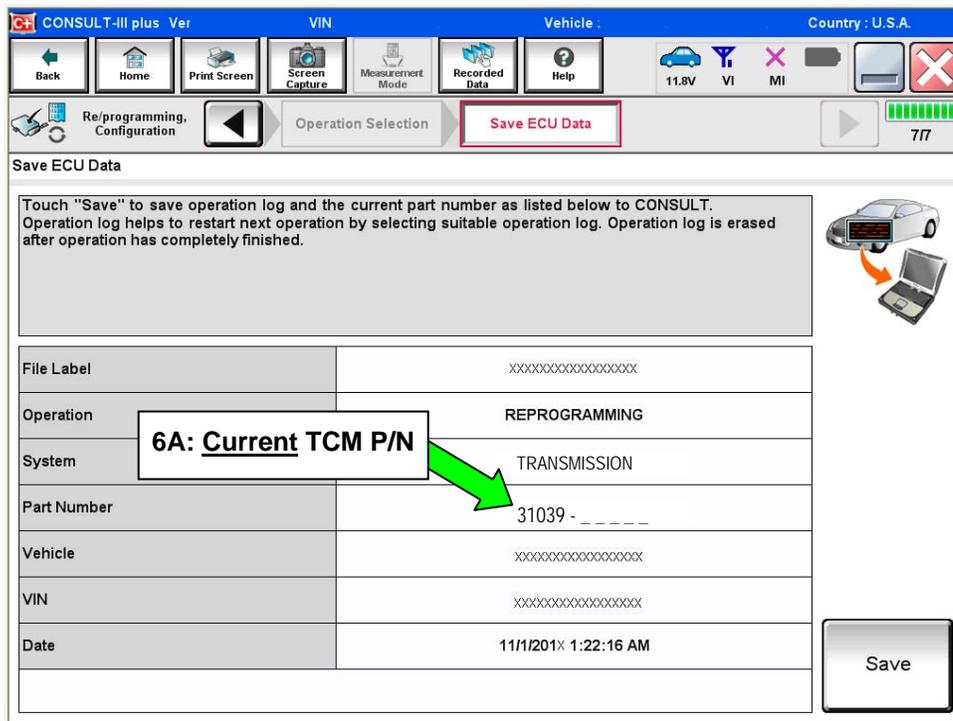
6. When you get to the screen shown in Figure 2, confirm this bulletin applies as follows.

A. Find the TCM Part Number and write it on the repair order.

**NOTE:** This is the current TCM Part Number (P/N).

5. Follow the on-screen instructions and navigate the C-III plus to the screen shown in Figure 2 on the next page.

B. Compare the P/N you wrote down to the numbers in the **Current TCM Part Number** column in **Table A** below.

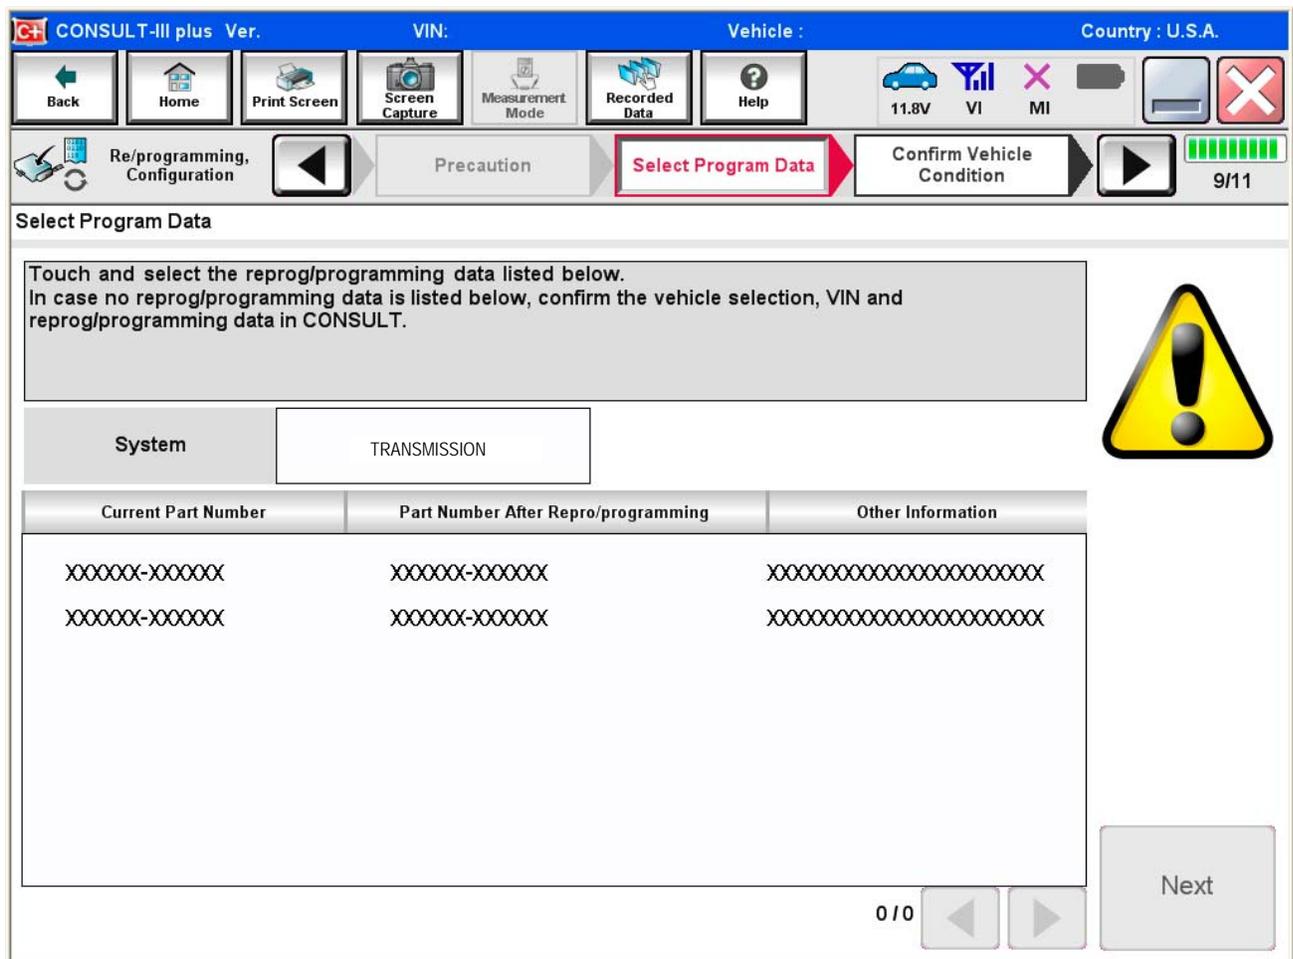
- In some cases, more than one new P/N for reprogramming is available.
  - In this case, the screen in Figure 3 displays.
  - Select and use the reprogramming option that **does not** have the message "Caution! Use ONLY with ITBXX-XXX".
- If you get this screen and it is blank (no reprogramming listed), it means there is no reprogramming available for this vehicle. Close C-III plus and refer back to ASIST for further diagnosis.

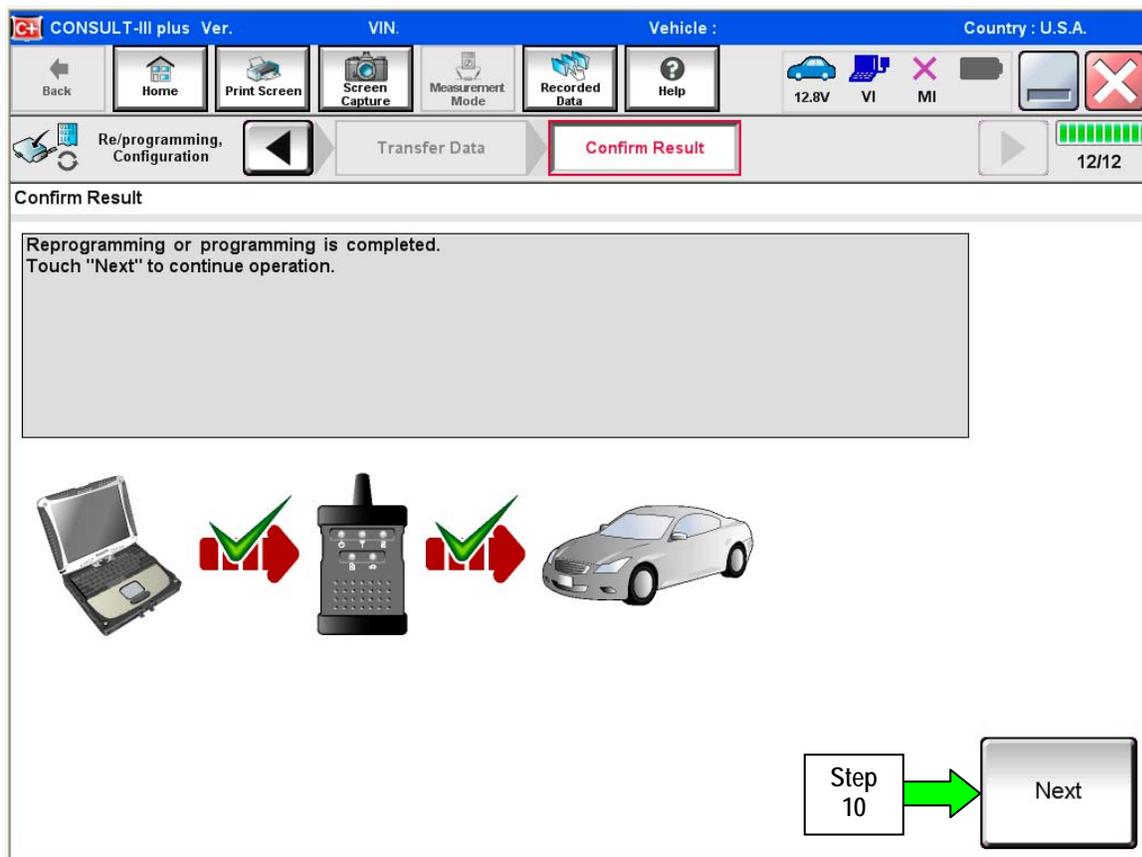
8. When the screen in Figure 4 displays, reprogramming is complete.
9. Disconnect the battery charger from the vehicle.
10. Select **Next**.

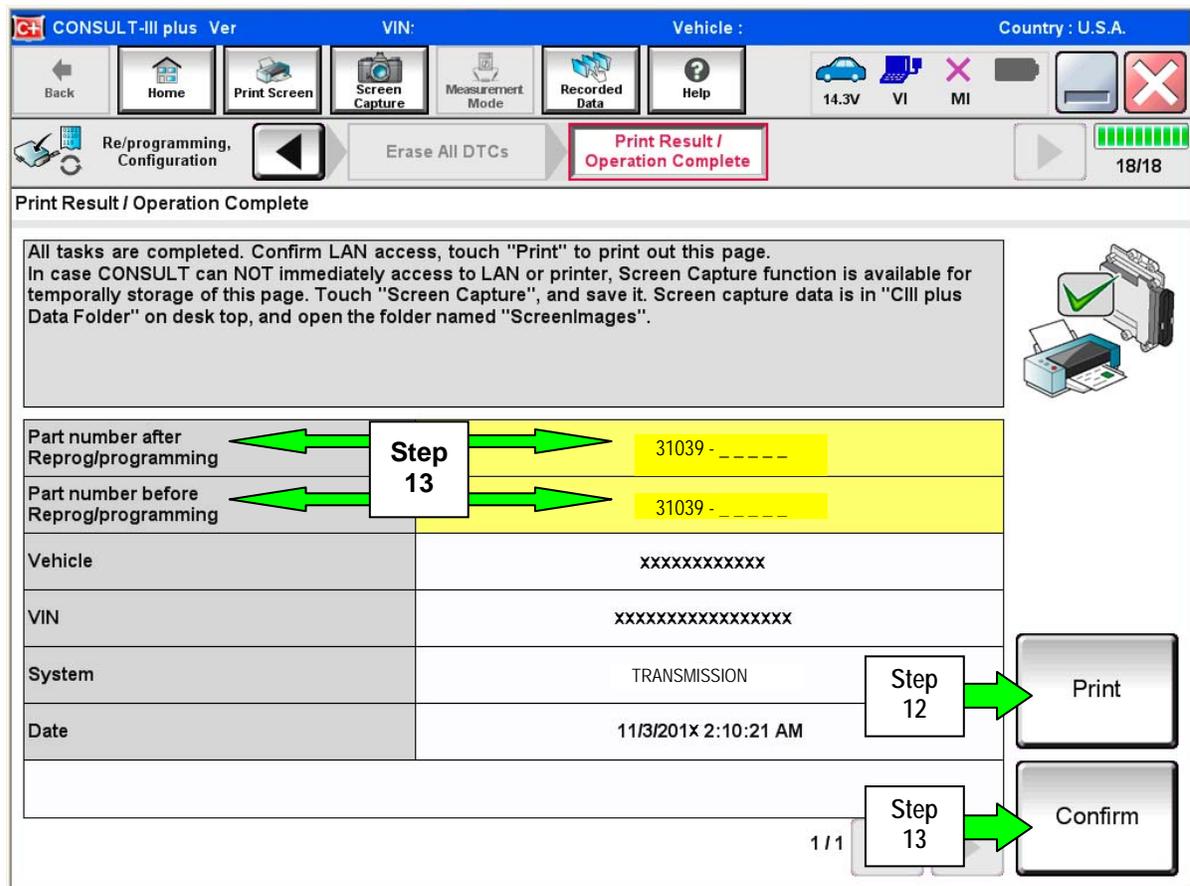
Figure 5

11. Verify the before and after part numbers are different.
12. Print a copy of this screen (Figure 5) and attach it to the repair order for warranty documentation.
13. Select **Confirm**.
