GI09-001a

ITB09-016a

INFINITI; SUPPLEMENTAL PRE-DELIVERY INSPECTION

This bulletin has been amended. The Applied VINs have been updated.

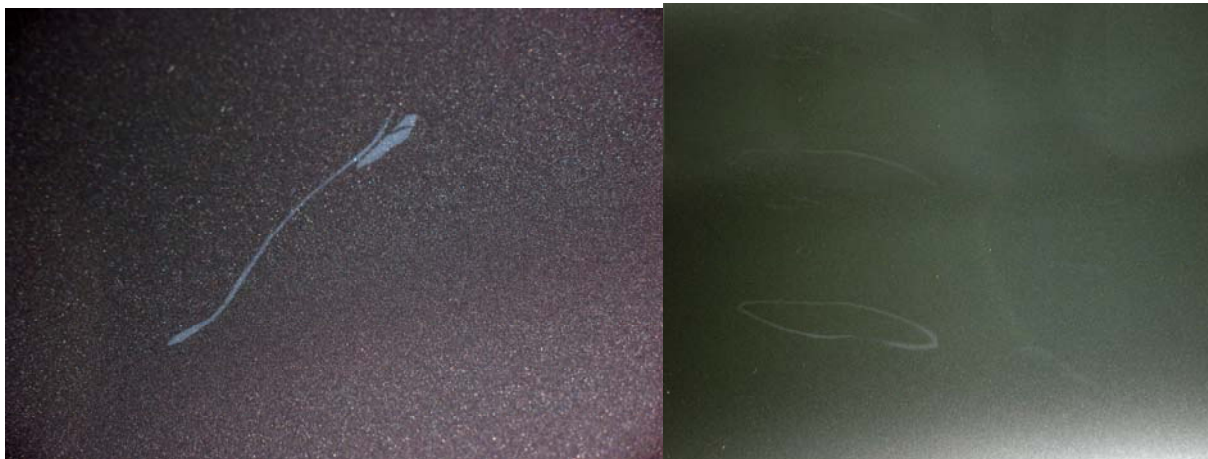
The paint under the PGF may absorb moisture which may cause temporary discoloration. Discoloration may appear as milky or whitish in color, or coffee stained (refer to the figures below for examples).

The size of the swell, stain, or spot may range from a dime to a clenched fist. It may have an irregular shape, and possibly a slightly raised surface. It may also have the appearance of streaks or lines. This incident may occur anywhere on horizontal and vertical painted surfaces under the PGF. In any case, use the following service procedure to correct the incident.

Use one of the following procedures to remove the moisture from the effected area(s).

In warm weather, place the vehicle in sun light. The paint condition should disappear in a few hours depending on the severity of the condition.

In cold weather, place the vehicle indoors at a temperature of approximately 70° F. The paint condition should disappear in about 8 to 12 hours depending on the severity of the condition.

If the condition does not disappear after the above service procedures are performed, the condition may be permanent and the affected area may have to be re-painted.

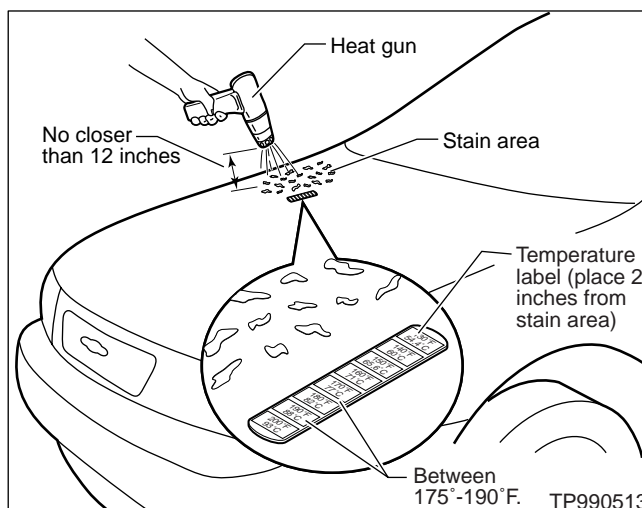
- The maximum total bulb wattage for the infrared heat lamp should not exceed 750 watts.
- The heat gun wattage should not exceed 1400 watts.
- Affix a paper label thermometer on the paint surface two inches away from the affected area (see Figure 4 below) to monitor the surface temperature.

- Do not hold the heat gun closer than 12 inches from the paint surface. Also, do not hold the heat gun in one position. Move it continuously. Alternate between circular and side-to-side motions. This will heat the surface area more evenly.
- Maintain the heat lamp/heat gun distance so the painted surface temperature is between 175° and 190°F (80° - 90°C).
- Do not apply the heat gun for more than 5 minutes as permanent damage (i.e., bubbling, burns, etc.) can occur to the paint.
- Do not apply heat directly on the paper label thermometer, as this will give a false temperature reading.

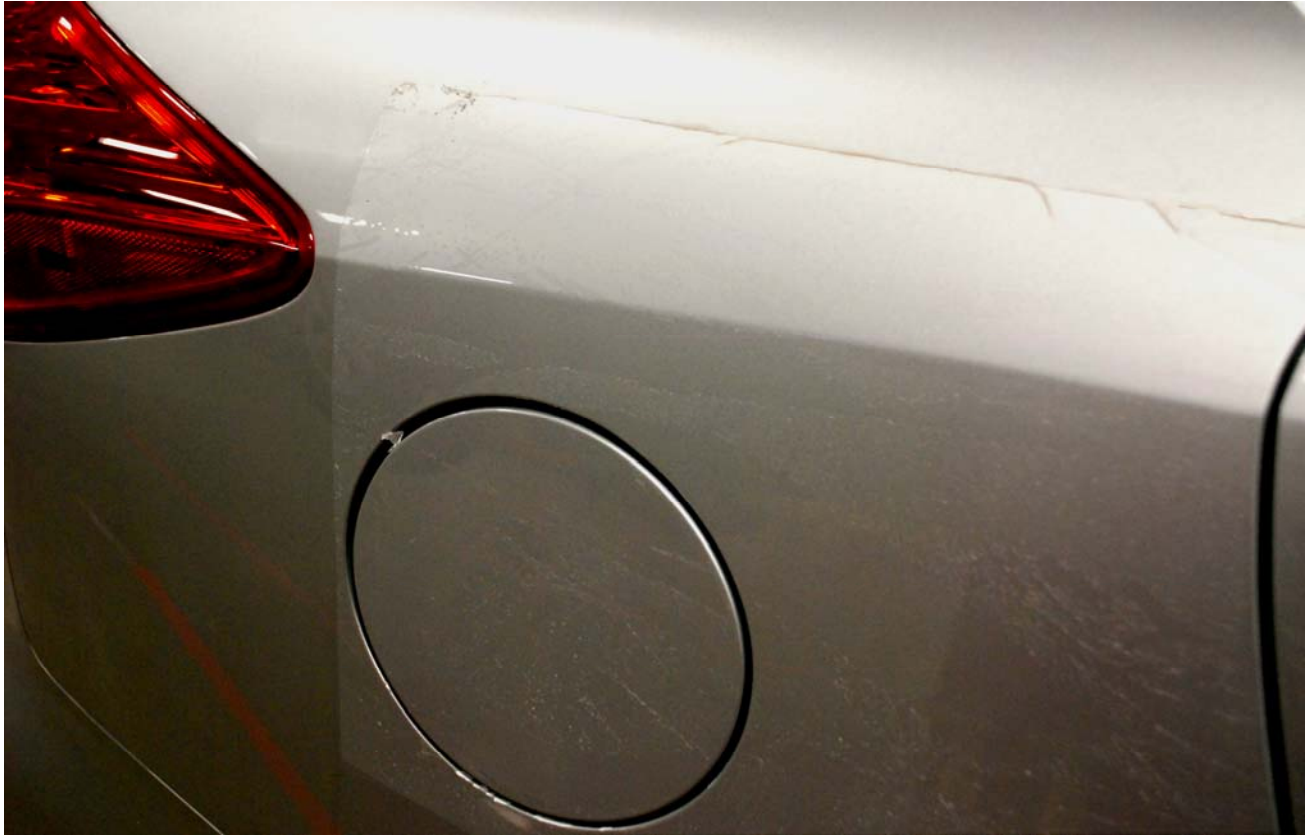
In some cases, thin lines or small patches of adhesive residue may be left on the painted body surfaces of vehicles after removing the paint guard film (PGF).

While removing the residue, you must use care not to scratch or mar the paint. Use a clean, soft, cotton cloth, and a solvent listed below or equivalent:

- 3M General Purpose Adhesive Cleaner, P/N 08984
- 3M Prep Solvent-70 [Low-V.O.C. (Volatile Organic Compounds)], P/N 08983

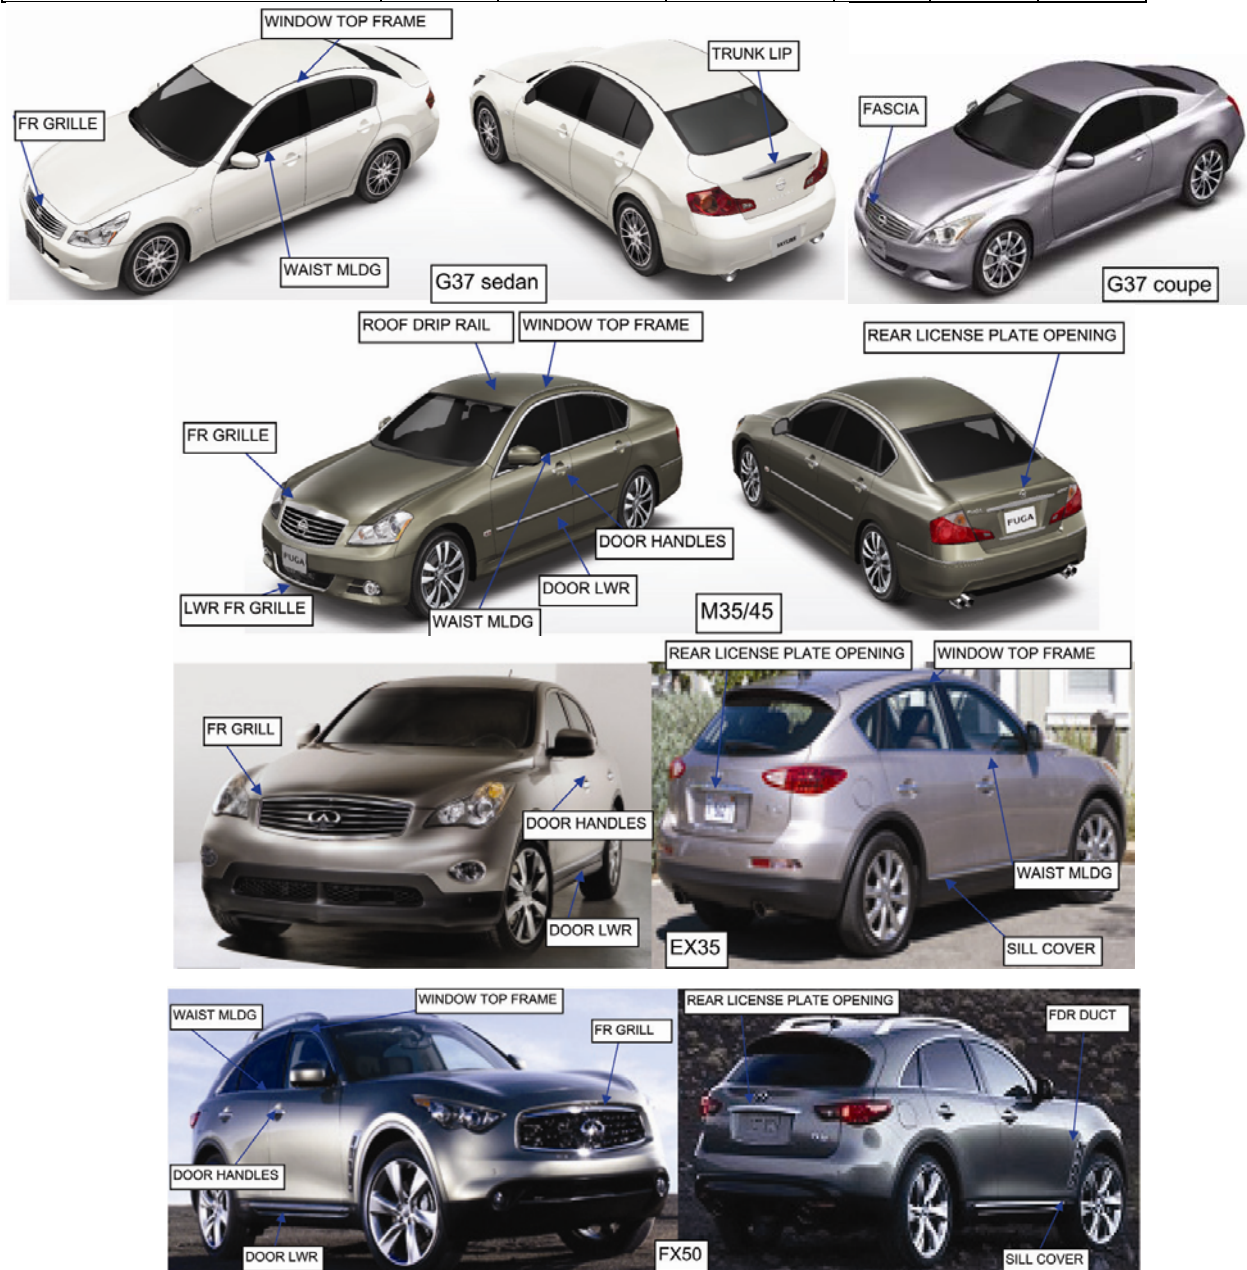
If necessary clean trim using the guidelines in the chart below.

1 = Use 3M™ Finesse-it™ II Glaze P/N 05928 or equivalent. Do NOT rub for more than fifteen (15) seconds.

2 = Clean with a mild detergent and water.

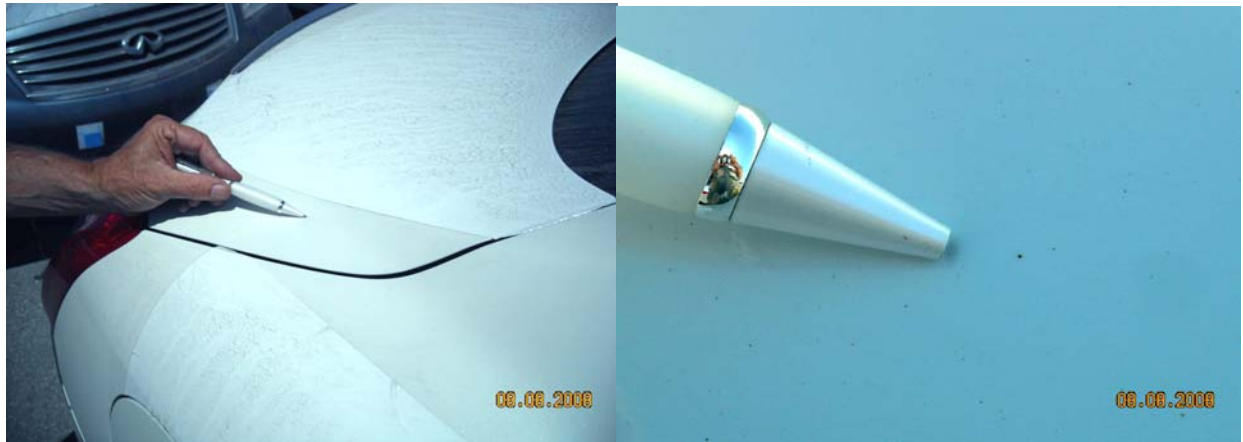
Environmental iron particles (sometimes called “rail dust”) can be identified as follows:

- On light-colored painted surfaces: Small rust/orange dots with black centers.
- On dark-colored painted surfaces: Small white or silver dots with a “rainbow hue” around the edge.

In both cases, the surface will feel rough or gritty to the touch.

1. Use a magnifying glass to check if iron particles are present.
2. Repair the paint damage (surface level only):

- Remove the iron particles using: 3M™ Perfect-It™ III Cleaner Clay, P/N 38070, or equivalent.

- Remove the iron particles using a chemical cleaning product such as ValuGard™ 3-Step Neutralization/Decontamination System by Automotive International, Inc., or equivalent.
