**Classification:**  
FA 10-007

**Reference:**  
ITB10-067

## WHEEL BEARING COLLISION DAMAGE

**APPLIED VEHICLES:** All Infiniti

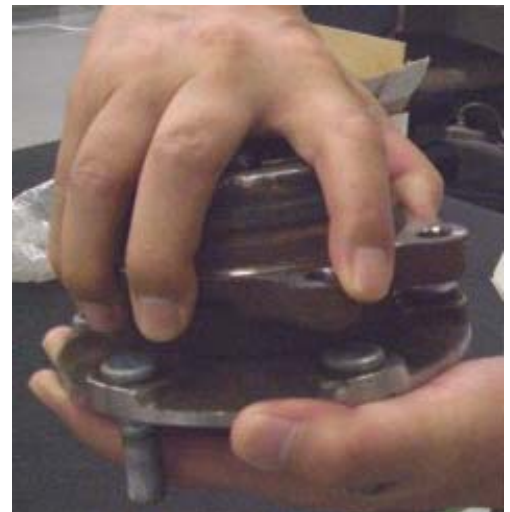
1. Remove the hub/bearing assembly from the vehicle.
2. Hold the hub/bearing assembly with both hands.
3. Rotate the hub/bearing assembly in both directions (clockwise and counterclockwise).
4. If any gritty or rough feeling is detected in the bearing replace it with a new one.
