Classification:
BT99-032c

Reference:
ITB99-043c

PAINT SWELL/STAIN/SPOTS UNDER PAINT GUARD FILM

APPLIED VEHICLES: All Infiniti Models with PGF

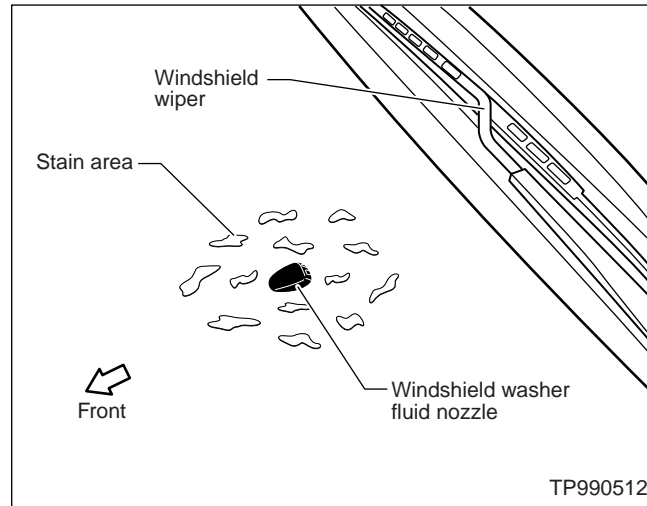
Figure 1

If an Infiniti vehicle exhibits swelling, stains or spots on the paint finish (which appear milky or whitish on dark colored vehicles and dark-shaded or coffee-colored on light colored vehicles) immediately after the PGF is removed, the cause may be moisture collection under pockets/creases of the PGF. The paint may absorb moisture which may cause the affected paint finish area to temporarily discolor.

The size of the swell, stain, or spot may range from a dime to a clinched fist and have an irregular shape and possibly a slightly raised surface. This incident may occur anywhere under the PGF, but may be noted in particular to occur around the windshield fluid nozzle (see Figure 1) and on the deck lid. In any case, use the following service procedure to correct the incident.

Use one of the following procedures to remove the moisture from the effected area(s).

In warm weather, place the vehicle in the sun light. The paint condition should disappear in a few hours depending on the severity of the condition.

In cold weather, place the vehicle indoors at a temperature of approximately 70° F. The paint condition should disappear in about 8 to 12 hours depending on the severity of the condition.

To speed up the recovery process of the condition, use a portable infrared heat lamp or a heat gun. Follow the "Important Points" listed below when using a heat lamp or a heat gun.

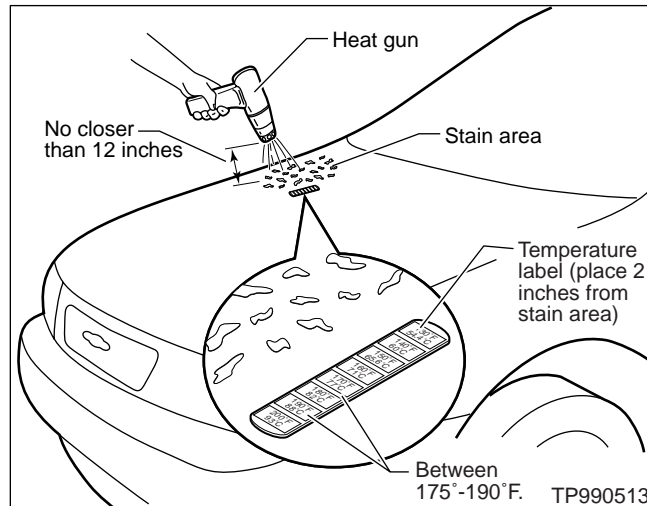
Figure 2

- The maximum total bulb wattage for the infrared heat lamp should not exceed 750 watts.
- The heat gun wattage should be between 1200 and 1400 watts.
- Maintain the heat lamp/heat gun distance so the painted surface temperature is between 175° and 190° F (80° - 90° C). Affix a paper label thermometer on the paint surface, two inches away from the effected area (see Figure 2), to monitor the surface temperature.

- Do not apply the heat gun for more than 5 minutes as permanent damage (i.e., bubbling, burns, etc.) can occur to the paint.
- Do not hold the heat gun closer than 12 inches from the paint surface. Also, do not hold the heat gun in one position, rather, move it continuously from side to side to heat the affected area evenly.
- Do not apply heat directly on to the paper label thermometer, as this will give a false temperature reading.
